Assessment Report – Battery Event at Narita on
a Boeing 787 aircraft operated by Japan Airlines

December 19, 2014
Japan Civil Aviation Bureau

- Operator : Japan Airlines Co., Ltd. (JAL)
- Type : Boeing 787-8
- Registration Number : JA834J
- Time of event : Approximately 16:15 (time is Japan Standard Time, the same shall apply hereinafter)
January 14, 2014
- Assessment : Battery event at Narita International Airport

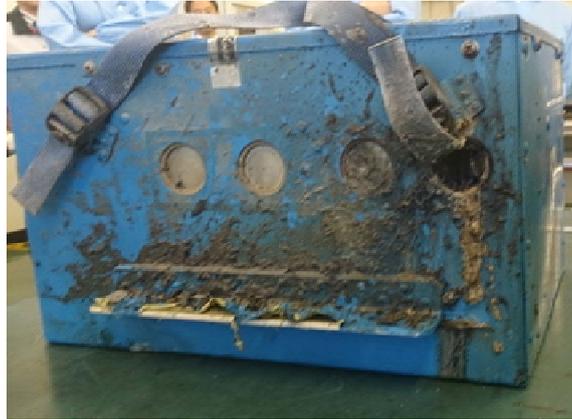
- b) Upon opening the main battery enclosure after the aircraft was towed into a hangar, traces of spilled electrolyte were observed inside the enclosure. Also, it was confirmed that the rupture disk of cell 5, which is one of eight (8) cells within the battery, was ruptured.

Outside surface of the battery
(Only the rupture disk of cell 5, most right, was ruptured).

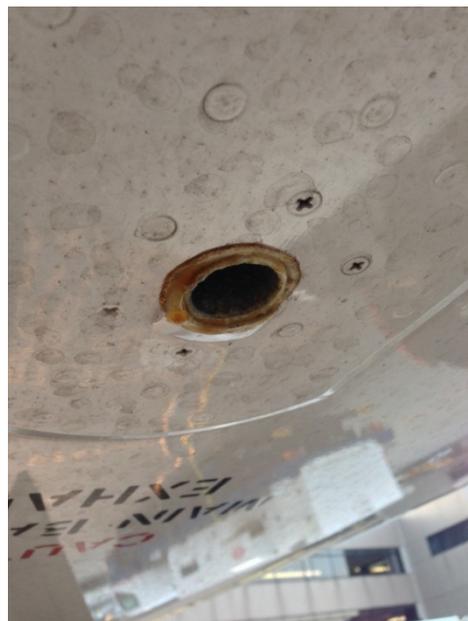
- c) Also, brownish liquid residue was around the area adjacent to the external vent port, which is located at the bottom of the aircraft and vents smoke and gas, etc from the battery enclosure.

External view of the vent port area

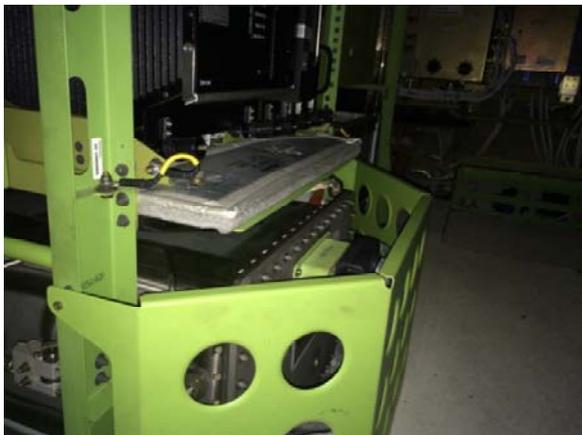
- d) In the forward Electrical/Electronics bay, no damage was found at the area adjacent to the enclosure.

Conditions surrounding the battery enclosure

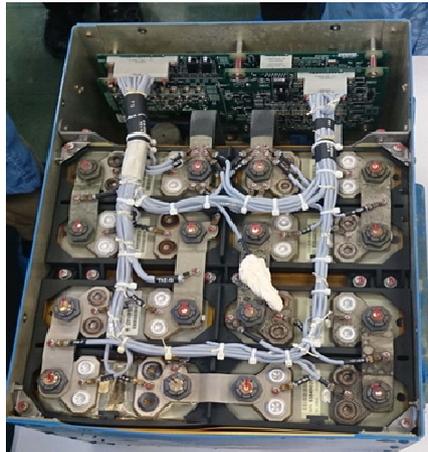
Conditions inside the battery

- g) Water droplets were observed at the time of the battery opening at Narita on the top cover insulator (on the face close to the battery cells) and also on bus bars. Other water traces were also observed inside the battery box at various locations such as: battery box sides, and on the bottom face close to the drain holes during the DPA of the battery at GS Yuasa.

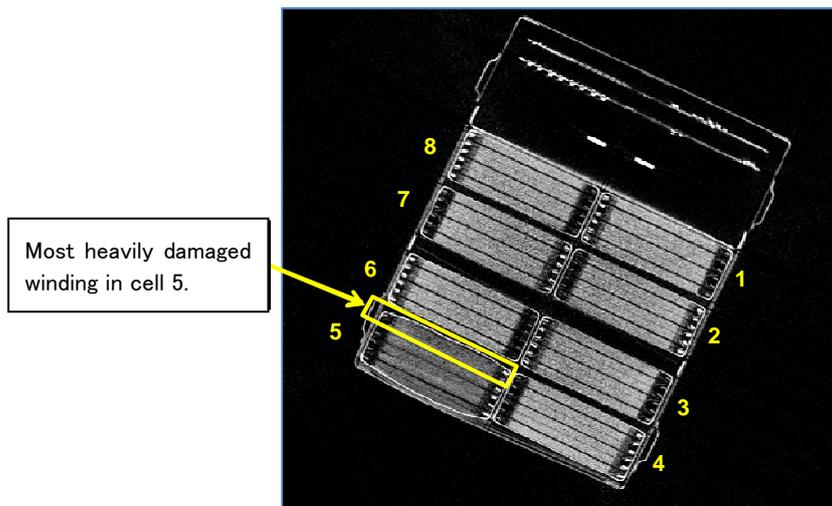
CT scan of the Battery

- b) Cell 5 was swollen and the positive current collector (aluminum) was partially melted.
- c) CT scanning inspection of each cell revealed no internal damage in any cell except for cell 5.

- g) Uneven levels of electrolyte between cells:
A CT scanning inspection revealed that levels of electrolyte varied slightly between cells, except for the vented cell 5. This result was deemed to possibly indicate leakage from cells. However, a leakage test by helium gas revealed that all cells, except for cell 5, met the leakage criteria required at manufacturing. Thus, no leakage was detected by the He leak test.

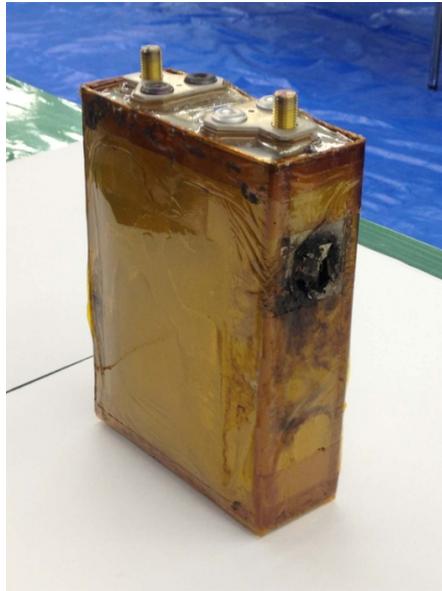
Cell 5 (Rupture disk was ruptured)

overheated/damaged and the rupture disk of cell 5 was ruptured.

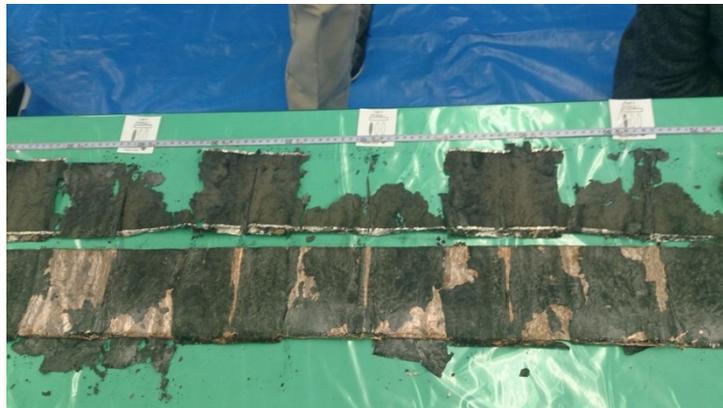
The three windings of cell 5 were damaged and the winding in the vicinity of cell 6 was the most heavily damaged. DPA of windings was not able to identify the initial cause of the heat.

Also, among the six (6) positive electrode current collectors (aluminum, with melting point of about 660 degree C) in cell 5, the two (2) current collectors closest to cell 6 were melted and had opened (fused open).

DPA of cell 5

Cell 5 was heavily damaged and all separators were deemed to be melted due to heat. Also, a large part of the base material of cathode (aluminum foil, with melting point of about 660 degree C) was lost, especially in the area close to the center of the winding near cell 6. Multiple samples selected from the remaining electrodes of cell 5

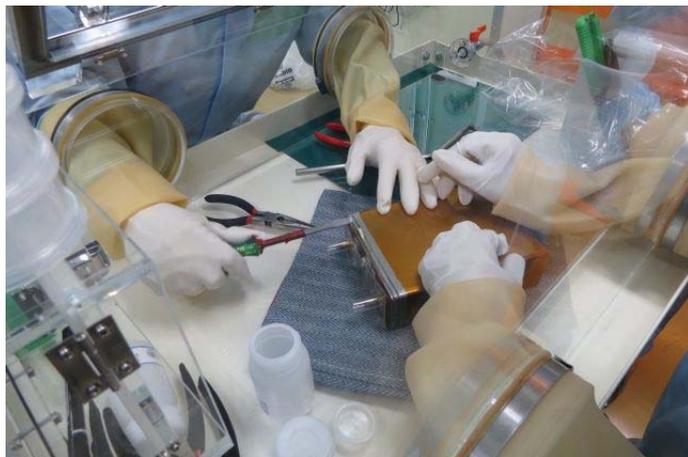
This inspection found some metallic particles (multiple, the size of 10 to 200 micrometer in diameter) in the windings of cell 2, 3 and 4. Component elemental analysis revealed that the material of the particles was steel, copper, or aluminum.

DPA of a cell in a glove box

Also, a small white/gray deposit was observed on the anode of cell 3 winding (at one (1) location) and monochromatic X-ray photoelectron spectroscopy (XPS) analysis revealed that small deposit was possibly metallic lithium.

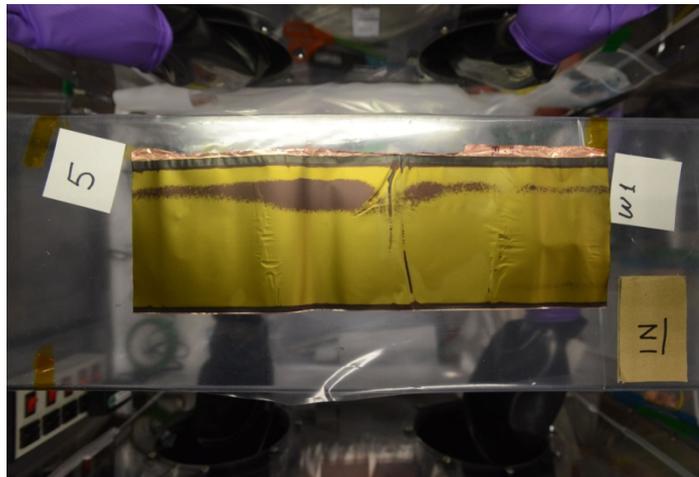
Wrinkle in anode foil

Except for cell 5, the four (4) cells (Cells 2, 3, 4 and 6) were disassembled, at 100% SOC (State of Charge) for cell 2, 3, and 4, and at 30% SOC for cell 6 respectively, to easily determine the electrode charge condition and it was confirmed that wrinkles were present on the anode foils in each cell. Due to the thermal damage and results of the electrical tests, cell 6 was disassembled at 30% SOC to avoid further damage.

- h) Regarding the wrinkles observed on anodes, it is said that wrinkles result in uneven distances between the anode and cathode and may facilitate the formation of lithium dendrites. However, only a small amount of possibly lithium metal was detected during the assessment of the cells from this event. Thus, no evidence was found that wrinkles could directly cause an internal short circuit.
