**Final Report  
of Committee on Large Container Ship Safety**

Committee on Large Container Ship Safety

The Bahamian flagged large container ship (8,000 TEU class) “MOL COMFORT” (herein referred to as “The Ship”) experienced a fracture of midship part while transiting the Indian Ocean from Singapore to Jeddah (Saudi Arabia) on 17 June 2013. Following this, The Ship split into two halves, which were adrift before sinking. Thanks to the swift rescue efforts of ships navigating the area and Indian disaster relief authorities, no loss of life occurred in this accident. We express our gratitude to those involved in this rescue.

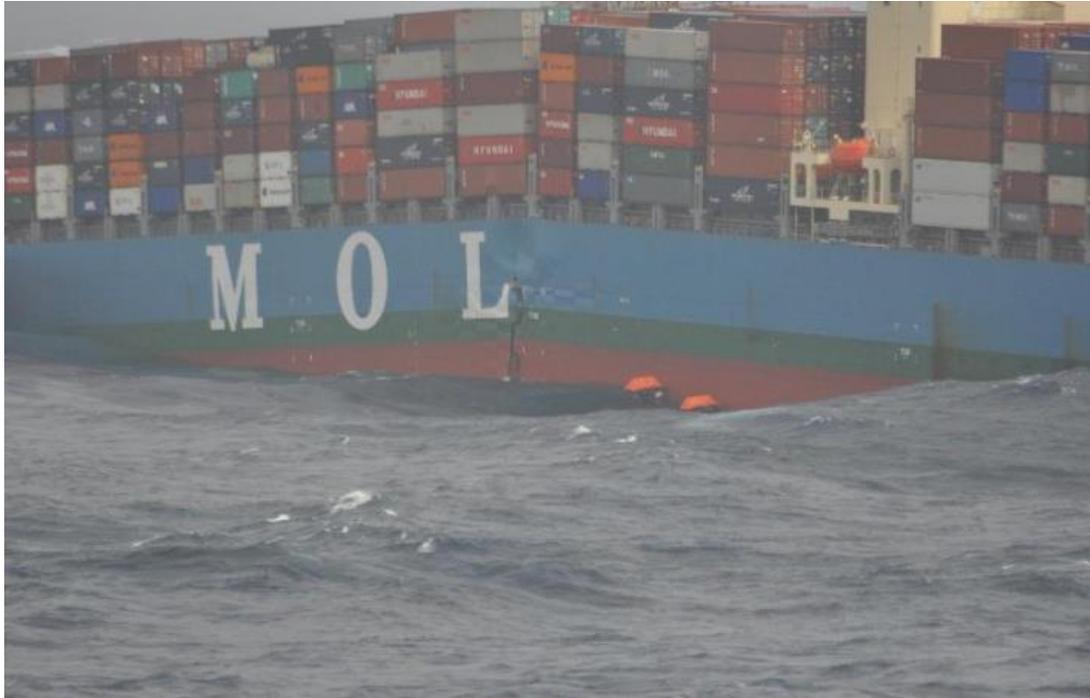
Water ingress was first detected by the water ingress alarm in the Duct Keel located near the center line of the double bottom of The Ship. Approximately two minutes later, further water ingress was detected in No.6 Cargo Hold located on the double bottom midship part. From the enlarged view in Fig. 1.3.1, the

crack progression ran upwards from the bottom of The Ship, at No.6 Cargo Hold. From this, it was assumed that the crack which triggered the fracture had originated in the bottom shell plates below No.6 Cargo Hold midship part.

Fig 1.3.1 Condition of The Ship at the time of the accident  
(Direction of the crack progression (photo by Mitsui O.S.K. Lines, Ltd))

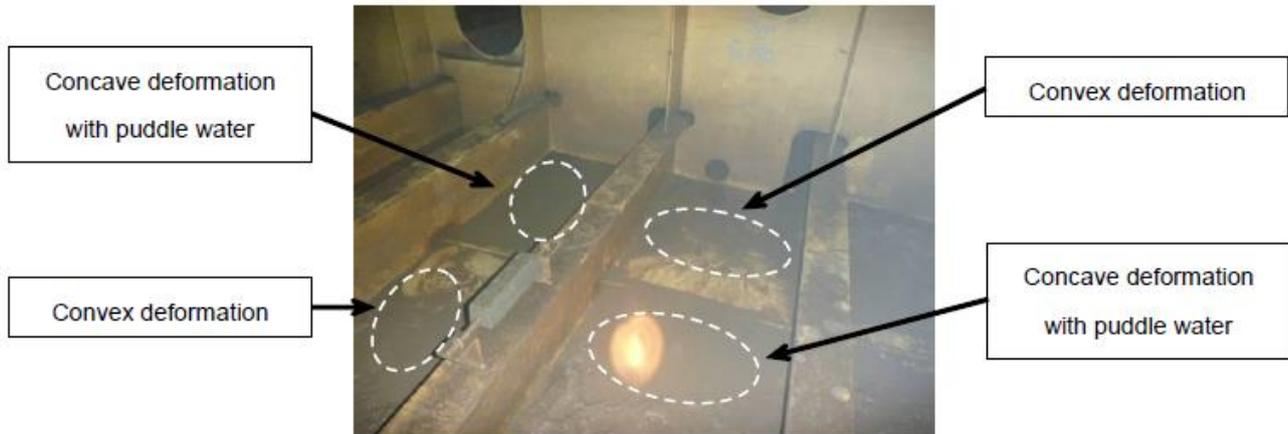
Fig 1.4.1 Example of buckling deformations observed in the bottom shell plates in double bottom midship part found on The Sister Ship operated by the same operator of The Ship (photo by Mitsui O.S.K. Lines, Ltd.)

Fig. 1.4.1 shows an example of deformation observed in The Sister Ship operated by the same operator of The Ship. The concave and convex buckling deformation of the bottom shell plates were observed between the bottom longitudinal stiffeners which were not deformed.

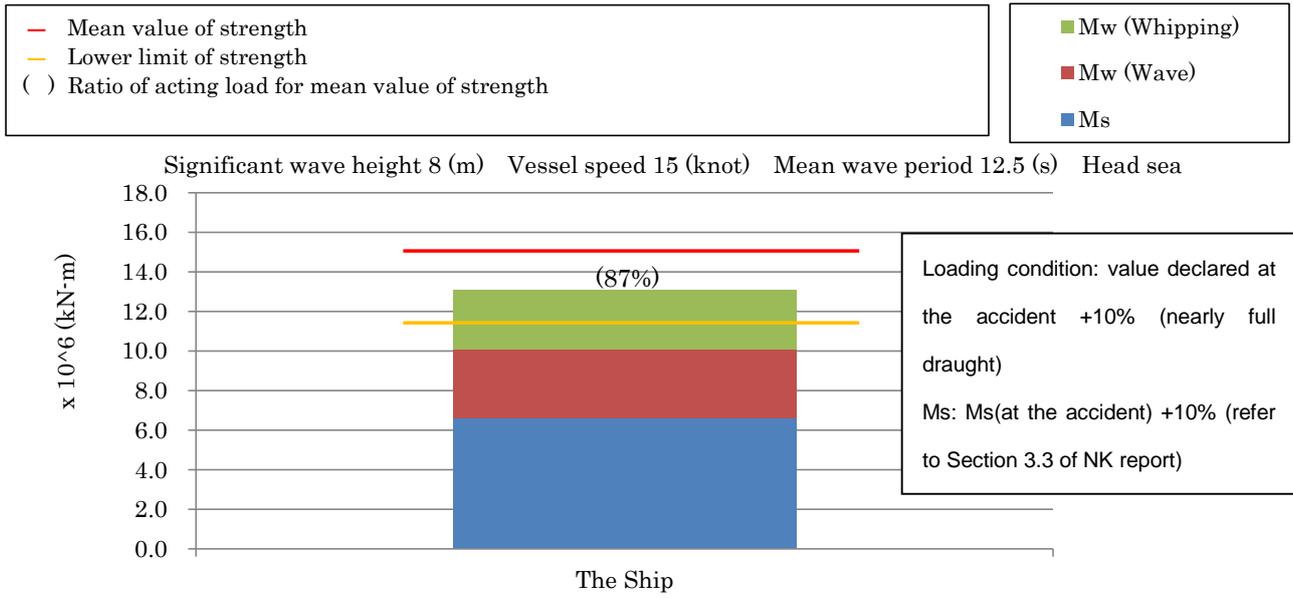
In order to verify the possibility of the accident, the simulation of acting loads was conducted by changing the condition of ship speed, significant wave height and mean wave period, taking into account deviation of the weather and sea conditions. And the result of this simulation was compared with ship structural strength simulated by calculation. In this simulation, ship speed and sea conditions (significant wave height, mean wave period and wave direction) were changed except for the wave direction in order to confirm that the condition, set in NK report which indicated the possibility of the accident, does not lead to peculiar results. Consequently, it was verified that it is actually possible that ship fracture happened where the load of the vertical bending moment exceeded the ship structural strength at the time of the accident as shown in Table 2.2.1 and Figure 2.2.1.

Figure 2.2.1 Consideration for possibility of the accident

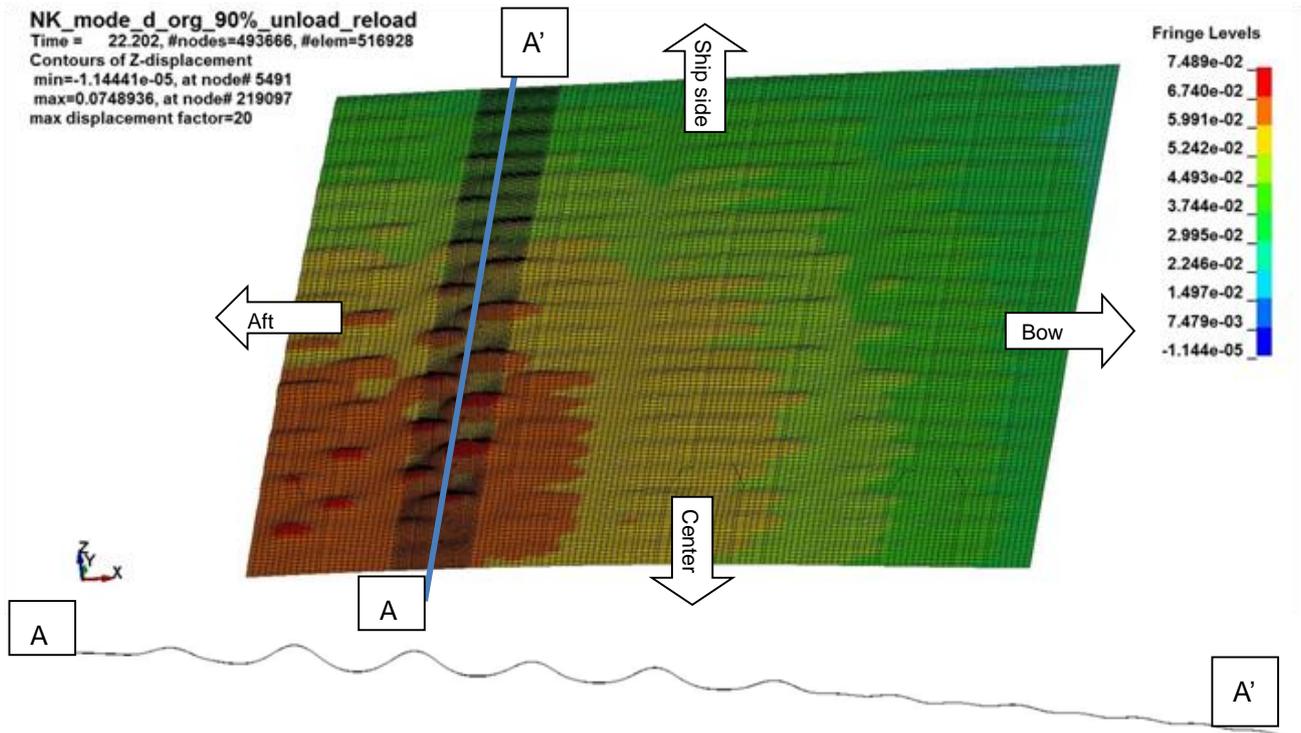
The buckling deformations of about 20mm height have been found in the bottom shell plates during safety inspection of the Sister Ships. In order to reproduce those phenomena, the simulation of structural strength of The Ship was conducted by applying slightly lower loads than the ship structural strength calculated under the condition of mean values of material strength and the assumption of possible small initial shape imperfection of construction in the bottom shell plates. Consequently, it was found that buckling deformations of the bottom shell plates might occur and then increase under subsequent repeated loads. The loads were applied in the following manner: when the load was, for example, a maximum of 90% of the mean value of the ship structural strength (95.2% of ultimate hull girder strength in case of the initial deformation given in Annex 3), the 90% of the mean value of the ship structural strength was applied first after providing the initial deflection of Annex 3 and kept in a certain period of time and unloaded to the value of still water bending moment (Ms). The loading/unloading were repeated between Ms and the 90% of the mean value of the ship structural strength. The reproduction of buckling deformations of the bottom shell plates was verified by the simulation of residual deformation after unloaded to Ms. The deformation was accumulated under such repeated loads and height of deformation was increased. It should be noted that the estimated value of the deformation tends to be large due to the characteristics of solution method of simulation. (refer to Figure 2.3.1 and Annex 3)

Maximum deformation 17.01 mm (double amplitude quantitative, deformation between longitudinal stiffeners would be about half of this double amplitude)

Figure 2.3.1 Sample of Simulation for Reproduction of buckling deformations on bottom shell plates (At Fourth unloading after repeatedly providing 90% of mean value of strength (95.2% of hull girder ultimate strength in case initial deformation (Annex 3) was provided))

As mentioned in paragraph 2.1, the values of the estimated hull girder ultimate strength of each The Sister Ship have the deviation. Therefore, the value of loads, which caused the buckling deformation, could not be definitely specified. However, it was found that buckling deformation of the bottom shell plates might occur in The Sister Ships although hull girder fracture did not occur.

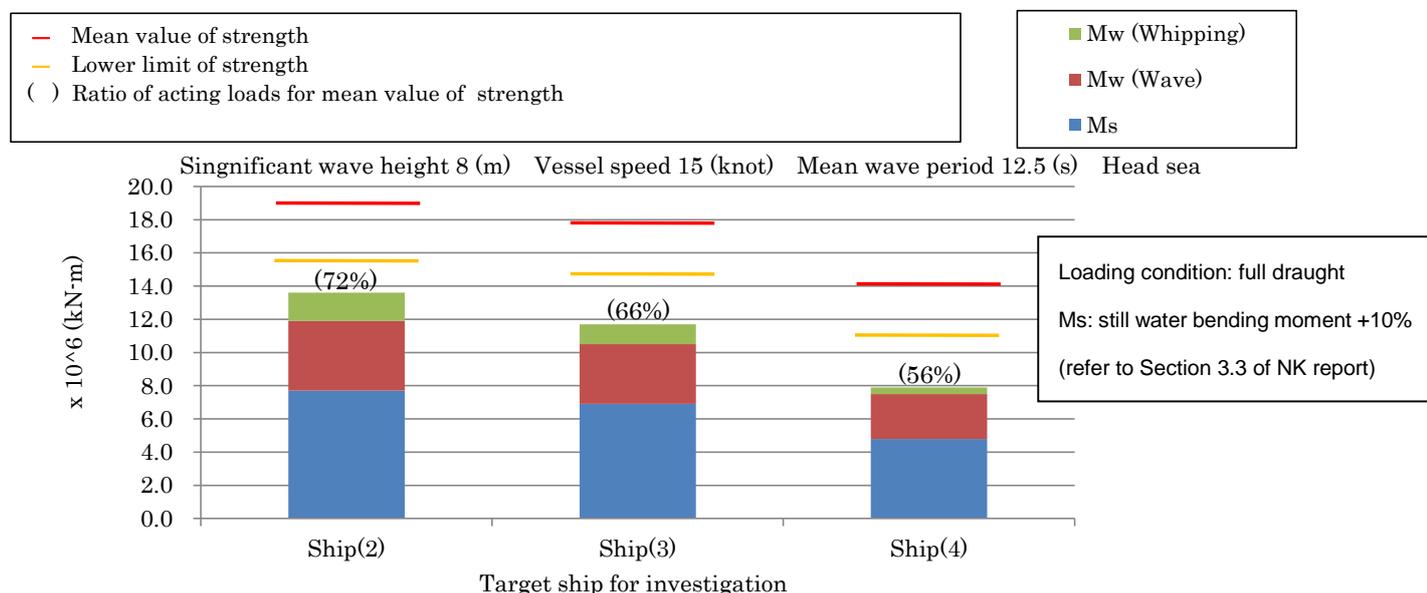
The results of the comparison between ship structural strength and acting loads are shown in Figure 3.3.1, which should be contrasted to Figure 2.2.1. It can be found that the large container ships except for The Ship (accident ship) had enough margins for ship structural strength compared to The Ship (refer to Figure 2.2.1).

Figure 3.3.1 Ship structural strength and acting loads for large container ships (other than The Sister Ships)

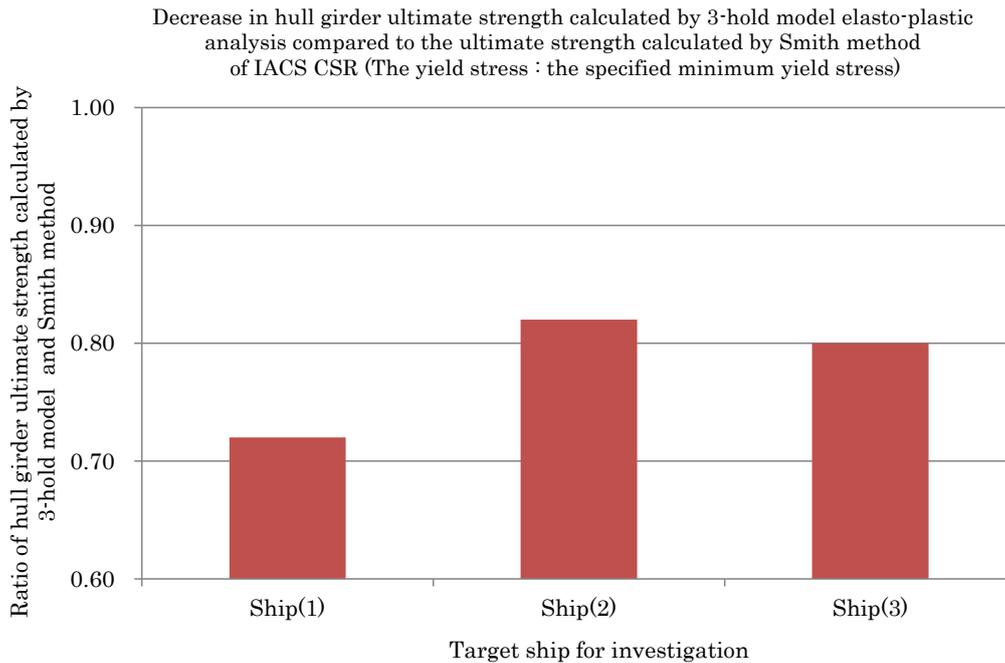
Ship structural strength (hull girder ultimate strength) should be considered, taking into account the decrease of The Ship structural strength by the effect of lateral loads, which induce bi-axial stress on the bottom shell plates. In order to prevent local buckling deformations detected in the bottom shell plates of The Sister Ships, sufficient safety margin should be considered in ship design from such a view point that the biaxial stress states induced by both the vertical bending stress and the lateral loads fall within the interaction curve of the buckling collapse strength of stiffened bottom panels (refer to Section 4.6 in NK report).

Figure 4.2.1 Decrease of structural strength by the effect of lateral loads (developed by Figure 4.4 NK report)

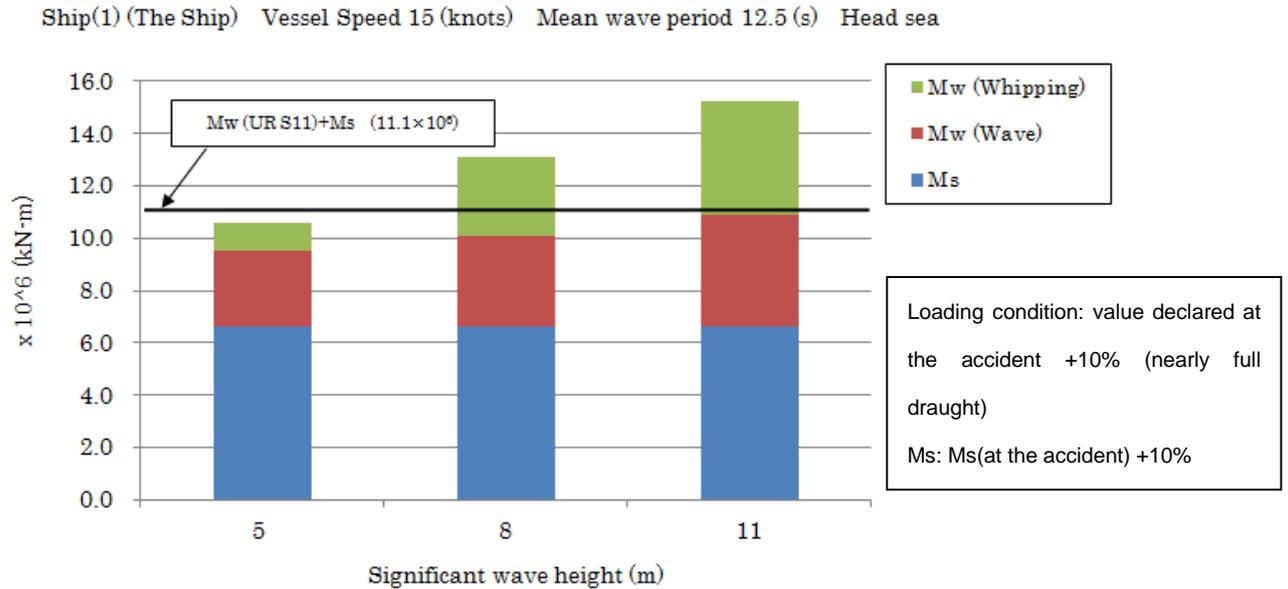
The acting loads may increase or decrease by sea condition and ship speed. On the other hand, wave-induced vertical bending moment in Longitudinal Strength Standard (S11) of IACS Unified Requirements is based on past operational results such as damage experiences, considering the effects operation such as rough sea avoidance,

but it does not explicitly take into account wave height, wave period and ship speed (refer to figure 4.3.3).

Figure 4.3.3 Relation to acting loads in IACS Unified Requirements (Mw(URS11))

Therefore, the representation of the technical backgrounds of requirements of longitudinal strength such as sea conditions, should be considered.

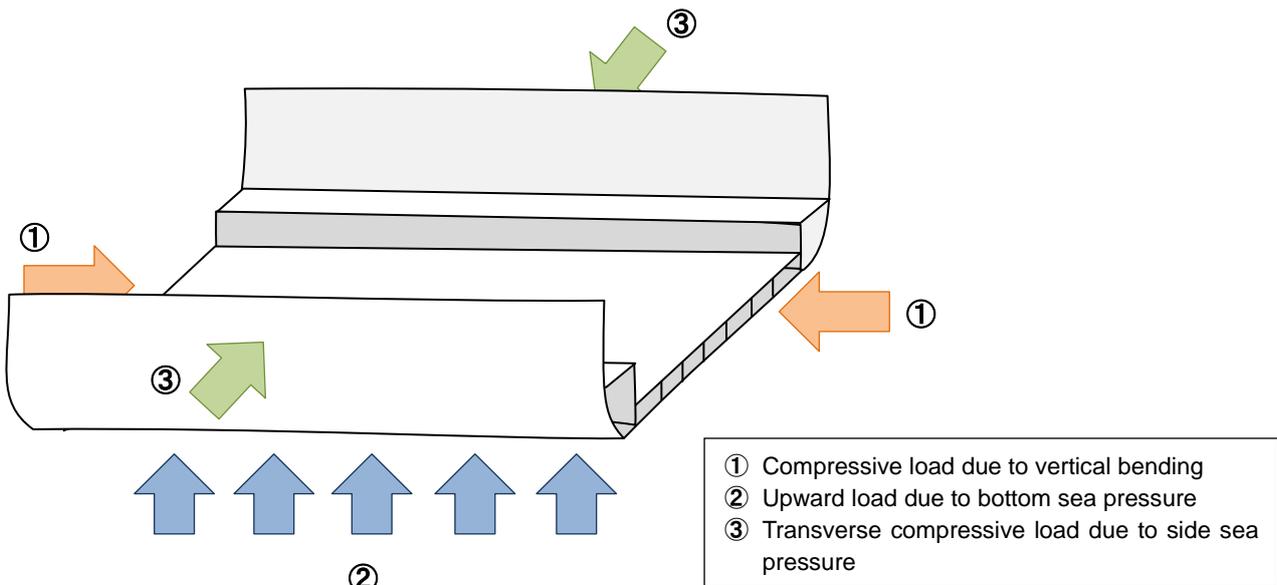
And the compressive load due to sea pressure acting on side shell is generated in the transverse direction. Hence, it can be said that the following 3 loads almost always act on the double bottom construction as shown in Fig. A2-1;

- ① Compressive load due to vertical bending
- ② Upward load due to bottom sea pressure
- ③ Transverse compressive load due to side sea pressure

Figure A2-1 Load acting on Double Bottom Construction of Container Ships

The compressive load due to vertical bending shown in ① causes longitudinal compressive stress to the bottom shell plates. And the transverse compressive load due to ③ causes transverse compressive stress to the bottom shell plates.

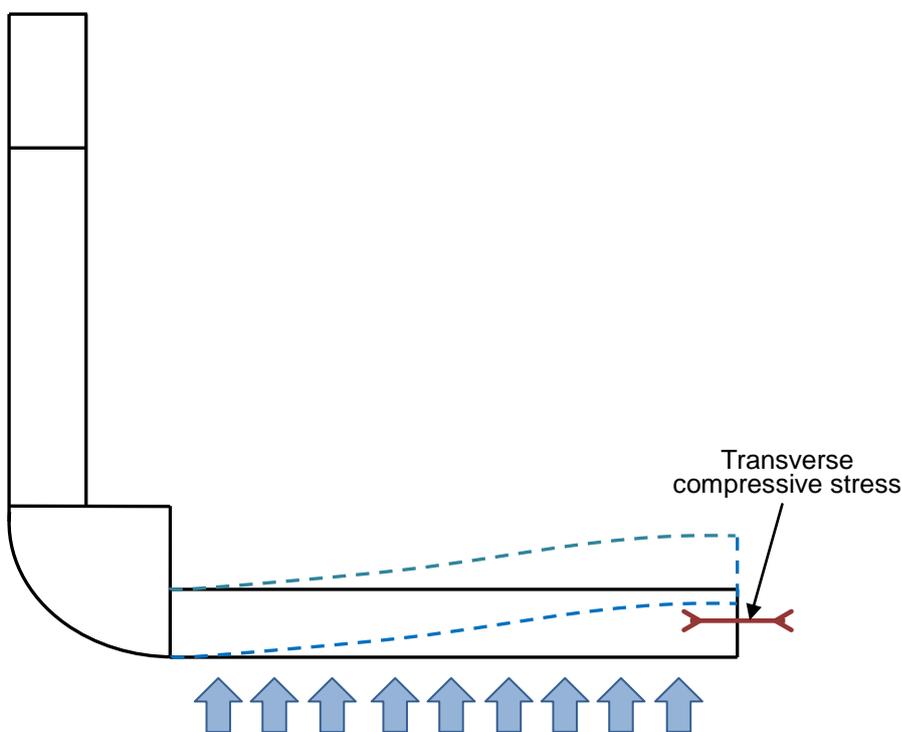
On the other hand, the upward load due to bottom sea pressure shown in ② makes convex deformation as shown in Fig. A2-2 on the double bottom construction consisting of bottom shell plates with bottom longitudinal, inner bottom shell plates with inner bottom longitudinal, girder and floor. As the result, transverse compressive stress on the bottom shell plates is generated near the center line. The deformation of the double bottom construction is maximized near the partial bulkhead within the longitudinal direction and therefore longitudinal compressive stress is generated in the bottom shell plates around the partial bulkhead.

Fig. A2-2 Stress generated in the Bottom Shell Plate due to Bottom Sea Pressure

Consequently, in the bottom shell plates at the center of the hold, i.e., near the center line and near the partial bulkhead, compressive stress due to ① (compressive load due to vertical bending) and due to ② (upward load from bottom sea pressure) are superimposed in the longitudinal direction, and compressive stress due to ② (upward load due to bottom sea pressure) and due to ③ (compressive load due to side sea pressure) are superimposed in the transverse direction.
