KOKU-KU-KI-1572

No. TCD-8201C-2016

Japan Civil Aviation Bureau
TAIKUSEI-KAIZEN-TSUHO
Airworthiness Directive

1. Applies to: Kawasaki BK117 series helicopters equipped with a Goodrich rescue hoist assembly having a Part Number (P/N) as listed in Table 2.1 of this AD.

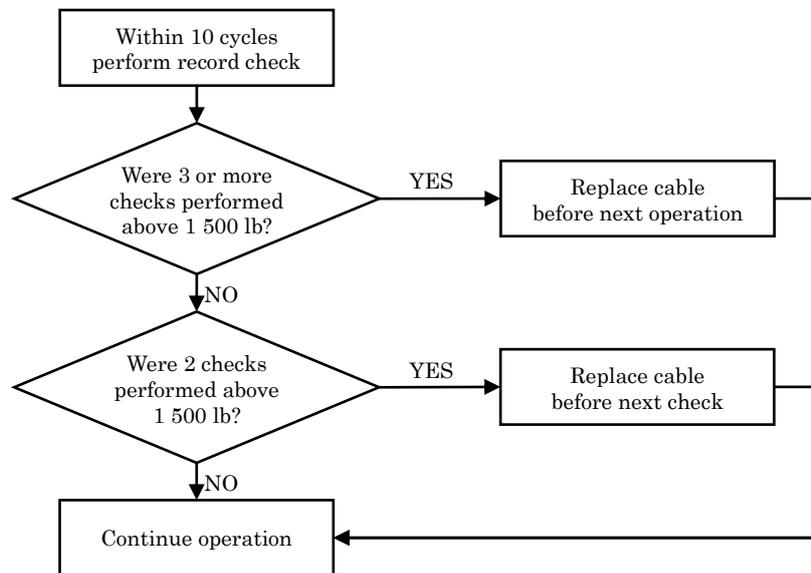
Figure 1

2.1 Within 10 hoist operating cycles after the effective date of this AD, accomplish a records check to determine whether, during any previous hoist load check/test, a cable was load-tested (average of 5 pulls) at 1 500 lb [680 kg] or more. If any cable is identified to have exceeded this limit during two or more hoist load checks/tests, replace the affected cable with a serviceable cable within the time interval shown in paragraph 2.1.1 or 2.1.2 of this AD. For replacement of a cable, see figure 1 of this AD.

2.1.1 If any cable is identified to have exceeded this limit during three or more hoist load checks/tests, before next hoist operation, replace the affected cable with a serviceable cable.

2.1.2 If any cable is identified to have exceeded this limit during two hoist load checks/tests, before the next hoist load check/test, replace the affected cable with a serviceable cable.
