# 航空事故調査報告書

キャセイ・パシフィック航空会社所属  
ロッキード式L1011-385-1型VR-HOC  
新東京国際空港  
平成2年3月24日

平成4年2月12日

キャセイ・パシフィック航空会社所属ロッキード式L1011-385-1型VR-HOCは、平成2年(1990年)3月24日、同社定期便508便としてホンコン国際空港を出発し、協定世界時05時12分(日本標準時14時12分)ごろ、新東京国際空港の滑走路16へ着陸する際ハード・ランディングして、左主翼翼根部リヤ・スパー及びその周辺部が破損し、第1燃料タンクから燃料が流出した。火災は発生しなかった。

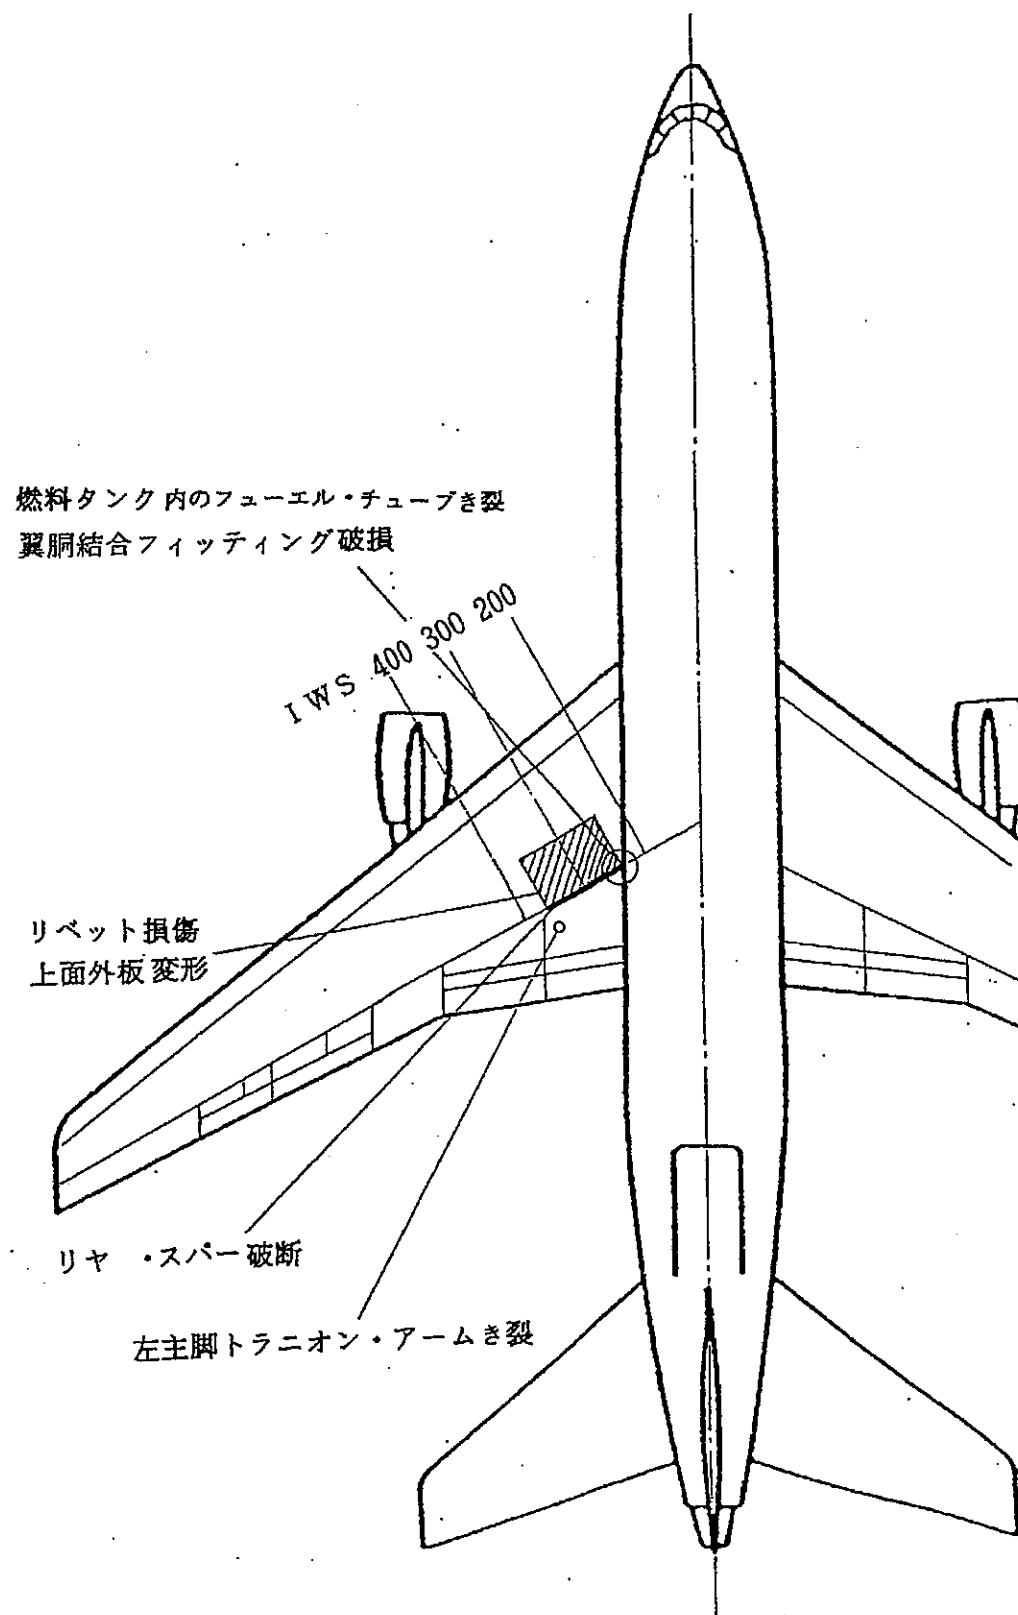
付図 4 機体損傷状況

左主翼翼根部リヤ・スパー及びその周辺部が破損し、第1燃料タンクから燃料が流失した(付図4及び5、写真1及び2参照)。

左主脚柱シリンダ上部の前方トラニオン・アームに多数の小さいき裂が入った。また、左主脚のタイヤ 4 本及び右主脚のタイヤ 2 本がショルダ及びサイドウォールに損傷を受けた（バーストはしていない）。

第 1 燃料タンク・ブースタ・ポンプの出口側に配管されているフューエル・フィード・チューブ及びクロス・フィード・チューブにき裂が入った。

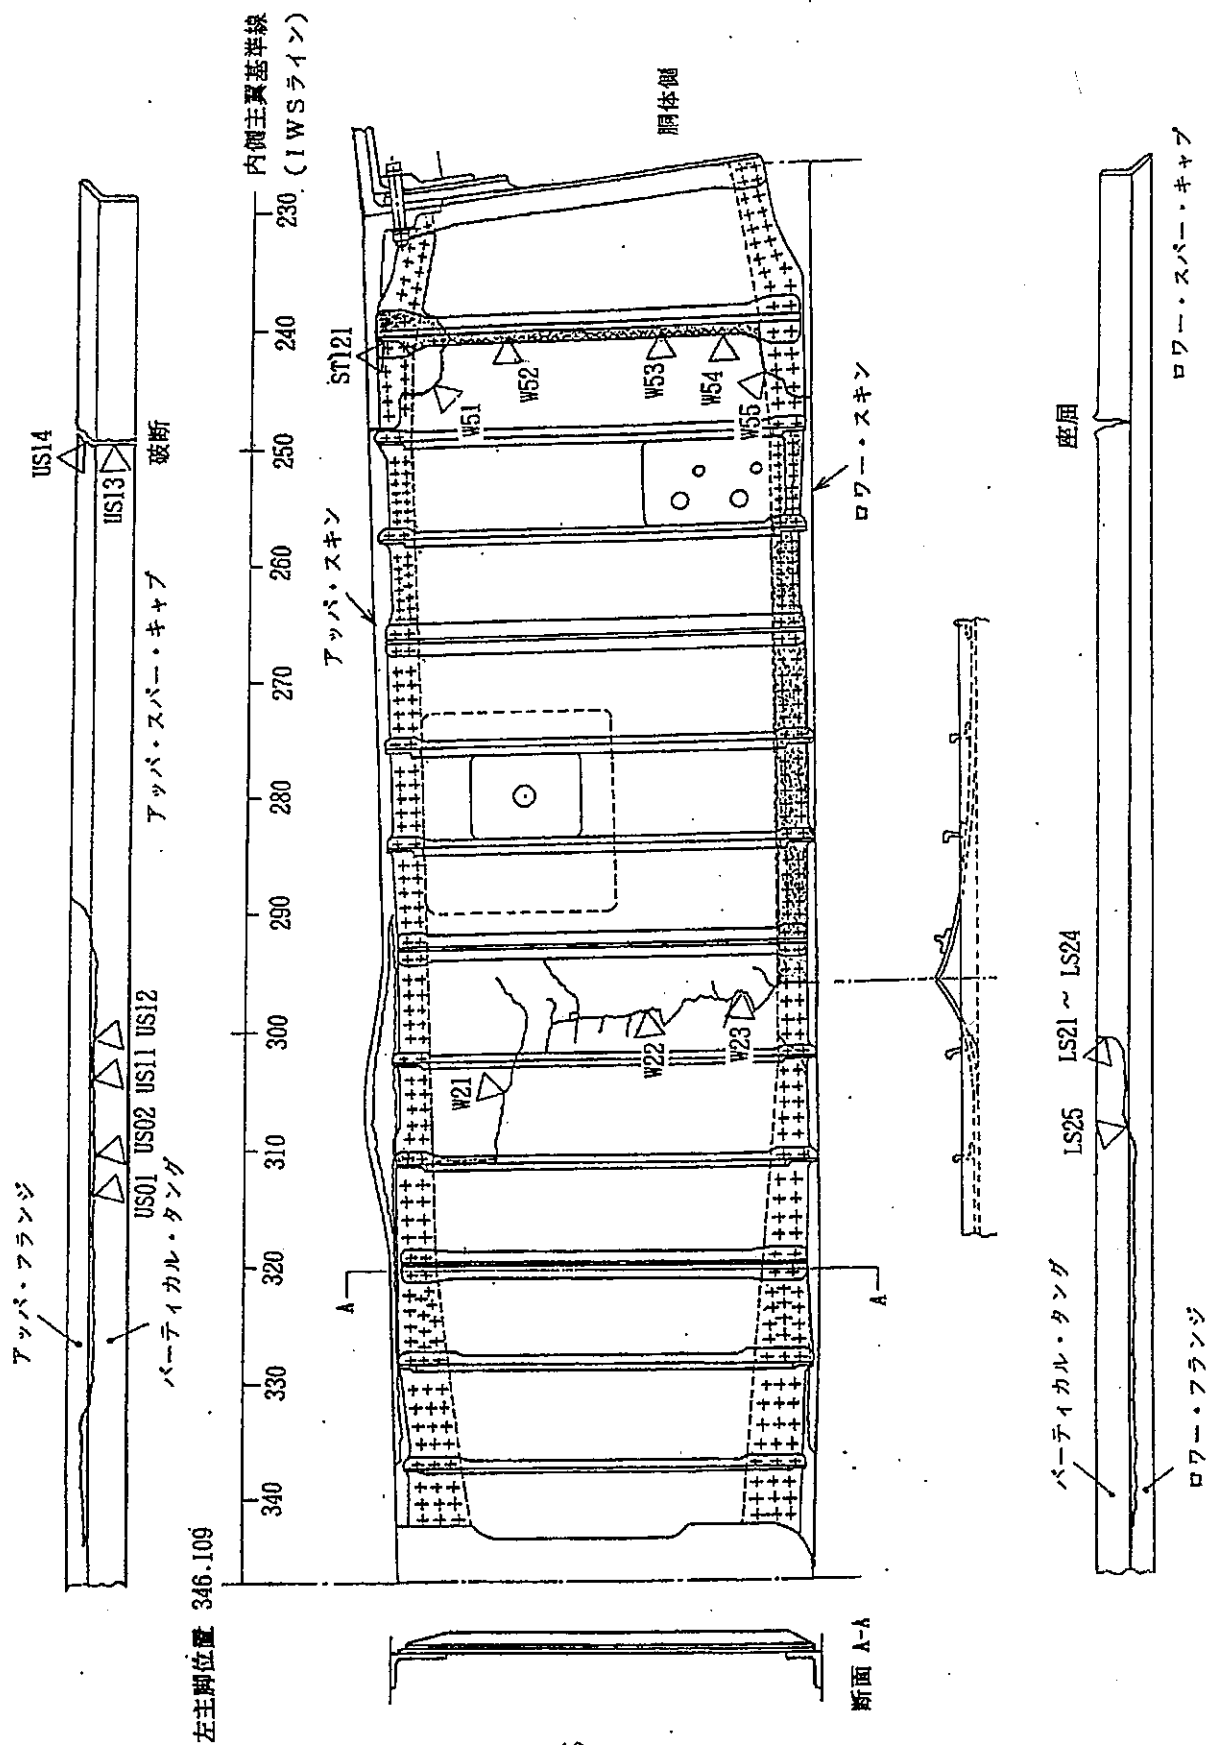
付図 5 左主翼リヤ・スパー付け根付近の損傷（後方より見た図）

左主翼リヤ・スパー・ウェブは、IWS241に取り付けられたスティフナのリベット・ホールに沿って垂直に剪断破断していた。アッパ・スパー・キャップはこれよりわずかに翼端側に寄った、アッパ・アウトボード・フィッティングの先端部分で破断し、付近の上面外板に変形を生じていた。ロワー・スパー・キャップはロワー・アウトボード・フィッティングの先端部分で上向きに座屈していた。

左主翼リヤ・スパー・ウェブは、IWS 300 を中心に座屈して後方へ突出変形し、下端から上方約 70 パーセントの高さまでき裂の進展・分岐が見られた。ウェブの下端のき裂から約 15 センチメートル翼端側において、ロワー・スパー・キャップのパーティカル・タンクにもき裂が入り、そこからロワー・スパー・キャップのコーナに沿って IWS 346 までき裂が伸びていた。アッパ・スパー・キャップは、スパー・ウェブのき裂位置よりやや胴体側の IWS 290 付近から IWS 346 ま でスパー・キャップのコーナに沿ってき裂を生じ、アッパ・フランジ側は上面外板 とともに約 7 センチメートル上方に盛り上がっていた。

アッパ及びロワー・スパー・キャップとリヤ・スパー・ウェブを結合するリベットが、リヤ・スパー・ウェブの座屈部分（上記（2））と付け根近くの剪断破断部分（上記（1））との間で剪断破断していた。

左主翼リヤ・スパーのアッパ・フォワード・インボード・フィッティング及びアッパ・アウト・ボード・フィッティングにき裂が生じていた。

すなわち、事故機は異常に大きな沈下速度で左主脚から接地して、その結果生じた過大な接地荷重により左主翼リヤ・スパー・ウェブが翼付け根近くでせん断破壊し、また、アップ及びロワー・スパー・キャップとリヤ・スパー・ウェブを結合するリベットも IWS 300 付近までせん断破壊した。その結果、左主翼後部付け根付近の剛性は大幅に低下して大変形を許し、スパー・キャップ及びフィッティングの損傷、リヤ・スパー・ウェブの座屈、上面外板の変形及びリベット頭部の損傷等を生じた。

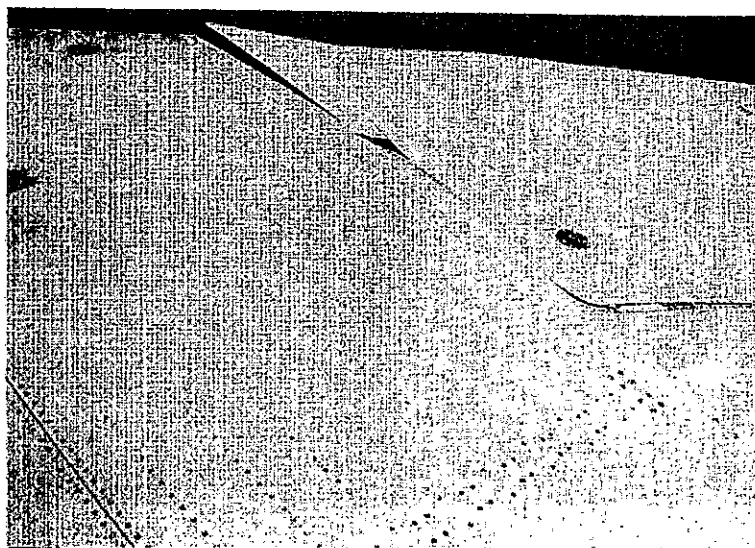
写真 1 左主翼上面の損傷状況

左主翼上面外板のリヤ・スパーとフロント・スパーの間で、翼付け根から IWS 346 までの範囲でリベット頭部が抜けたり、浮いたりする損傷があった。

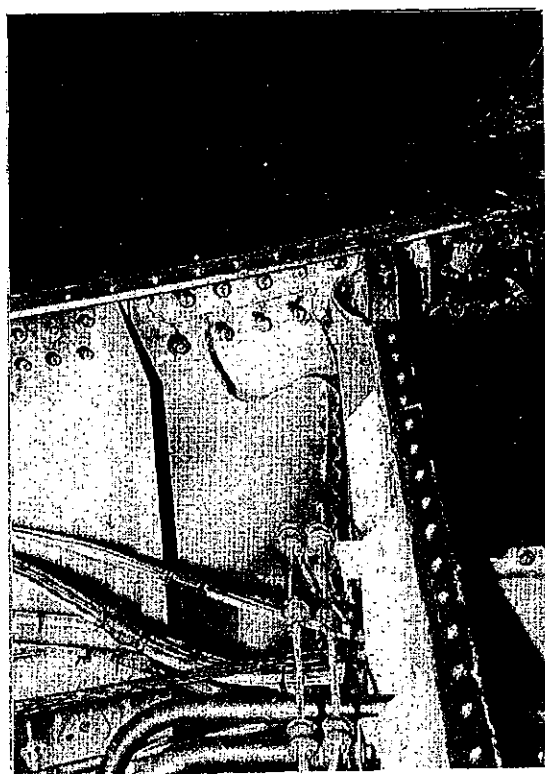
写真 2 左主翼リヤ・スパーの損傷状況（IWS241 付近）

リヤ・スパー・ウェブについてはリベット孔に沿って、せん断及び引張荷重による静的破壊によって破面が形成されたものと認められる。リベット孔縁に半径2ミリ程度の扇状の疲労破面が1箇所認められた以外はすべて静的破壊に特有のディンプル状破面が支配的であった。上記の疲労破面は今回の静的破壊の起点ではなかったと認められた。

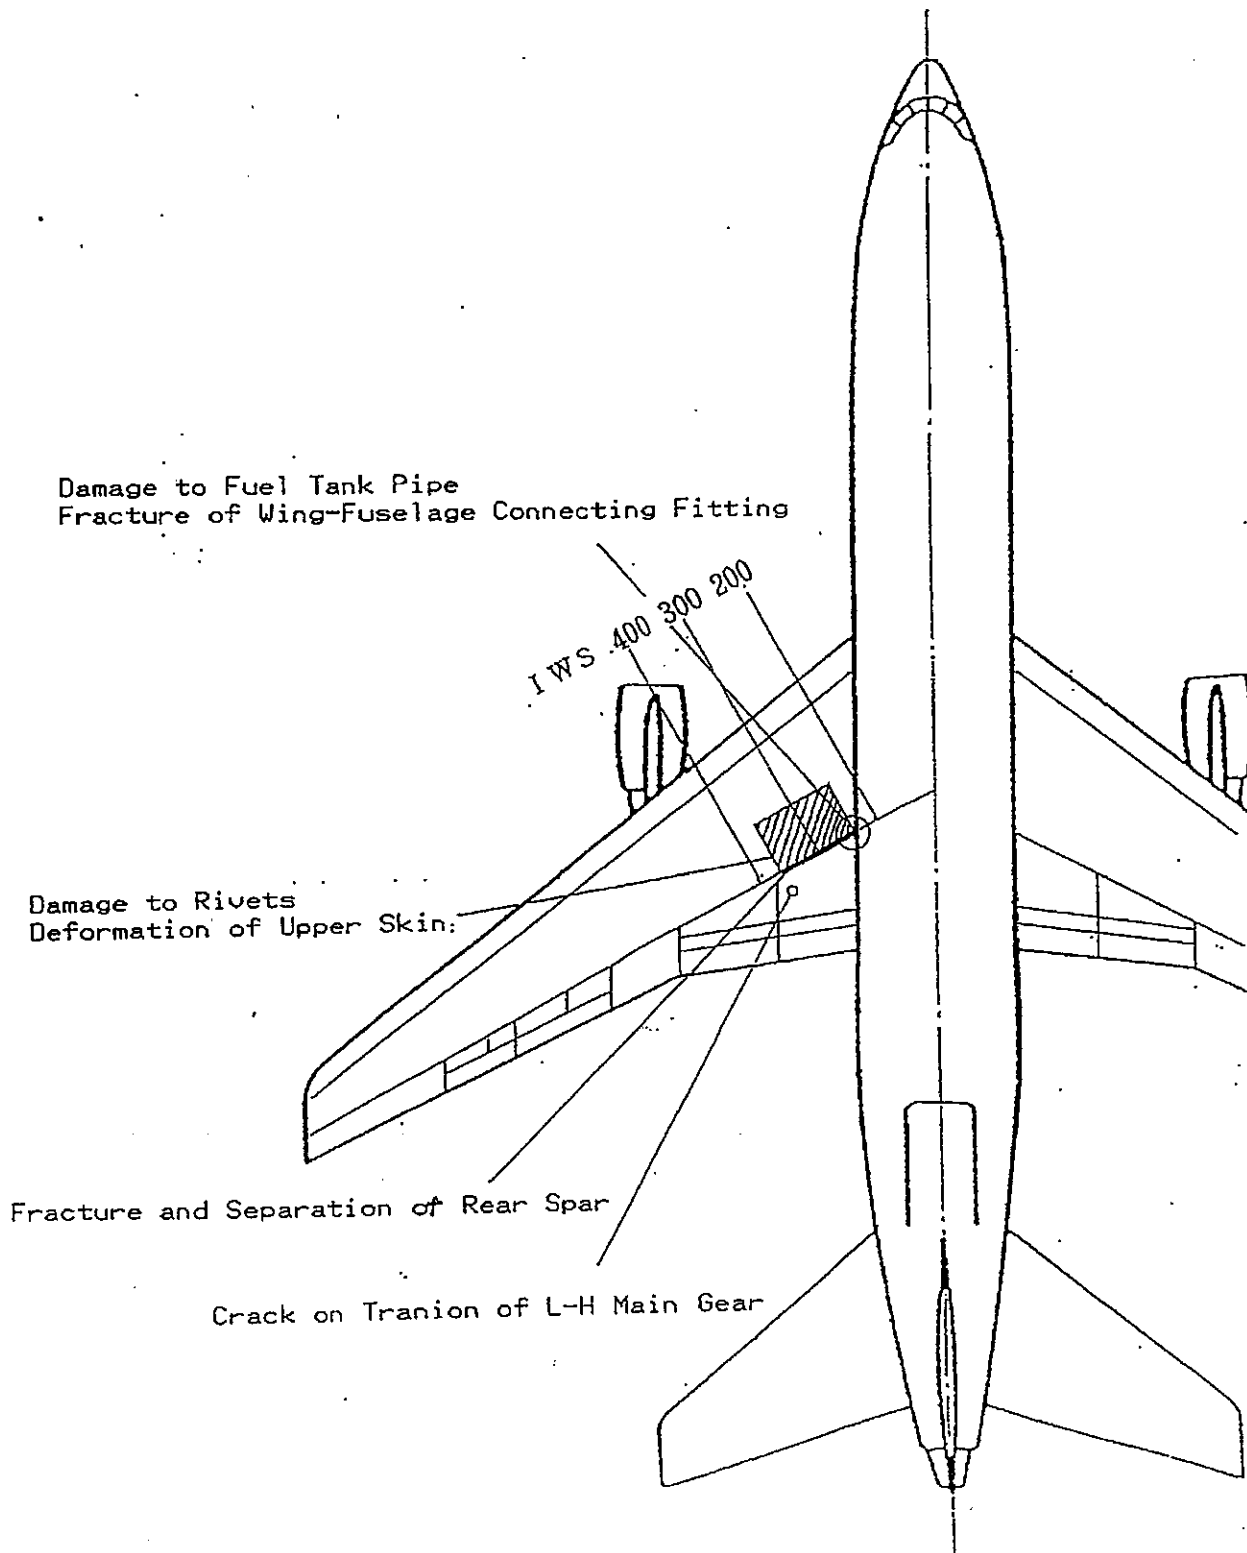
Attached Fig. 4 Damage to Airframe

The rear spar of the left wing root and its vicinity were fractured and fuel leaked out from No.1 fuel tank. (see Attached Figs. 4 and 5, Photos. 1 and 2)

There were found many small cracks on the foreward trunnion arm on the upper part of the cylinder of the left main gear. Four tires of the left main gear and two tires of the right main gear were damaged at the shoulder and the side wall. (not burst)

Cracks were found on the fuel feed tube and the cross feed tube installed on the outlet side of No.1 fuel tank booster pump.

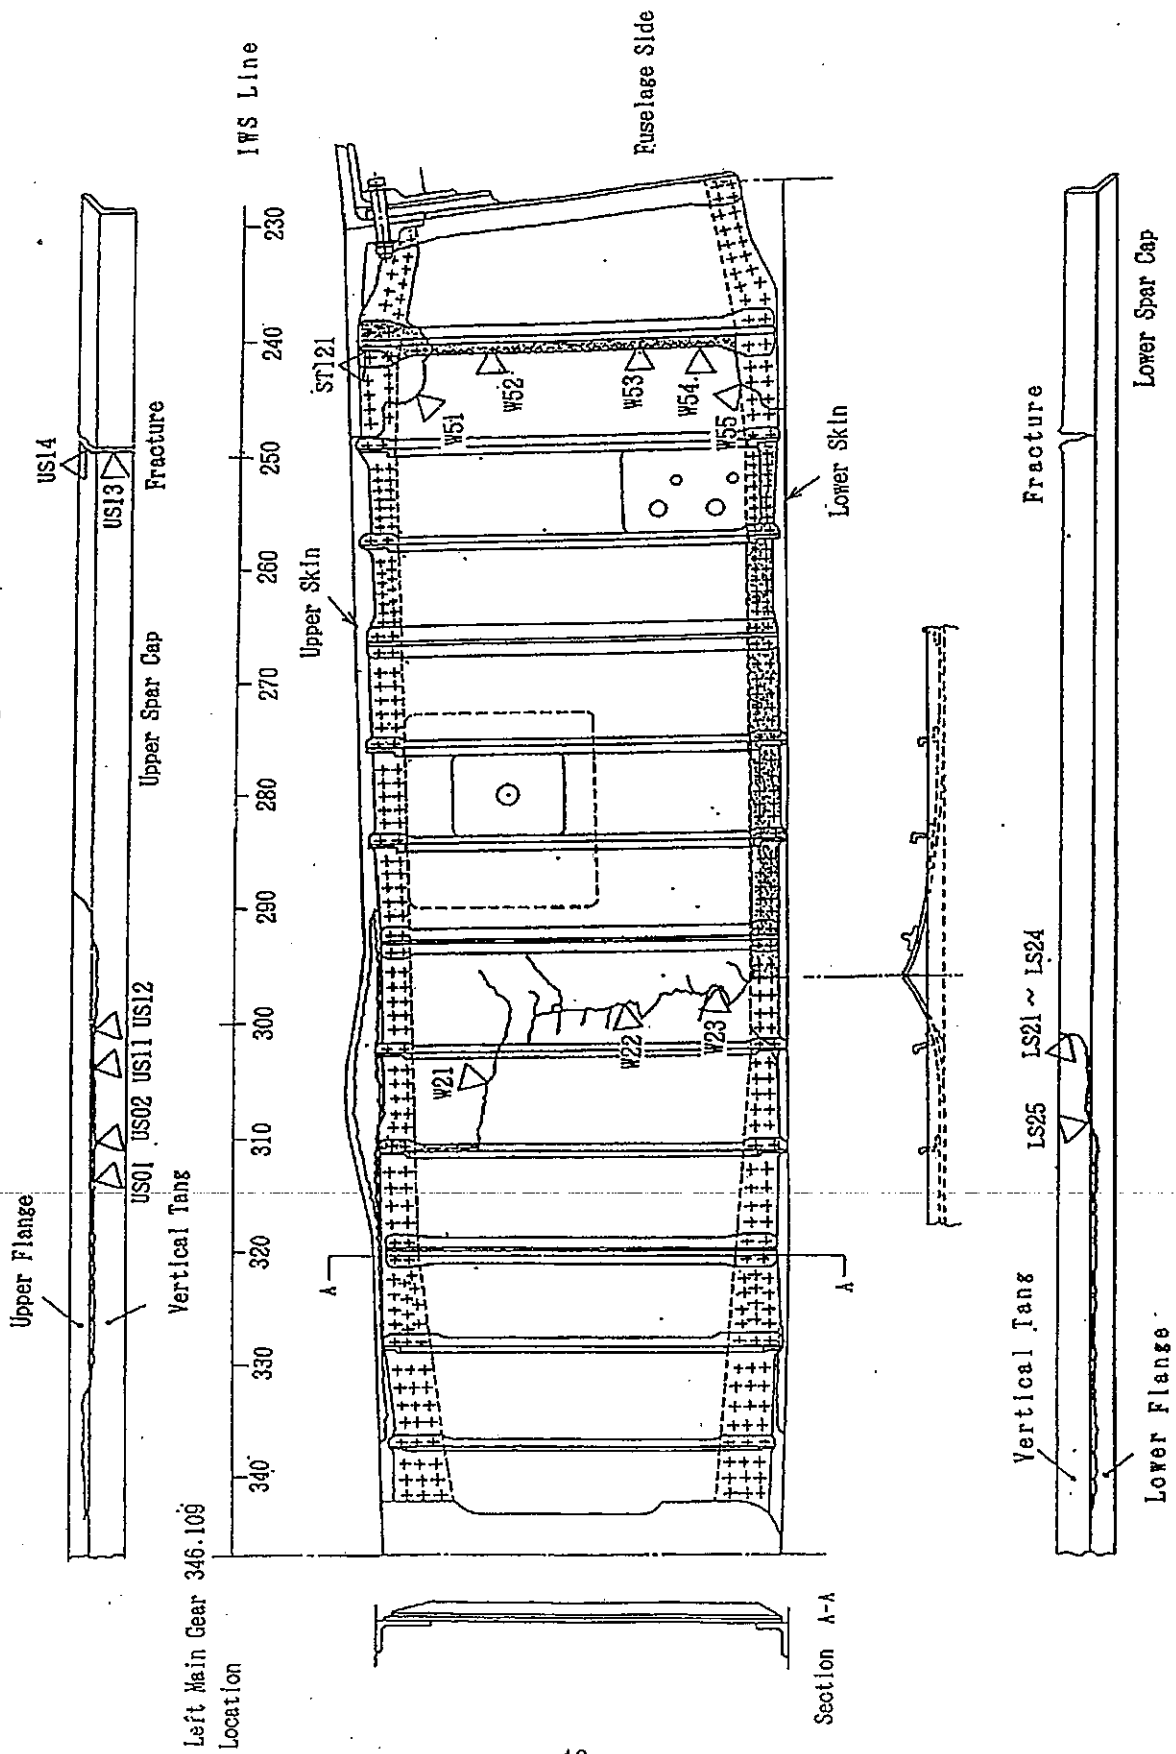
Damage to Neighborhood of Root of L-H Wing Rear Spar

(1) Fracture of the left wing rear spar web at IWS (Inner Wing Station) 241  
The left wing rear spar web was shear-fractured vertically along rivet holes of the stiffener attached to IWS 241. By this fracture the upper spar cap was fractured at the tip of the upper outboard fitting located slightly nearer to the wing tip, causing a deformation of the upper skin in the vicinity. The lower spar cap was buckled upward at the tip of the lower outboard fitting.

The left wing rear spar web was buckled making its center at IWS 300, projecting backward, and a crack was found propagated and branched from its lower tip upward to its 70 % height. On the wing tip side, about 15 cm from the crack at the lower tip of the web, another crack was also initiated on the vertical tang of the lower spar cap, from where the crack extended up to IWS 346 along the corner of the lower spar cap. As to the upper spar cap, a crack was initiated at the vicinity of IWS 290, somewhat nearer to the fuselage side than the crack of the spar web, up to IWS 346 along the corner of the spar cap, and the upper flange side was heaved about 7 cm upward together with the upper skin.

Rivets connecting the upper and the lower spar cap with the rear spar web were shear-fractured between the buckled portion of the rear spar web (refer to (2) above) and the shear-fractured portion near the root portion (refer (1) above)

Cracks were observed on the upper forward inboard fitting as well as on upper outboard fitting of the left wing rear spar.

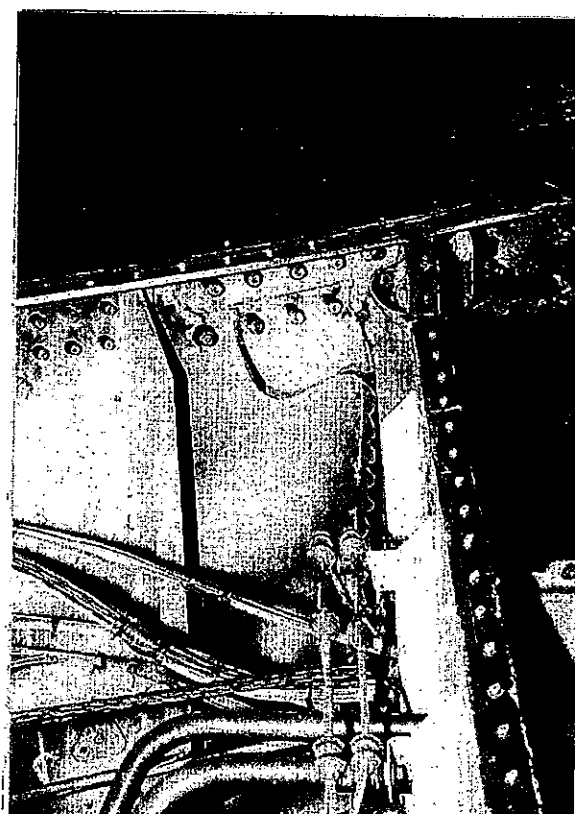
Photograph 2

Damage: Wing Rear Spar (L/H) (near IWS241)
