航空事故調査報告書  
ノースウエスト航空会社所属  
ボーイング式747-400型  
N663US  
新東京国際空港  
平成3年(1991年)9月19日

平成5年8月26日

航空事故調査委員会議決

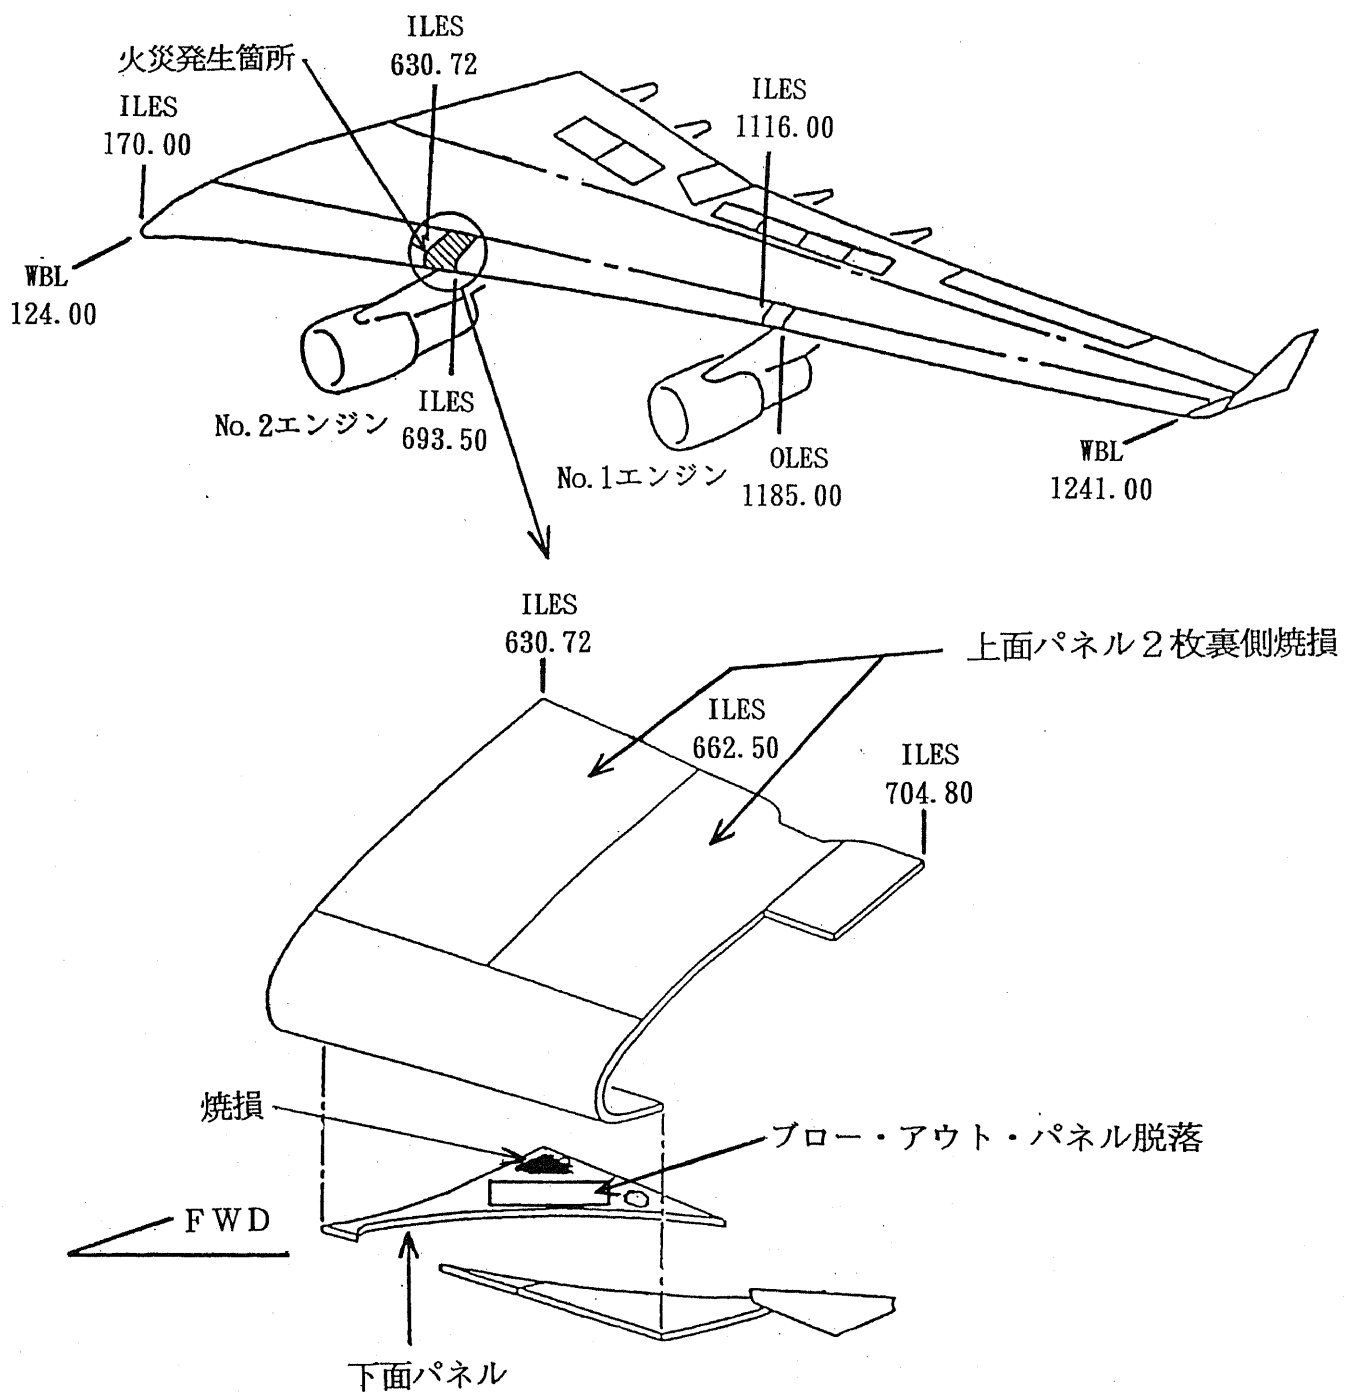
付図 5 左主翼前縁内の火災発生箇所

同機のN o . 2 エンジン燃料フィード・パイプ及びN o . 1 ジェネレータ・フィーダ・ケーブルが接触し互いに擦れ、絶縁被覆が損傷して燃料フィード・パイプとジェネレータ・フィーダ・ケーブルの間にアークが発生した。N o . 2 エンジン燃料フィード・パイプはアークにより、あるいはケーブルとの擦れも関与して孔が生じ、燃料が流出し、これにアークにより引火したものと推定される。この際に左主翼前縁内 (ILES630~693) に装備されていたワイヤ・バンドルが焼損し、短絡または断線してE I C A S に《ELEC GEN OFF 1》アドバイザリ・メッセージを含む各種システム不具合発生のメッセージが表示されたものと推定される。N o . 1 ジェネレータは一旦はオフにされたものの、リセット操作でオンにされたままとなっていたため発電を続け、アークは繰り返し発生したものと推定される。

同機は10時31分UTCごろ成田空港に着陸したが、着陸滑走中の同32分UTCごろ左主翼前縁内で火災が発生したものと認められる。これは、同機が着陸滑走中、速度の減少とともに流入する空気流が少なくなり、ジェネレータ・フィーダ・ケーブルまたは飛行中の火災により損傷したワイヤ・バンドルが短絡して発生する火花あるいはアークにより、流出燃料に引火して火災が発生したものと推定される。この火災によりN o . 2 エンジン・パイロン・ストラット上部の構造部材とともにILES630~693の間に装備されているワイヤ・バンドルが損傷し、アルミニウム合金製の左エンジン消火用配管が溶損したものと推定される。運航乗務員は、「左エンジン火災」の連絡をタワーから受け、N o . 1 エンジンに不具合があると思っていたため、同エンジンを停止するとともに消火措置を行ったと述べているが、消火用ガスは溶損していた配管から火災エリアに放出され、一旦鎮火したものと推定される。

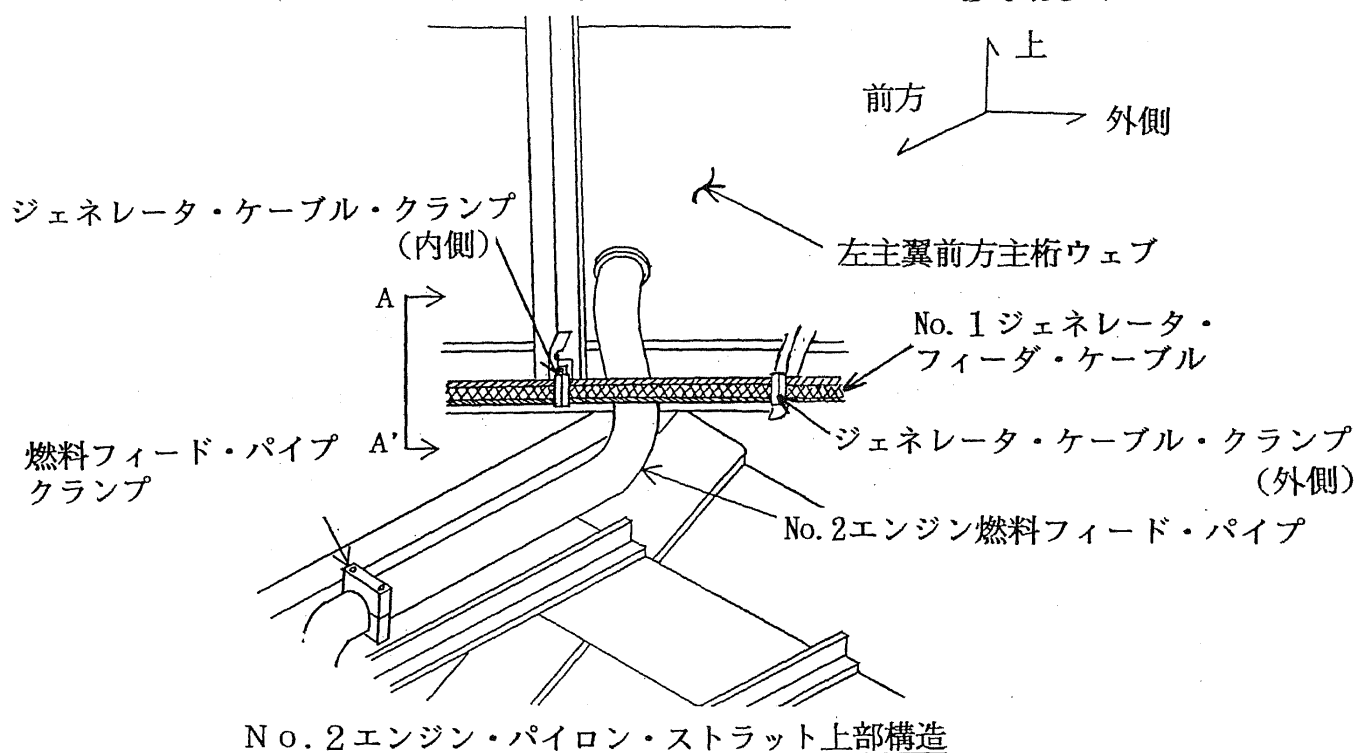
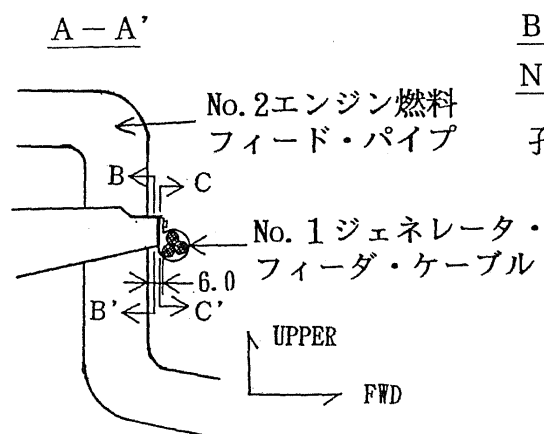
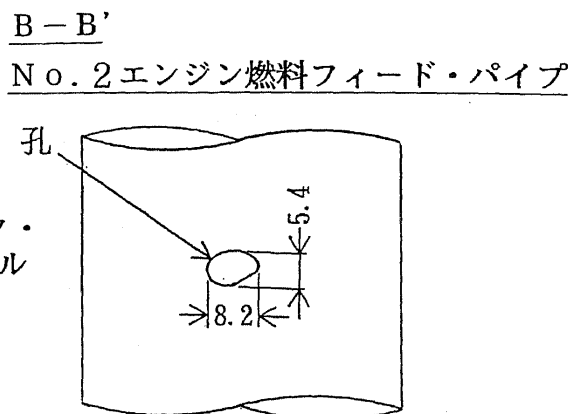
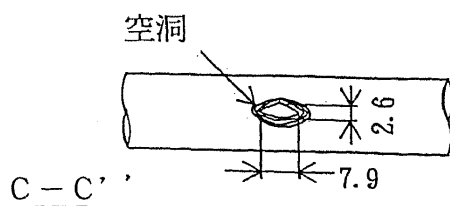
付図 6 No.1ジェネレータ・フィーダ・ケーブル及びNo.2エンジン燃料  
フィード・パイプの損傷状況

ジェネレータ・フィーダ・ケーブルが横切っている後ろ側の位置で、同機の燃料フィード・パイプに長径が8.2ミリメートル、短径が5.4ミリメートルの大きさの孔があいていた。パイプの欠損（孔の面積×肉厚）は約28立方ミリメートルであった。また、孔の周辺部は防錆皮膜が擦り取られており、擦られた痕跡が残っていた。当該部分は長径が9.9ミリメートル、短径が7.1ミリメートルであった。No.2 エンジン燃料フィード・パイプの孔の生じた位置に貼られていた燃料フィード・パイプの識別テープ（材質：ガラス繊維）にもパイプの孔とほぼ同じ大きさの穴があいていた。

当該ジェネレータ・フィーダ・ケーブルはボーイング社の材料規格であるBMS 13-35E (MIL規格W-7072) により製造されたもので、ケーブルの直径は12.15ミリメートル(約0.48インチ) で、導線はアルミニウム合金のより線であり、絶縁被覆はフルオロ・カーボンでコーティングしたポリイミド・テープを3層に重ね巻きしたもの〔厚さ約0.008インチ(約0.2ミリメートル)〕である。ジェネレータの定格は3相交流、115/200ボルト、400ヘルツ、90KVAである。ジェネレータ・フィーダ・ケーブルは、3本が束ねられた状態で主翼前縁内を通っており、クランプを介して主翼前方主桁の前方に取り付けられている。同機においては、No.2エンジン燃料フィード・パイプに孔が生じていた直前の位置(ILES680) でNo.1 ジェネレータ・フィーダ・ケーブルが損傷していた。損傷は3本のケーブルのうち、No.2エンジン燃料フィード・パイプに一番近いケーブルに生じたもので、絶縁被覆にポリイミド・テープの積層が明瞭に見られる楕円状の擦過痕を伴った損傷があり、アルミニウム合金の導線に空洞があった。損傷はNo.2エンジン燃料フィード・パイプと接触したことにより生じたものと認められた。導線の空洞は溶解によるものと認められ、放電した形跡を示していた。

ジェネレータ・フィーダ・ケーブルと燃料フィーダ・パイプは、両者の損傷状況から、互いに接触して擦られ、ケーブルの絶縁被覆が損傷しアークが発生したものと推定される。3.1.4項で述べたように、燃料フィーダ・パイプには擦れ及びアークによるものと思われる損傷が生じており、また、ジェネレータ・フィーダ・ケーブルにもアークによると思われる空洞が生じていた。

2.13.4項で述べたとおり、事故後ジェネレータ・フィーダ・ケーブルと燃料フィーダ・パイプの間隙を測定したところ6ミリメートルであった。間隙が2.13.4項に述べたボーイング仕様書 (No.D6-13053Rev.L) を下回っていたのは、同機の製造時からのものか、又は2.14.4項で述べたフィーダ・ケーブルの損傷修理作業によるものかは明らかではない。なお、右主翼の対応する位置の間隙は8ミリメートルであった。

1. N o . 2、N o . 3 エンジン・ストラット内の燃料フィード・パイプ及びジェネレータ・フィーダ・ケーブルに損傷又は擦れがないか検査する。
2. N o . 2、N o . 3 エンジン・ストラット内の燃料フィード・パイプとジェネレータ・フィーダ・ケーブルの間隙を検査し、0.375インチ（9.53ミリメートル）以上の間隙を確保する。
3. 両者の間隙が0.75インチ（19.1ミリメートル）未満の場合はその後500時間を超えない間隔で、また、0.75インチ以上の場合は1,000時間を超えない間隔で上記1及び2項の検査を繰り返す。
4. 全エンジンのストラット・ドレンの検査を行い、その後は1,000時間を超えない間隔で検査を繰り返す。
5. 検査の結果損傷が発見された場合は修理を実施し、燃料フィード・パイプとの間隙が0.375インチを超えるようジェネレータ・フィーダ・ケーブルを移設する。

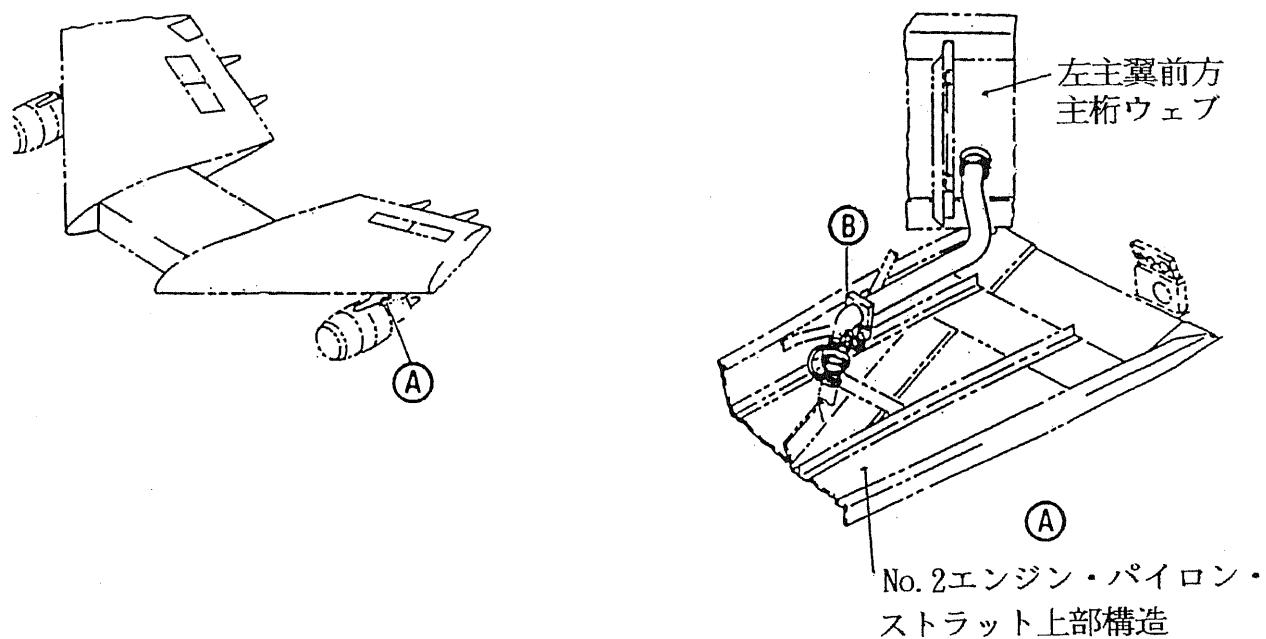
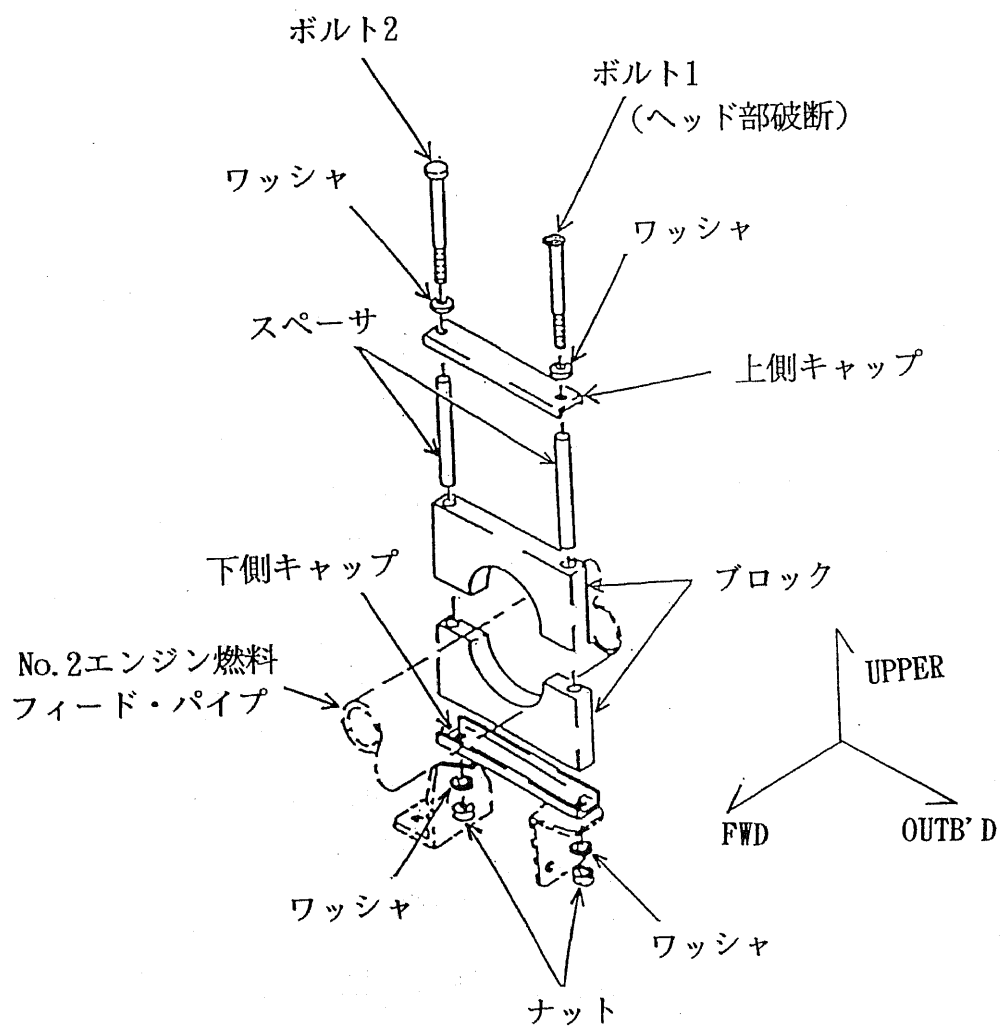
付図 7 No.2エンジン燃料フィード・パイプ・クランプ

同機の当該クランプの外側のボルト・ヘッド部が破断していた。クランプの部品を目視及び走査電子顕微鏡等により観察した結果は次のとおりであった。

ヘッド部が破断しており、破断面の中心部に約1.5ミリメートル×1.5ミリメートルの菱形状の平面があり、その周囲はざらざらした面であった。

ボルト1の破断面全面をカドミウムが覆い、そのうち約3分の1は球状になっていた。特に中心部の菱形状の平面部の周囲に球状カドミウムが集中していた。

2.3.2項及び2.13.5項で述べたとおり、調査時No.2エンジン燃料フィード・パイプ・クランプの2本のボルトのうち外側のボルト・ヘッド部が破断しているのが認められた。この破断面の電子顕微鏡及びX線成分分析装置による調査の結果、破断面全体がカドミウムで覆われていた。また、破断箇所には伸び変形はなく、破断面には静的破壊を生じた際に見られるディンプルはほとんど認められなかった。

火災によりボルトに施されていたカドミウム・メッキが溶解するだけの熱を受け、スパーサ（アルミニウム合金製）とボルト（鉄合金製）の熱膨張率の相違からボルトに熱膨張による引っ張り応力が加わり、カドミウム脆性が生じて伸び変形を伴わずに破断したものと考えられる。溶解したカドミウムはボルト破断後、その破断面に付着したものと考えられる。

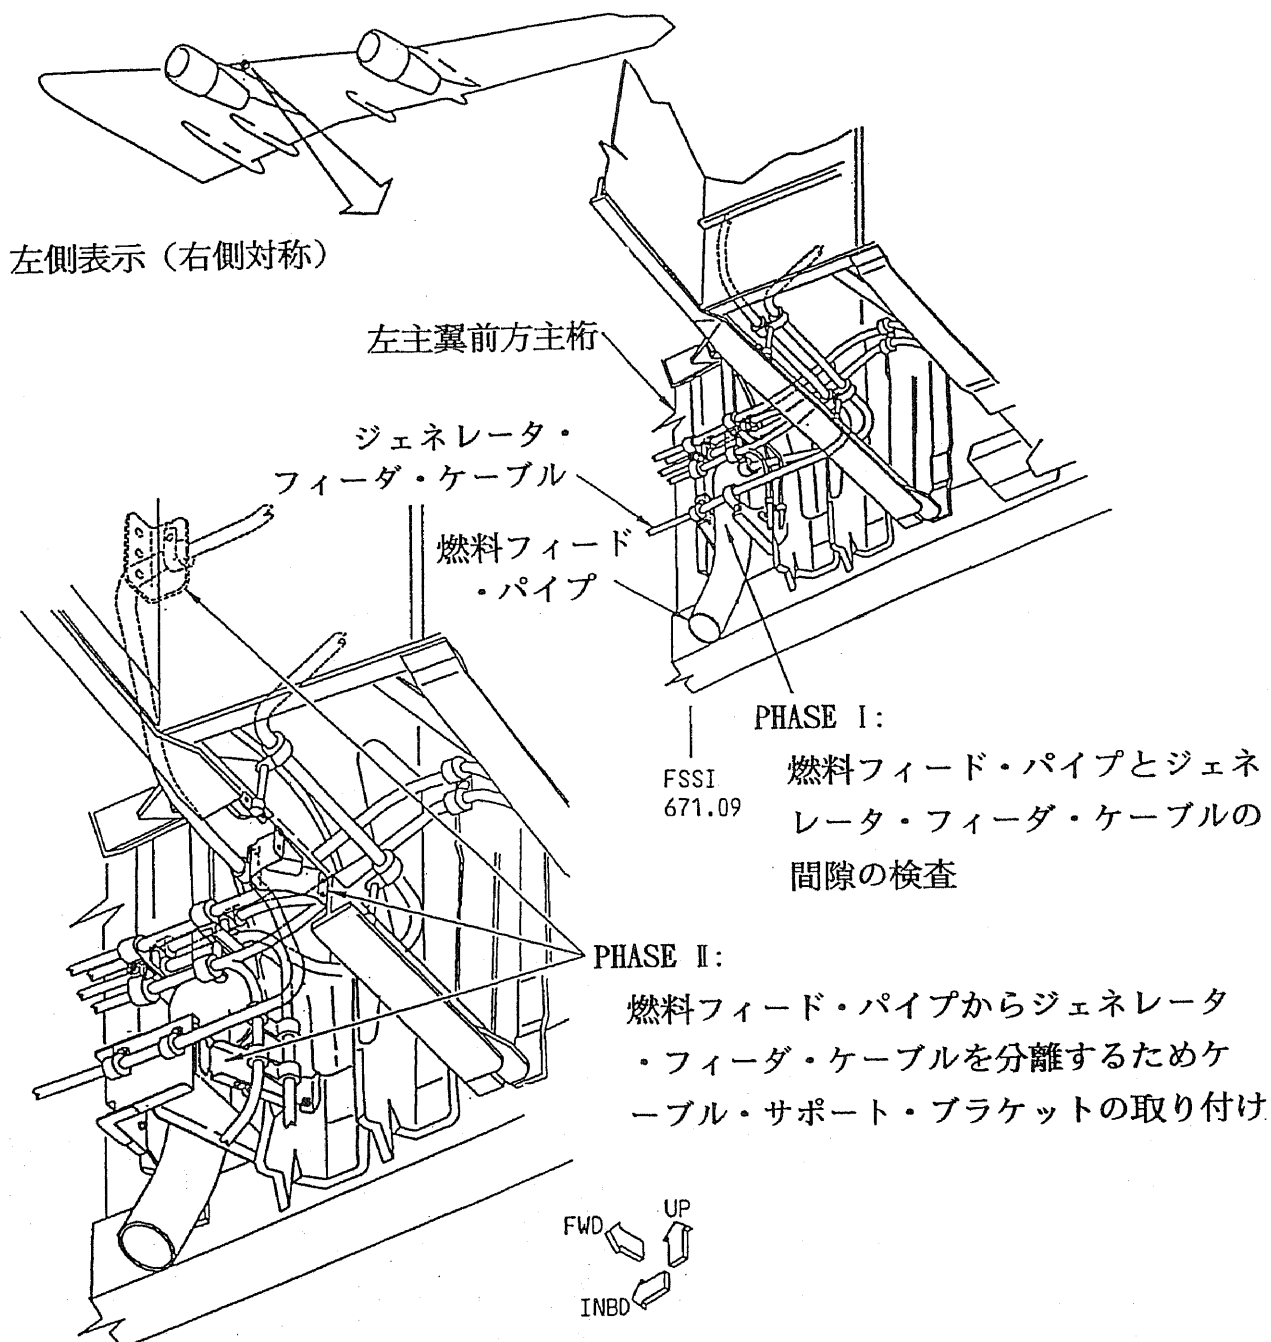
# 付図 10 ボーイング社 S B による NO. 1 ジェネレータ・フィーダ・ケーブル ・サポート・ブラケット取り 付けの改修

本サービス・レターはボーイング式747-400型機に適用するもので、外側と内側のエンジンの中でジェネレータ・フィーダ・ケーブル・クランプが破損し、フィーダ・ケーブルと構造部材が接触してフィーダ・ケーブルの絶縁被覆が摩耗し、アークが発生しジェネレータがトリップした事例があったため、クランプ突出部を上向きからサポート・プレートを介した下向きに変えて、クランプの曲がりや破損を防止することを推奨している。

同機は、本事故の約1年前の1990年10月8日、飛行中にNo.1 ジェネレータ・トリップ《ELEC GEN OFF 1》及びNo.1 ジェネレータ・システム故障《ELEC GEN SYS 1》というEICASメッセージが表示され、点検の結果、No.1 ジェネレータ・フィーダ・ケーブルがNo.1 エンジンとNo.2 エンジンの間にある燃料給油パネル付近の位置で焼損しているのが発見された。この原因は、ジェネレータ・フィーダ・ケーブルを支持しているクランプ2個が破損したためフィーダ・ケーブルが構造部材と接触し、絶縁被覆が損傷してアークが生じたためであった。

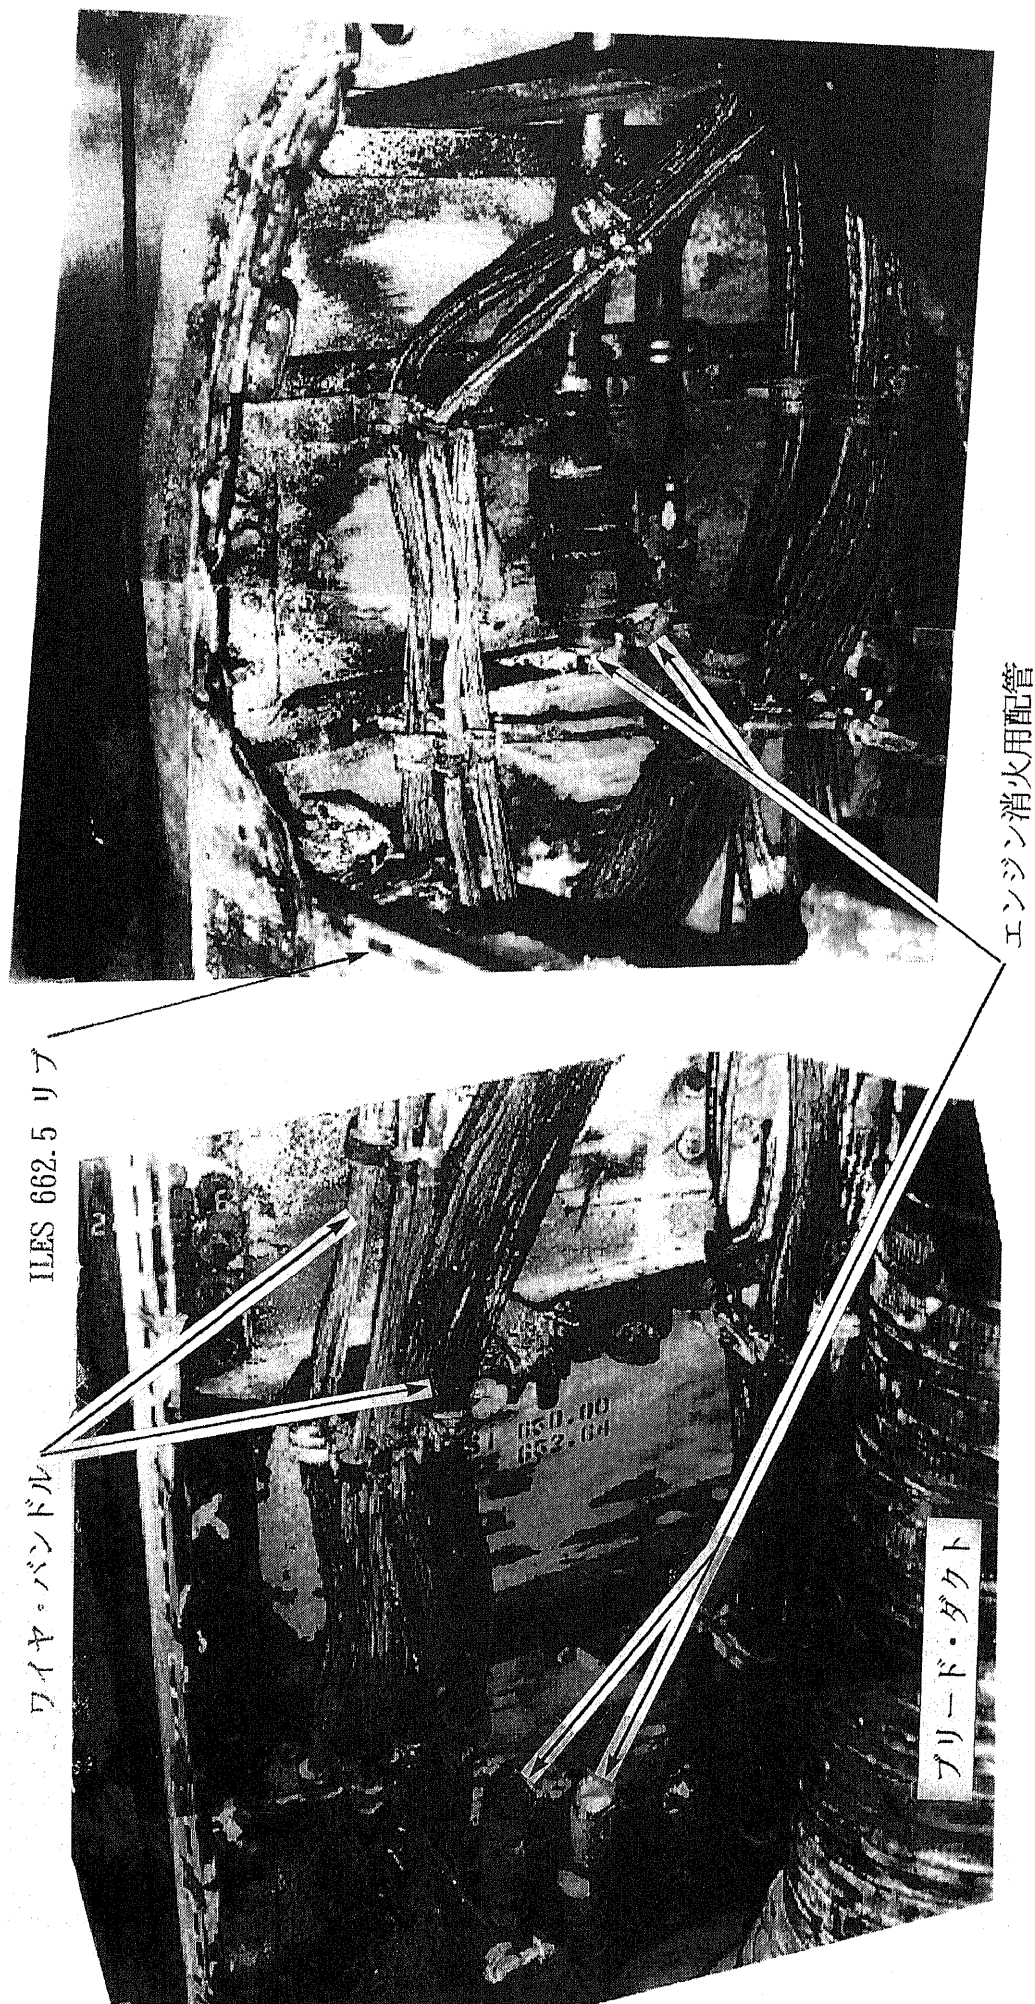
写真2 左主翼前縁内の焼損したワイヤ・バンドル、エンジン消火用配管等

4.1.6 左主翼前縁内で発生した火災により、当該エリアに装備されていたワイヤ・バンドル、エンジン消火用配管等が焼損したものと認められる。ジェネレータ・フィード・ケーブルの損傷、ワイヤ・バンドルの損傷等により、エンジン・オーバーヒート、ブリード・ダクト・リーク等のメッセージが表示され、ジェネレータ、前縁フラップ、燃料投棄等のシステムに不具合も発生したものと推定される。

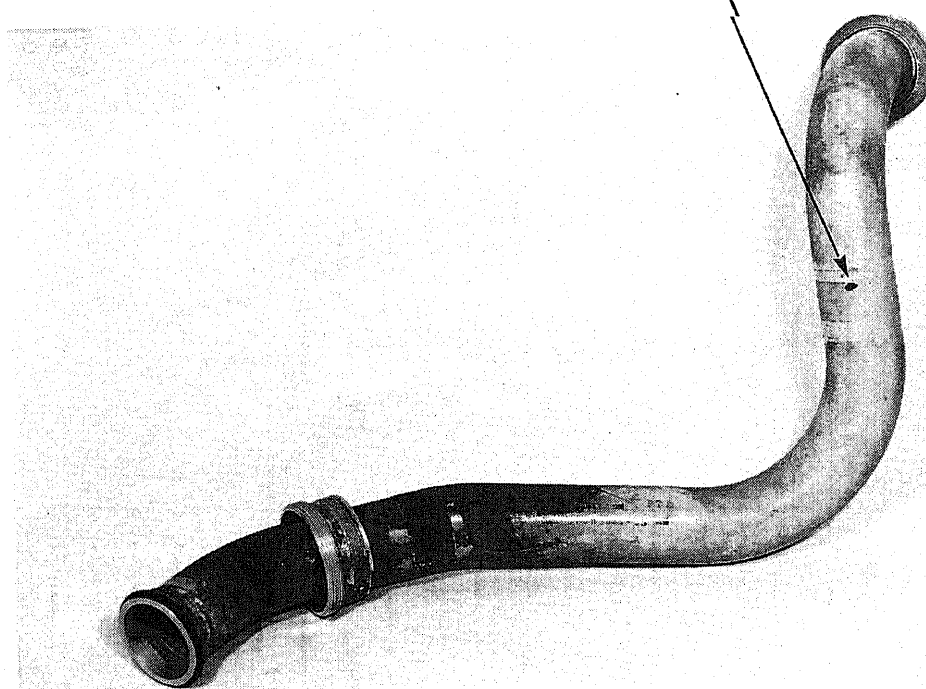
### 写真3 No.2エンジンの燃料フィード・パイプ

No.2エンジン燃料フィード・パイプの損傷部（孔）

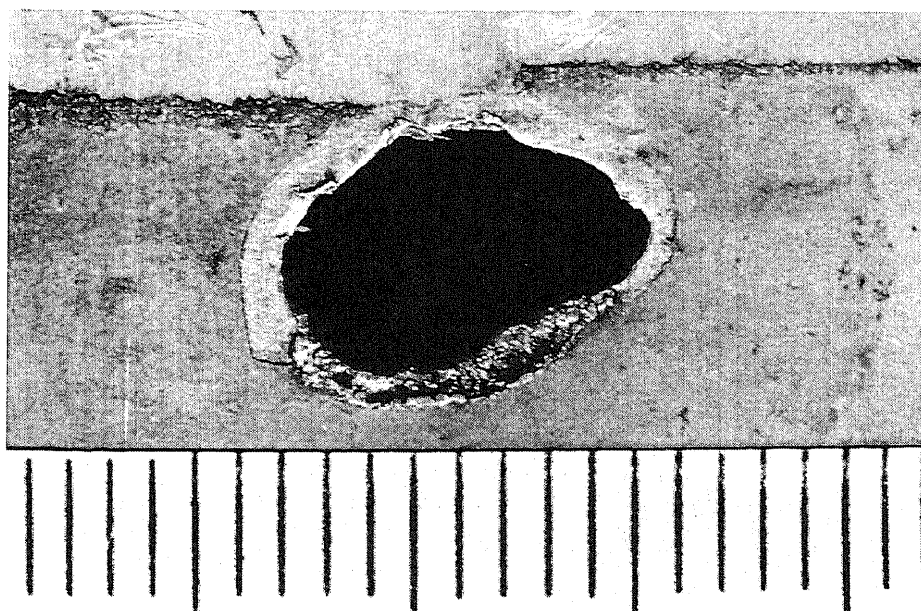
写真 4 No.2エンジンの燃料フィード・  
パイプの損傷部（孔）（拡大）

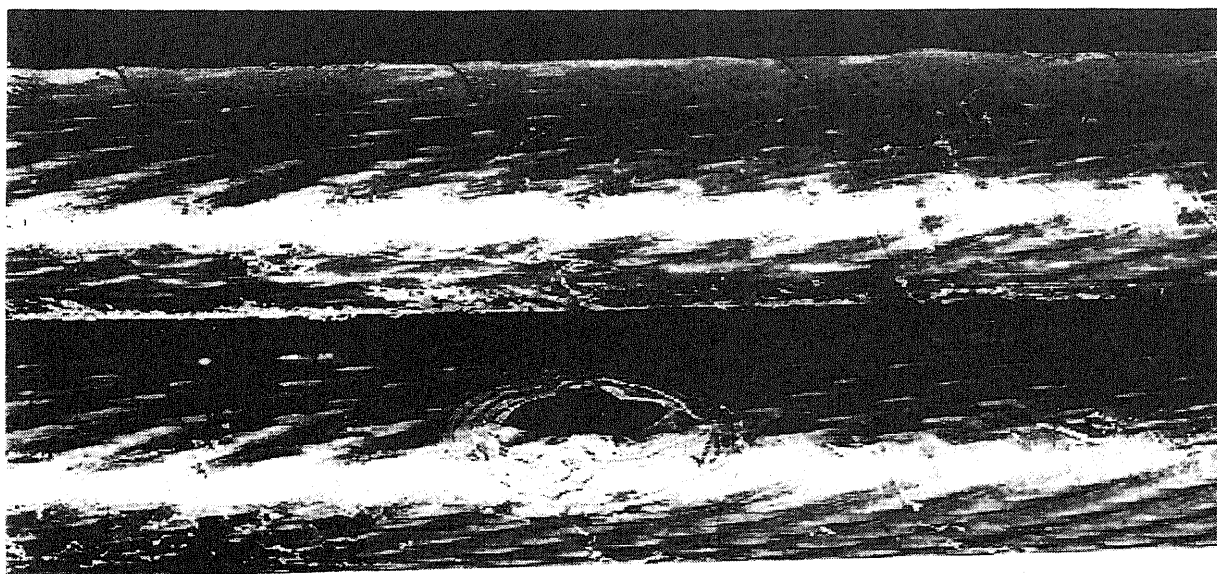
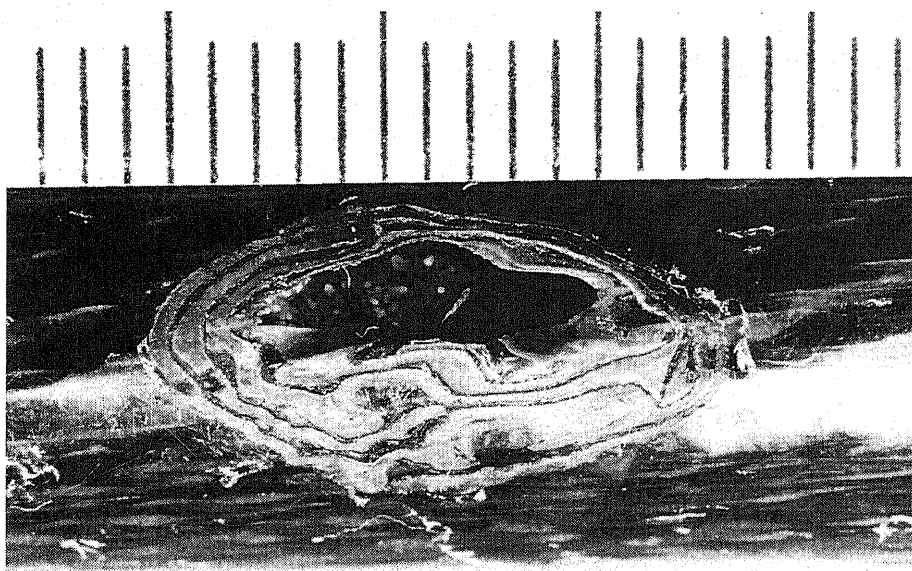
なお、雷のような高電圧が引き金となってアークが生じることが考えられるが、2.13.3項で述べたとおり、同機のジェネレータ・フィーダ・ケーブルの絶縁被覆の損傷した孔のまわりに、このようなアークでは形成されることがないポリイミド・テープの積層が明瞭に見られる擦過痕が楕円状に残っていたことから、同ケーブルのアークによる溶損は雷が引き金となったものではないものと推定される。

写真6 No.1ジェネレータ・フィーダ・  
ケーブルの損傷部（空洞）

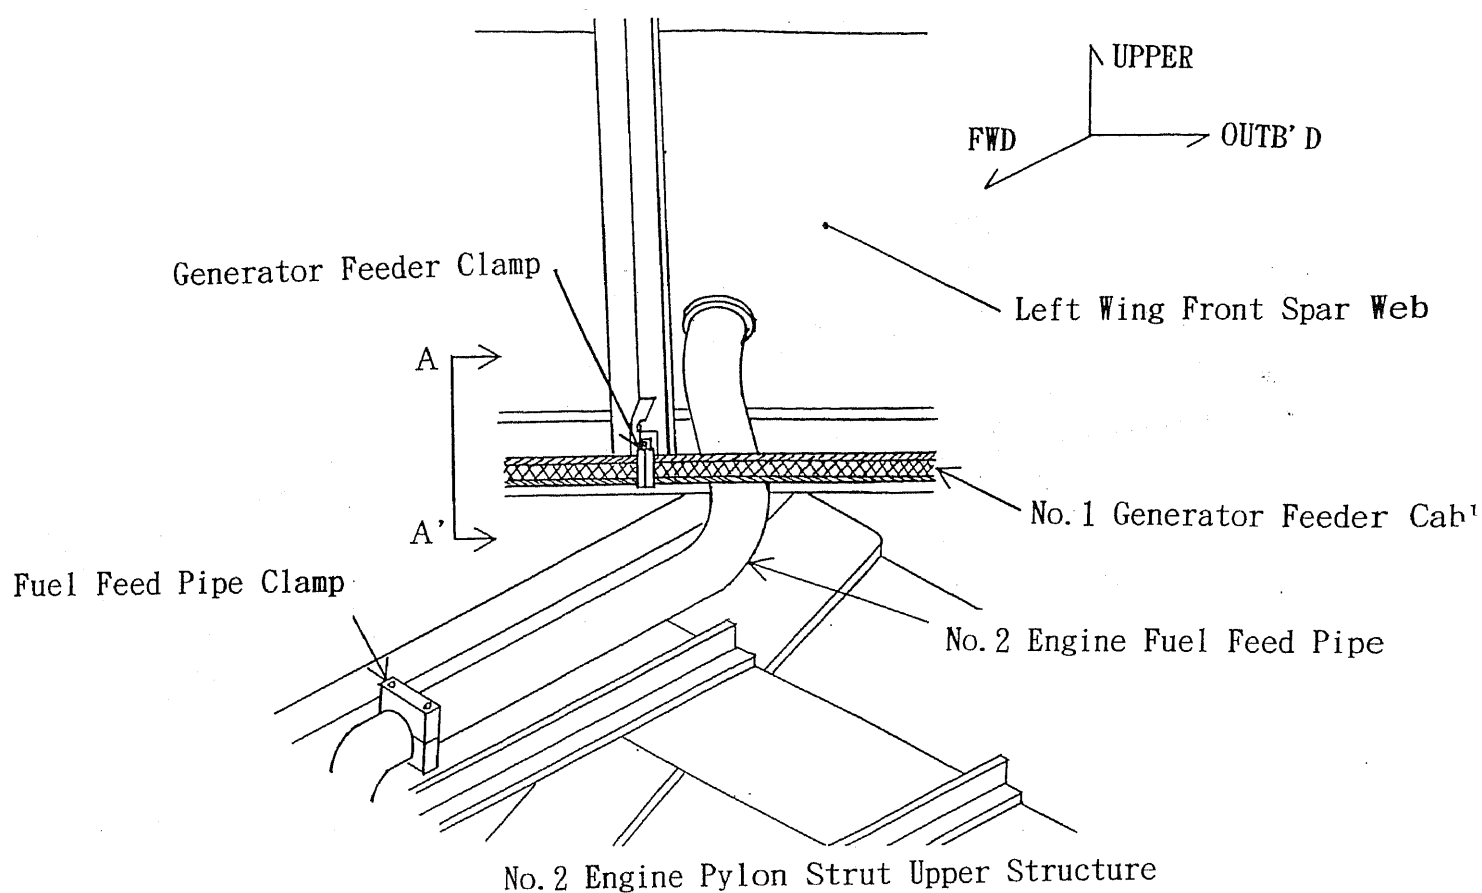
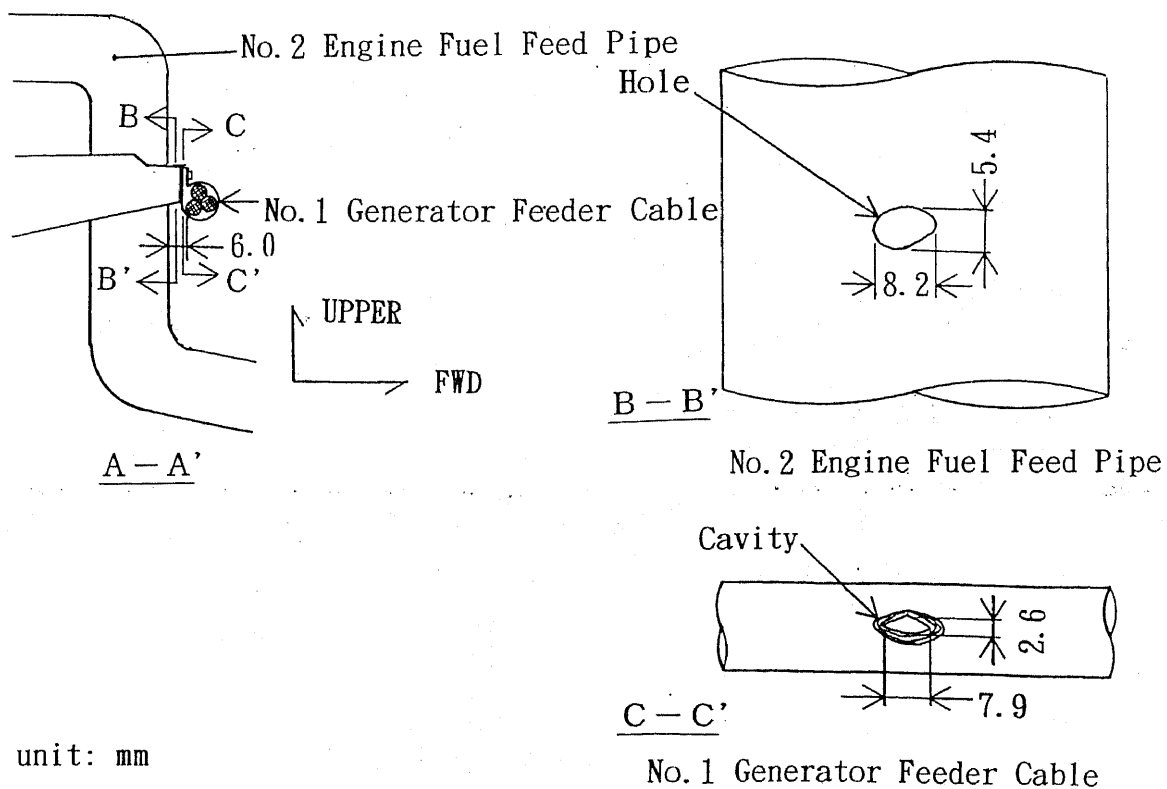
Attached Fig.6 Damage to No.1 Generator Feeder Cable and  
No.2 Engine Fuel Feed Pipe

- \* No.2 engine fuel feed pipe: damaged (hole)
- \* No.1 generator feeder cable: damaged (cavity)
- \* No.2 engine fuel feed pipe
  - clamp bolt: fractured,
  - block: burned
- \* Wire bundles: burned
- \* Piping for fire extinguisher for No.1 and No.2 Engine: melted
- \* Wires of electric motor for driving leading edge flaps: burned

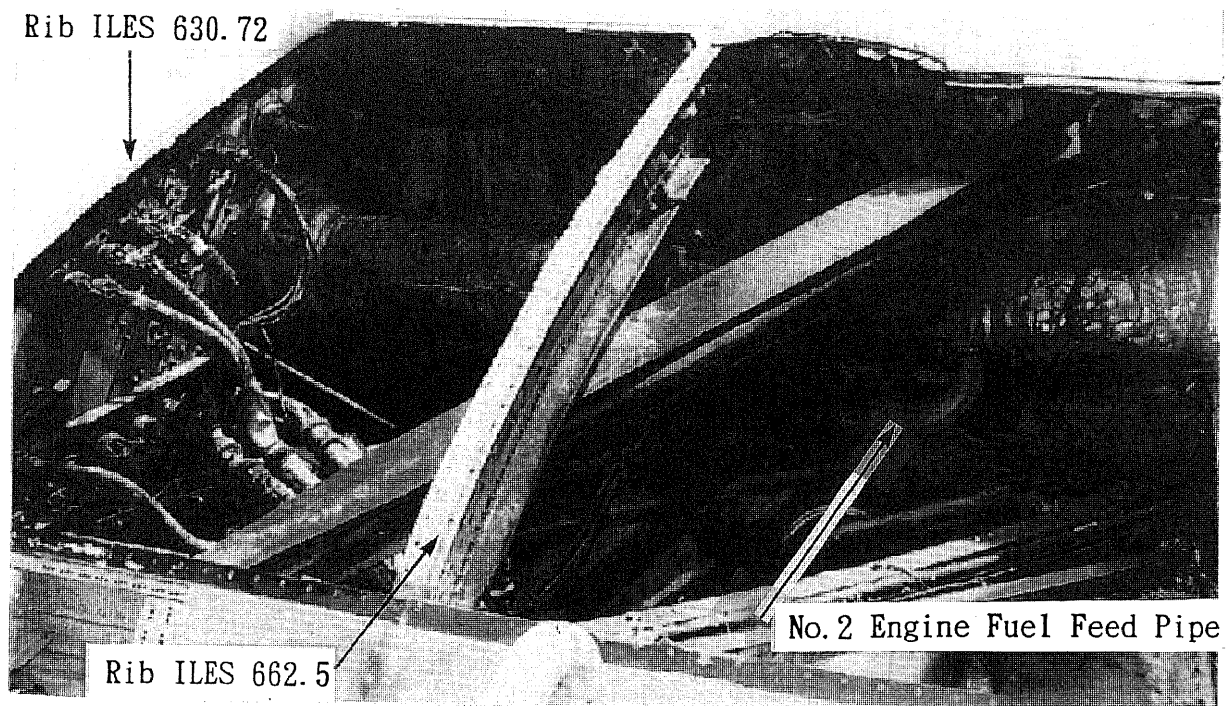
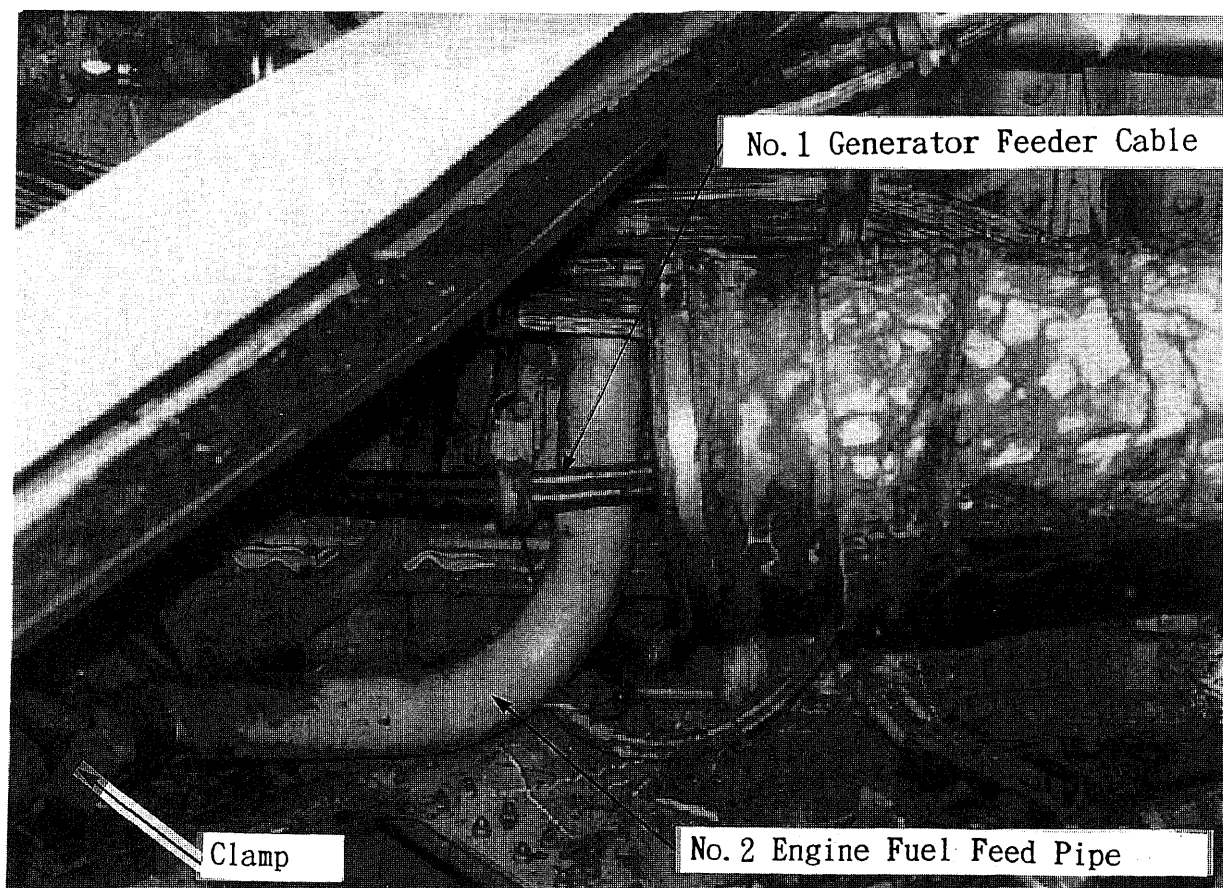
Photo. 1 Location of Left Wing where fire occurred

- \* Access panel(No.511BB) on the wings undersurface inboard of No.2 engine pylon strut: burned, and the blowout panel: separated (the said blowout panel is designed to separate by a differential pressure of 2.5 psi)
- \* Access panel (No.511CT) on wing's upper surface as well as the inside of the fixed panel adjacent thereto: burned

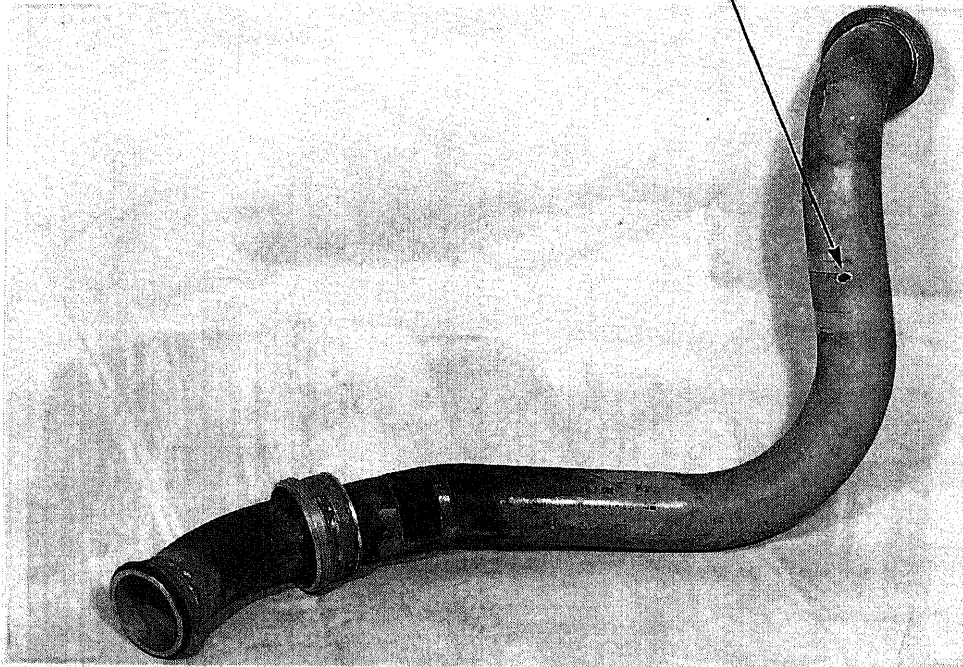
Photo. 3 No. 2 Engine Fuel Feed Pipe

Damaged Portion of No. 2 Engine Fuel Feed Pipe (Hole)

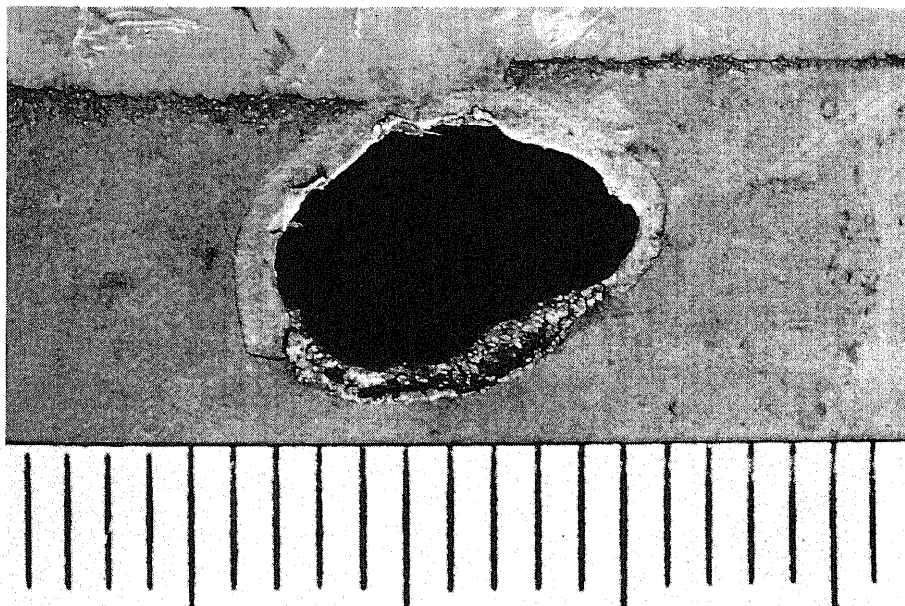
Phote. 4      Damaged Portion of No.2 Engine Fuel Feed Pipe (EXPANDED)

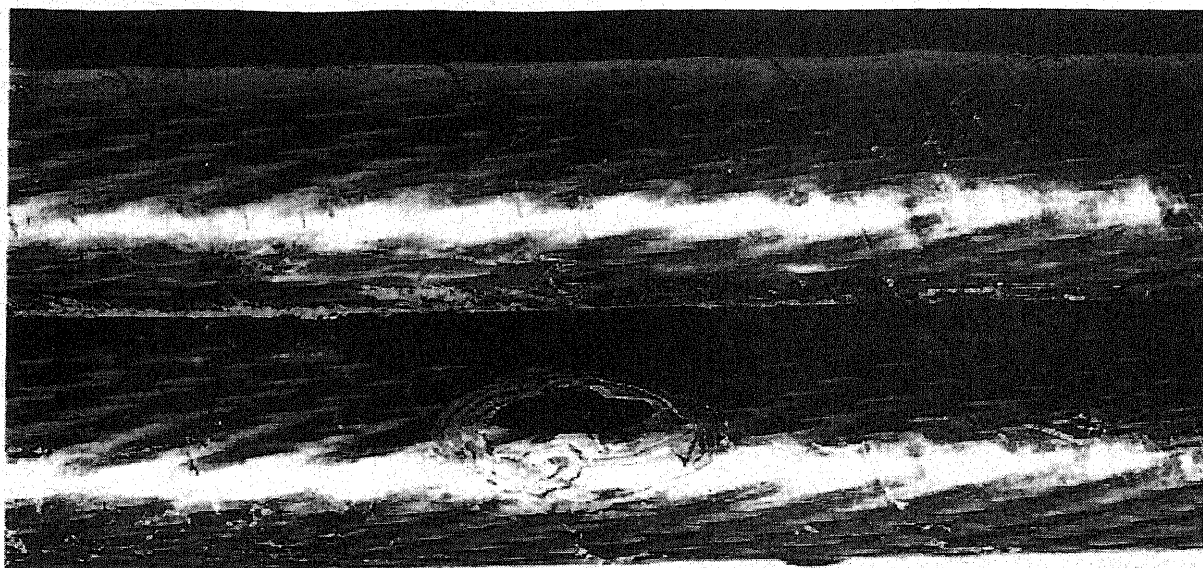
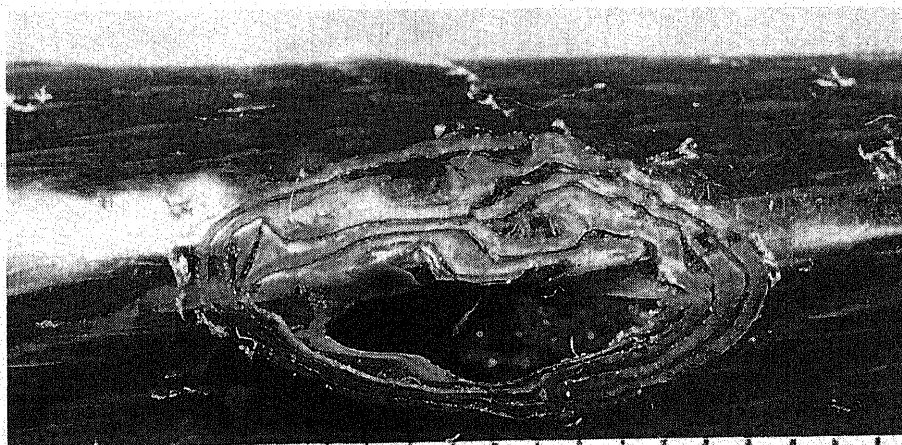
Phote. 6      Damaged Portion of No.1 Generator Feeder Cable (Cavity)
