## Chapter 3 Railway accident and serious incident investigation

## 2. Procedure of railway accident/incident investigation

### 3. Statistics of investigations of railway accidents and serious incidents

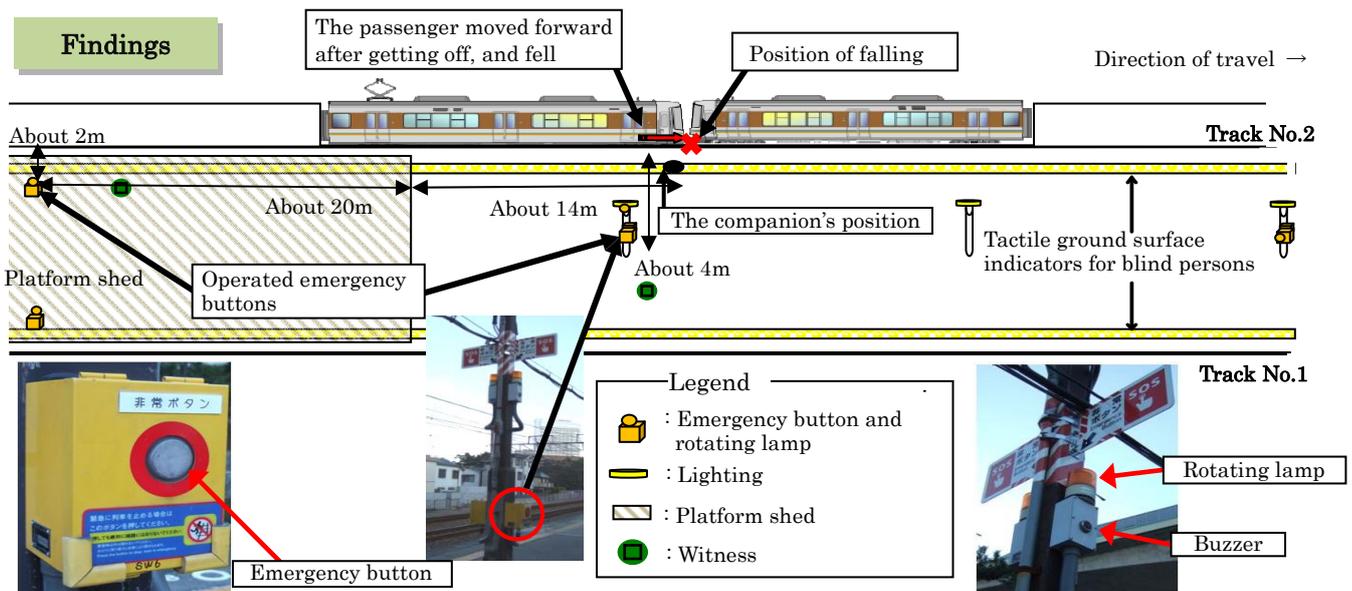
**Schematic drawing of the accident site**

It is highly probable that the passenger walked along the train in the direction of travel after getting off the train, and fell from the platform into the space between the 4th and 5th cars (without a vestibule diaphragm for falling protection). It is somewhat likely that alcohol drinking was involved in the falling from the platform.

**Probable causes:** It is highly probable that the accident occurred because the passenger walked along the train in the direction of travel after getting off the train, the train departed after the passenger fell from the platform at a position between the 4th and 5th cars, and the head of the passenger who was standing with the upper body straight got caught between the train and the platform.

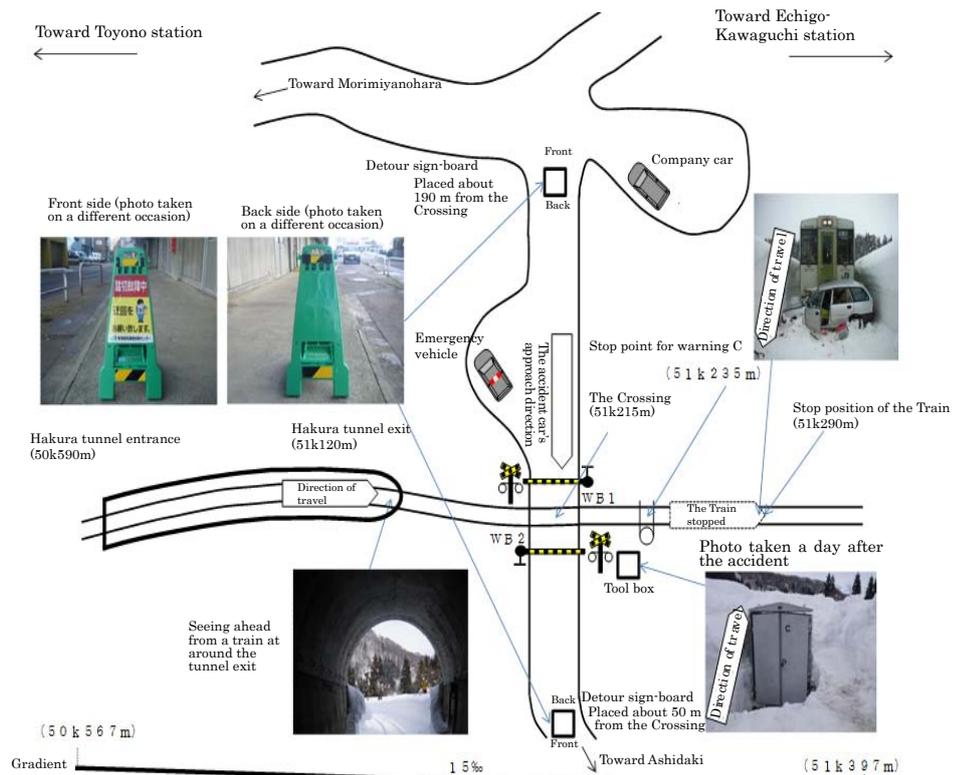
**Schematic drawing of the accident site**

It is highly probable that the existence of any oncoming train was not checked before the crossing rod was raised.

It is probable that the existence of any oncoming train was not checked because (i) level crossing guard A assumed that there would be an interval of more than 10 minutes in the operation schedule between westbound and eastbound trains, and (ii) level crossing guard B assumed from the work schedule given by A that the train would come at about 12:30.

It is probable that the tall heaped snow around the level crossing obstructed the visibility for noticing a train approaching and absorbed the traveling sound of a train.

It is highly probable that the driver of the train was not informed of the failure of the level crossing because of the decision made by the train dispatcher not to warn against the failure of the crossing.

The Company did not provide for a regulation about cancelling a level crossing failure warning, and when two or more level crossing guards were assigned at a level crossing, the practice of cancelling such a failure warning was followed unless asked by the field staff to continue the warning. It is probable that such a practice followed by the Company is not appropriate from the viewpoint that a level crossing failure warning will be cancelled even when the field staff has missed asking for the continuation of the warning.

**Probable causes:** It is highly probable that the accident occurred because when the level crossing guards, without checking the existence of any oncoming train, raised the crossing rods which had been at closing position due to failure, the truck entered the crossing and collided with the train.

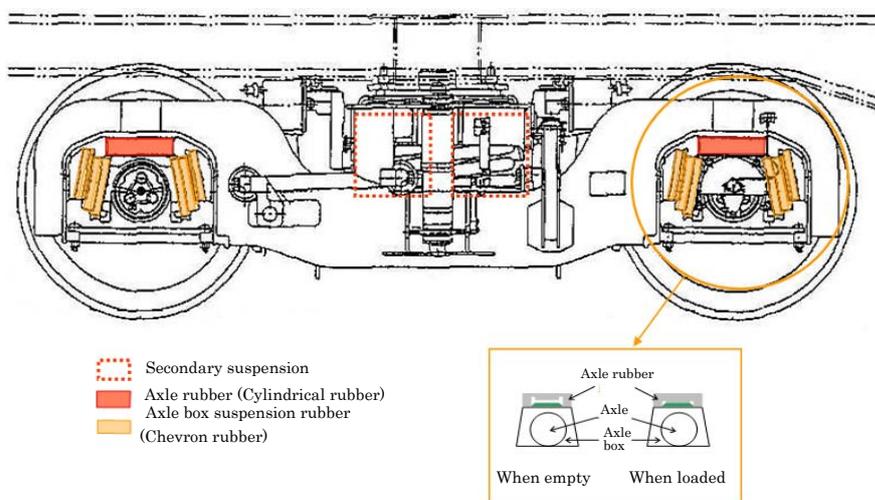
**Axle box suspension of the derailed freight cars**

It is somewhat likely that due to aged deterioration for having been used since it was newly made, the spring of the axle suspension (axle rubber and axle box suspension rubber) for the freight cars became stiffened and the track followability was decreased. On the other hand, it is somewhat likely that the cars of the train were shaking at the curbed section at around the derailment point where a large track irregularity was observed. It is probable that the large track irregularity observed between 9k553m and 9k558m had largely changed the load and lateral force of the outside wheel of the first axle in the rear bogie of the derailed freight car, and contributed to the occurrence of derailment by making the derailment coefficient larger at around a point with a relatively large track irregularity.

**Probable cause:** It is probable that the accident occurred because after running along a 406-m-radius left circular curved track, the outside (right) wheel of the first axle in the rear bogie of the 9th freight car of the train ran on the rail and was derailed to the right due to the decreased wheel load at first, and the second axle also ran on the outside (right) rail and was derailed. It is highly probable that the reason for the overturning of the 9th freight car which entered the premises of Namegawa station in a state of being derailed was that the front bogie and the derailed rear bogie of the 9th freight car ran on different tracks after passing the turnout, and the car body became unbearable to running. It is probable that the front bogie of the 10th freight car was derailed after running into wrong track because it was pulled by the rear bogie of the 9th freight car which ran into wrong track.

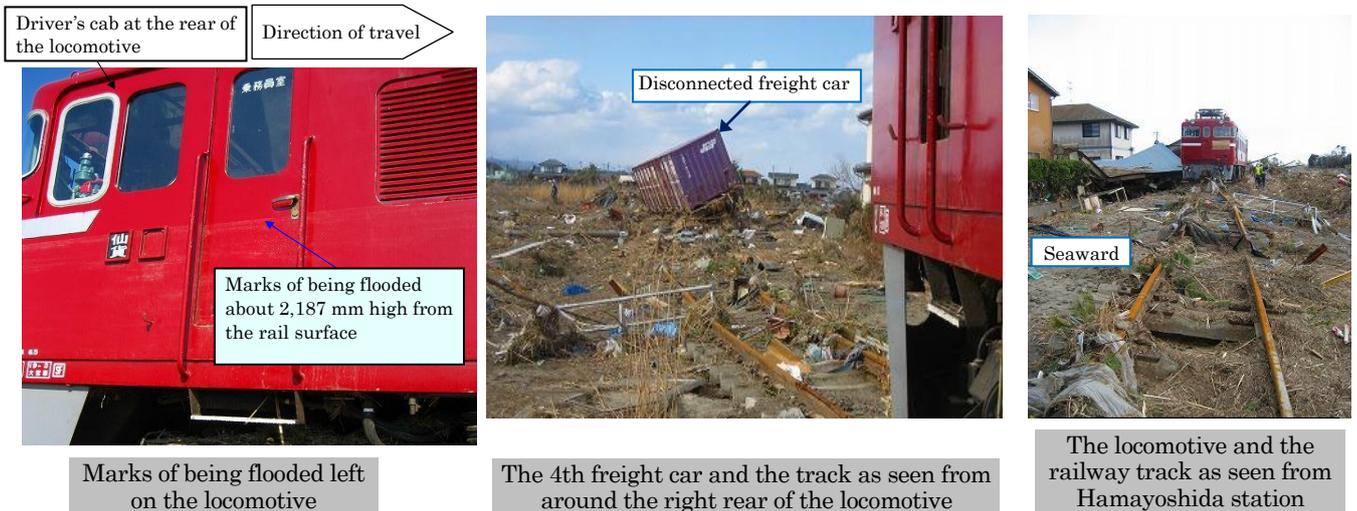
According to the findings that the train hit by the tsunami had marks of being flooded on the surface of the locomotive at a position about 2,187 mm from the rail surface, it is somewhat likely that the freight cars were flooded to the level almost half as high as the height of the loaded containers. It is probable that for that reason, 20 freight cars (all container cars) were derailed by the force of the tsunami and buoyancy, and were scattered around while some of the freight cars were disconnected as their couplers became disengaged, and others were washed away to the right (mountain side).

It is probable that the reason for the locomotive not being derailed was that the mass of the locomotive was larger than that of the freight car when fully loaded, that there were houses on the left of the locomotive (seaward), and that the disconnected freight cars weakened the force to derail the locomotive.

**Probable cause:** It is probable that the accident occurred because after the driver stopped the train by applying the emergency brake upon receiving a train protection radio, the train was hit from the left (seaward) by the tsunami caused by the earthquake, and all of the freight cars were washed away and derailed to the right (mountain side) by the force of the tsunami and buoyancy.

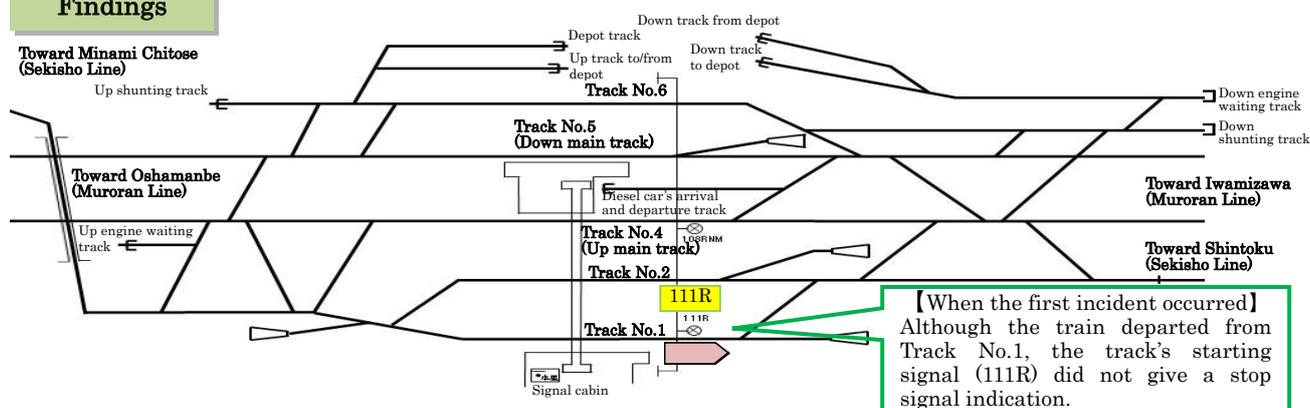
Schematic diagram of Oiwake station's premises

All of the four incidents were caused by the work to improve signal facilities, and from the aspect of signal facilities, they all have an almost identical occurrence mechanism. To be precise, with respect to the wiring work for adding a new relay circuit to the existing signal facility, adoption of an improper work method created a circuit which allowed the electric current to flow to the signal control relay of the starting signal when setting a route for Sekisho Line and Muroran Line at the same time, which then created a situation in which the starting signal did not give a stop signal indication even when the train entered the track circuit in the protection area of the signal.

The adopted work method was improper because (i) minus side terminals of each cradle of the newly added relays were connected with each other by the wiring, (ii) each of the newly added relay devices was inserted into cradles, and (iii) a change-over plug was not inserted during the wiring work in the signal relay room to connect a plus side of each of the newly added relays to the plus side of the power source for the existing facility, which resulted in keeping the circuit always connected.

It is probable that the reason for the occurrence of an almost identical incident for several times was that the event in which the indication lamp of the starting signal on the indication panel was not extinguished was considered to be due to a temporary failure of the indication panel, that the indication lamp was extinguished when operating the control console, that necessary measures were not taken immediately because the relevant persons were not informed of the event on the understanding that the wiring work would not involve much danger as the next train would not come until the next morning, and that the work transfer between the signallers was not properly done.

**Probable cause:** It is probable that the serious incident occurred because during the improvement work for Centralized Traffic Control system (CTC) and Programmed Route Control system (PRC), a new circuit was created so that the electric current could flow the signal control relay of the starting signal for eastbound trains when setting a route for Sekisho Line and Muroran Line at the same time, which caused the indication of the starting signal not to change from proceed to stop even when the train entered the protection area of the starting signal for eastbound trains on Sekisho Line.
