Chapter 4 Marine accident and incident investigations

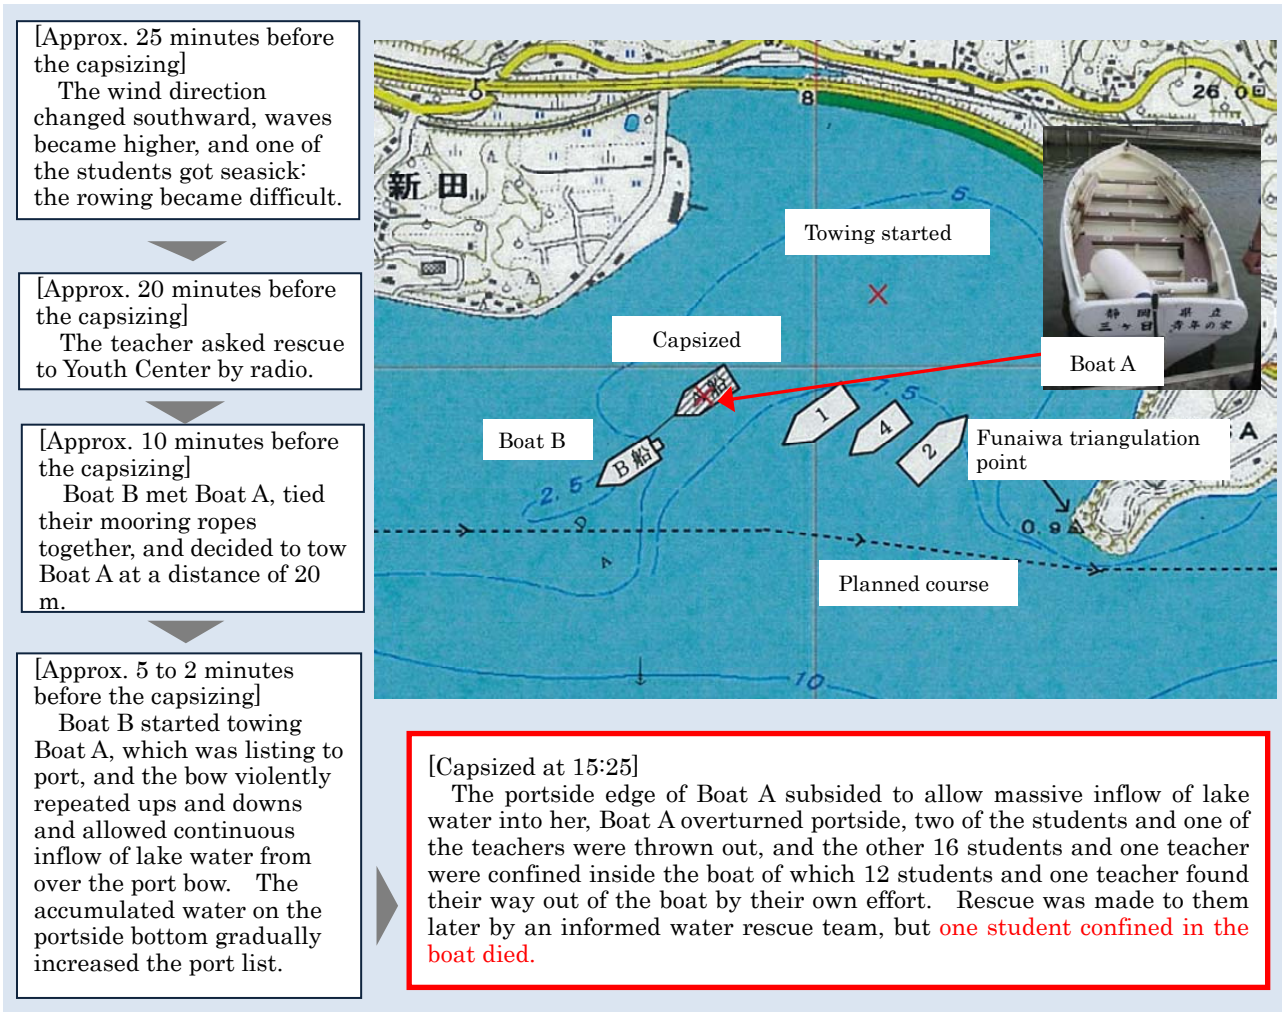
Summary: On June 18, 2010, 18 students and 2 teachers were in the training of cutter rowing on a cutter (Boat A) of Prefectural Youth Center as an outdoor activity lesson of the junior high school. The wind and waves became so heavy that the crew then found it difficult to continue the rowing. At around 15:25 when running southwestward off the south of Sakume in Lake Hamana, while being towed by a motorboat (Boat B) of the Youth Center, Boat A capsized.

One of the students confined in the overturned boat died.

Probable causes: The probable causes of this accident are as follows. Under rainy weather of which heavy rain, thunder, gale, high-wave and flood advisories had been forecast, Boat A was used for an outdoor exercise for the junior high school at the Youth Center and was engaged in a cutter rowing training without a trainer along an east course, which is a usual way of the training, off the north shore of Lake Hamana. The gale and wind grew stronger to render the rowing difficult, and the director of the Youth Center went for rescuing on Boat B, and towed Boat A obliquely to port with continuous inflow of lake water thereinto from the port bow. When being towed in those states southwestward off the south of Sakume, the Boat A's port list developed under increasing flowed-in water accumulation on her bottom and caused the portside oars to catch water and to turn her bow to port. Sometime later, the students sitting on the starboard side lost balance and were shifted toward portside, to further increase the port list. Consequently, the port side submerged, lake water flooded into the boat, and the boat overturned portside.

3) In view of the results of the accident investigation of the capsizing of the cutter (unnamed), the JTSB gave recommendations to the Shogakukan-Shueisha Productions Co., Ltd. for the safety of activities related to the cutter training at Shizuoka Prefectural Mikkabi Youth Center on January 27, 2012 as follows.

4) In view of the results of the accident investigation of the capsizing of the cutter (unnamed), the JTSB gave recommendations to the Shizuoka Prefectural Board of Education for the safety of activities related to the cutter training at Shizuoka Prefectural Mikkabi Youth Center on January 27, 2012 as follows.

The Board should review the criteria for training suspension, the training methods, and the crisis management manual of the Youth Center, should give them necessary corrections, if found any, and should have tow training practiced.

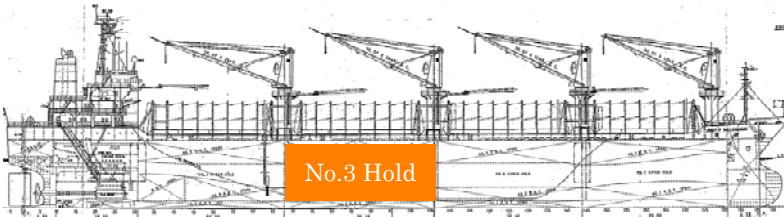
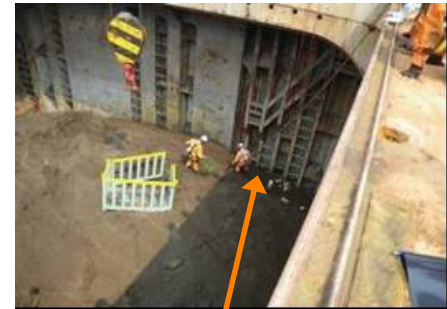
Passage into the Hold

Summary: This cargo ship was moored for discharging copper sulfide concentrate alongside the quay in Saganoseki Port. At around 08:30 on June 13, 2009, one of the stevedore workers was stepping down the ladder in the No.3 Hold to work, and fell down on it. Two of three workers who went to rescue him also fell down in the Hold.

The three fallen workers were taken out of the Hold but eventually confirmed dead.

During the voyage, the copper sulfide concentrates in the closed NO.3 Hold had oxidized, consuming the inside oxygen, to turn the atmosphere*1 in the Hold oxygen-deficient. The flotation reagent adsorbing onto the copper concentrates had produced toxic odorous gases which, heavier than air, had stayed there.

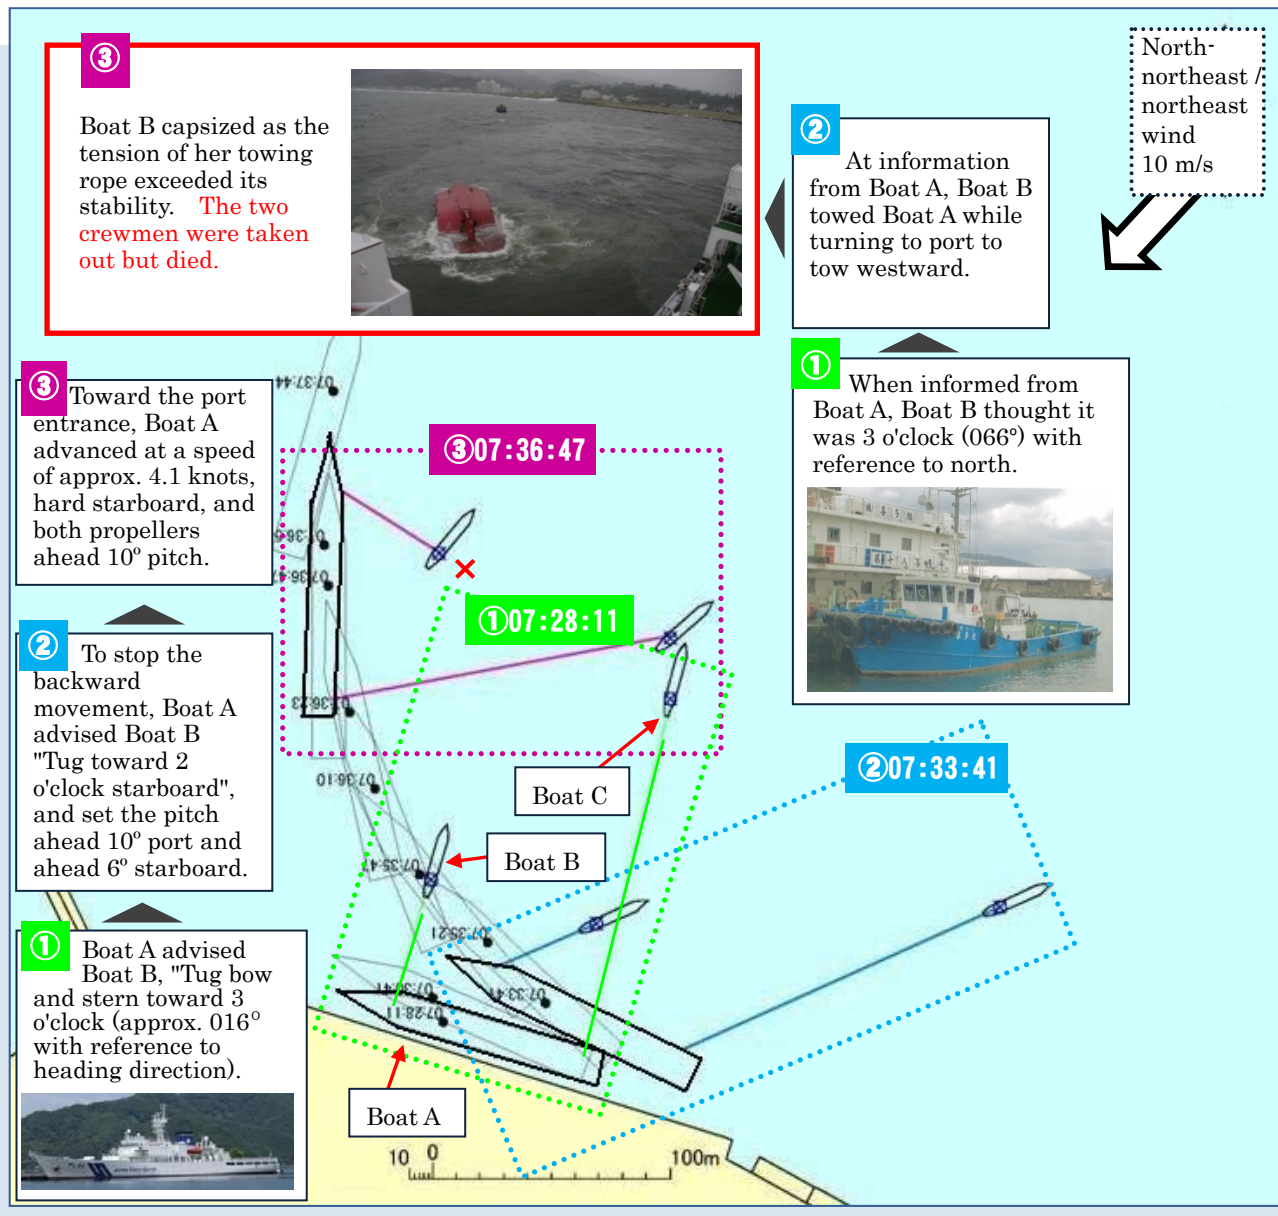
Summary: When towing the patrol boat MIURA (Boat A) to assist her departure, together with the tugboat KITA MARU No.8 (Boat C), the tugboat KITA MARU No.12 (Boat B) with a skipper and a crewman aboard it capsized at around 07:36:47-54 on Sept. 19, 2011.

All the crew (2 crewmen) of Boat B were taken out of the water but died. On a later day, the boat was salvaged but was declared a total loss.

Probable causes: It is probable that when Boat B, along with Boat C, was towing Boat A to assist the departure of Boat A from Wajima Port, with the towing rope tied at the bow of Boat A, under north-northeast to northeast wind velocity of approx. 10 m/s and wave-height of approx. 3 m, Boat B capsized because the tension of her towing rope exceeded her stability.

6) In view of the results of the accident investigation of capsizing of the tug boat KITA MARU No. 12 the JTSB recommended Kita-Gumi Co., Ltd. to take the following measures for the purpose of ensuring the safety of the towing the vessel with the tug boat on November 30, 2012.

The Kita-Gumi Co., Ltd. is recommended to take the following actions to ensure the safety of towing operations with its boat:

- (1) To check and maintain towing hooks and to perform its operation training.
- (2) To instruct the crew members to wear such outfits as lifejacket properly during the towing operations.

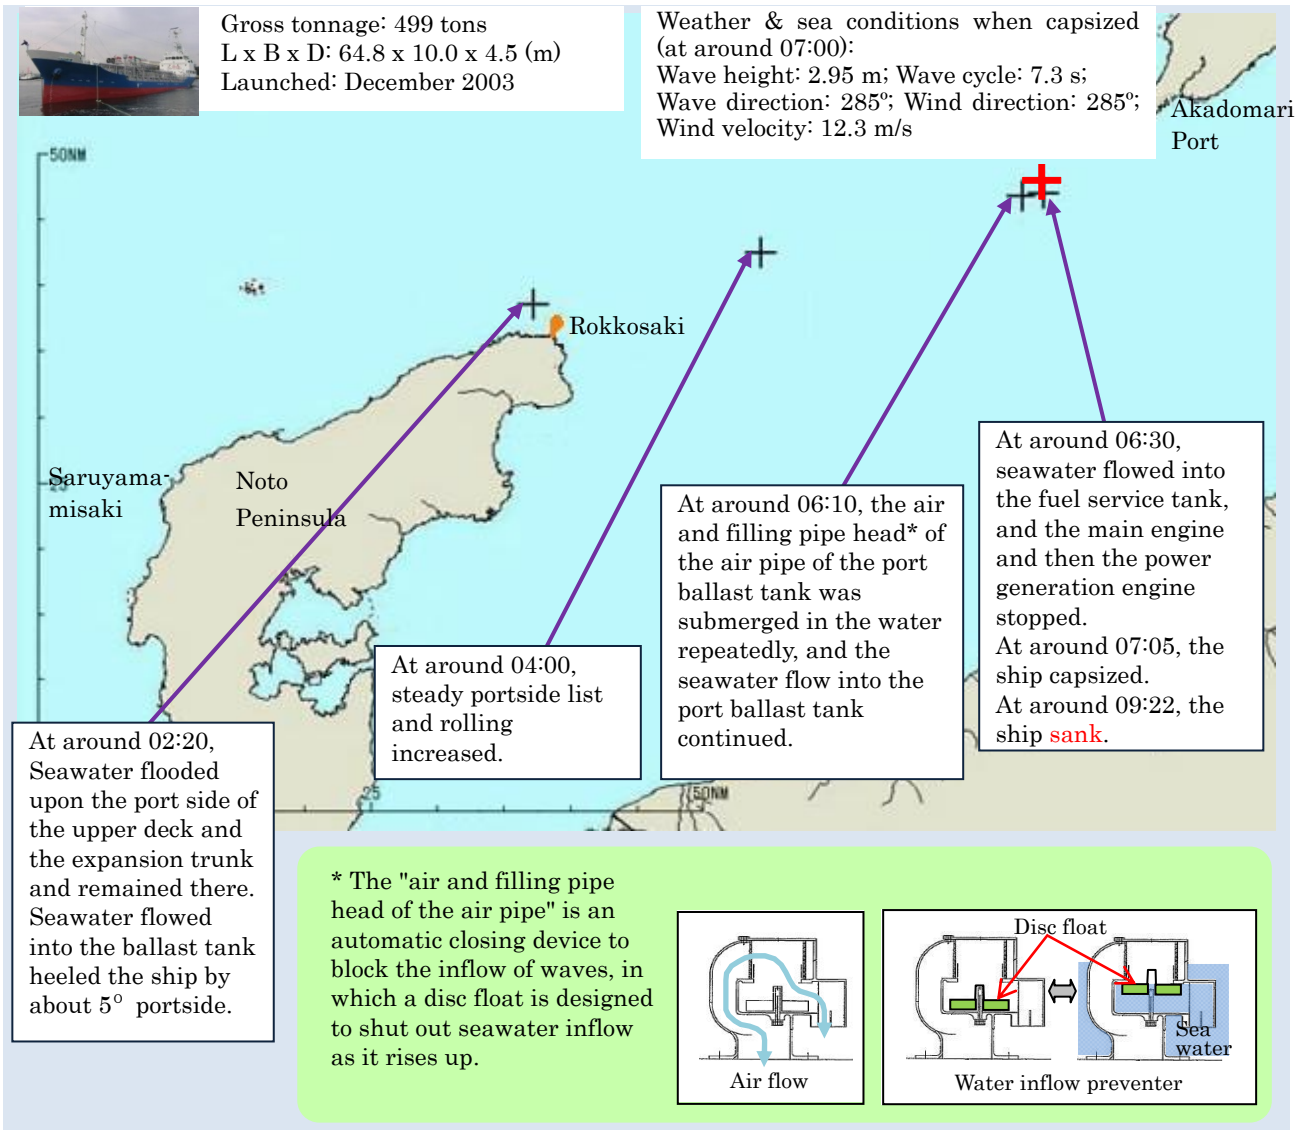
Summary: When this tanker, manned with a master and 4 crewmen and loaded with approx. 1,000 tons of vinyl acetate monomer, which had left an anchorage off the Oita Airport, Oita Prefecture and had passed off the Rokkosaki (Noto Peninsula), Suzu City, Ishikawa Prefecture, was heading east-northeast toward Akadomari Port (Sadogashima), Sado City, Niigata Prefecture on Jan. 9, 2011, she capsized and, at around 09:22, sank.

The chief engineer died and the master went missing.

Probable causes: It is probable that this accident occurred as follows. When this ship was sailing off Saruyama-misaki toward Akadomari Port in a quartering sea from port side, the water inflow preventive function of the air and filling pipe head of the air pipe of the port ballast tank failed to function and allowed seawater to flood upon the port side of the deck and the expansion trunk and to continuously stay. The seawater that flowed into the ballast tank increased the list of the ship to port and caused to repeatedly submerge the air and filling pipe head of the air pipe. Flowed-in seawater from the air pipe into the port ballast tank continuously increased the port list to consequently turn over and sink the ship.

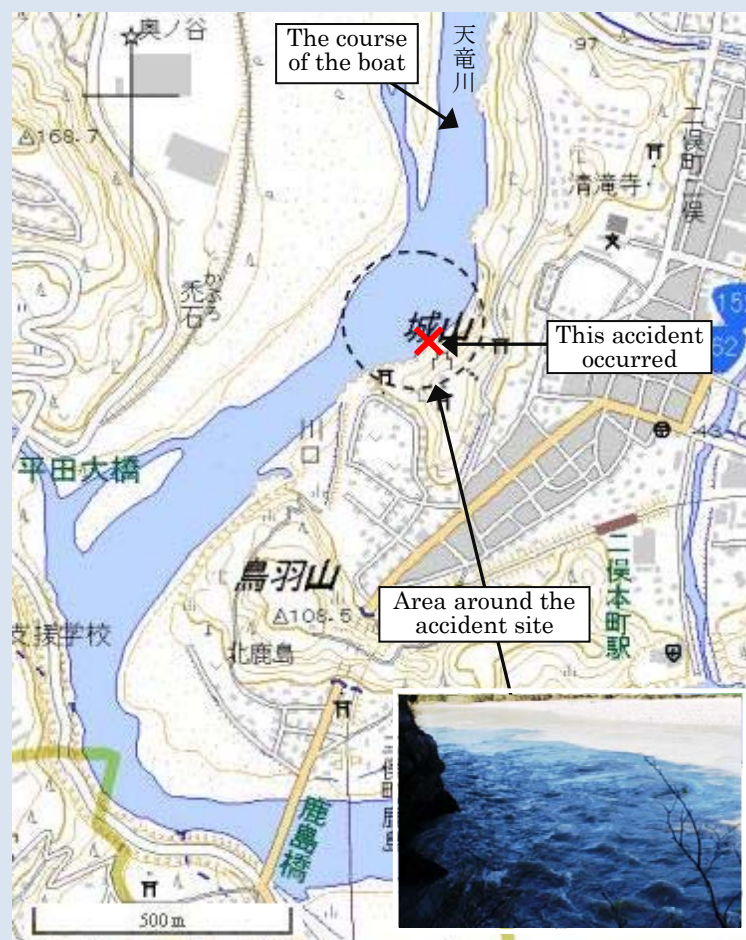
With a total of 21 passengers aboard, consisting of 14 adults including a boatman on the bow and a boatman the stern, 1 junior high school pupil, 5 children and 1 infant, this boat left the embarkation pier.

It is probable that when this boat approached the water area of this accident, the boatman on the stern started the outboard motor at upstream of the area and, at a central part of the rapids, took a course to run by the right-hand side of the swirling water without increasing the outboard motor speed. As a result, the bow was turned rightward by the swirling water so much as it was directed to face the right bank of the river.

It is somewhat likely that, with the addition of repelling waves from the right bank, the boat bow might have been turned upstream.
