Chapter 3 Railway accident and serious incident investigations

3 Statistics for the investigations of railway accidents and serious incidents

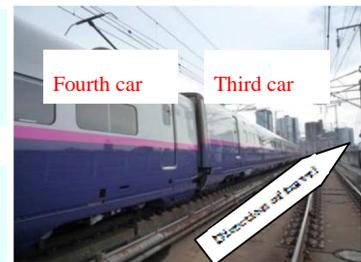
Situation of the train

Considering the results of the vehicle movement simulations, the upper center rolling could have been caused by the large shaking at the No.3 Odawara viaduct, which had a frequency exceeding 1.5-1.7 Hz. Shaking of this magnitude is prone to generating upper center rolling of an orthogonal direction in the rails).

It is considered probable that out of the frequency components of the earthquake's seismic vibrations, the vibrations around 1.8 Hz, which are the natural frequency of the bridge, have enlarged significantly by resonance, even more so than the other frequency ranges.

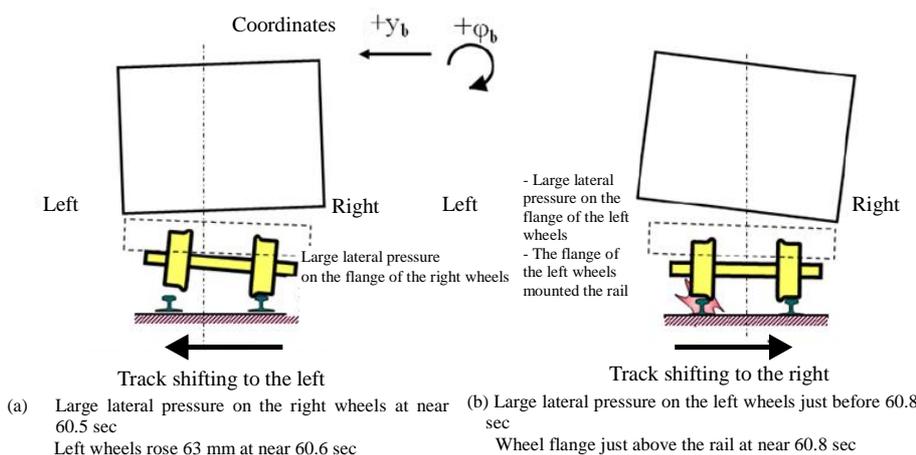
Movement of the train and cars just before derailment (conceptual diagram)

We conducted a vehicle movement simulation that was similar to the method used to determine the cause of the train derailment accident in the Joetsu Shinkansen Line, which was caused by the Niigata Chuetsu Earthquake. (Simulation times are shown on the left)

Probable causes: It is considered highly probable that the train was derailed by the seismic vibration of the main shock from the Great East Japan Earthquake. It is also considered highly probable that, when the accident occurred there were no problems with the railway facilities including the tracks, the train or any of its operations. Furthermore, the time of the derailment is thought to be just after the time when the main shock from the Great East Japan Earthquake had arrived at Sendai city.

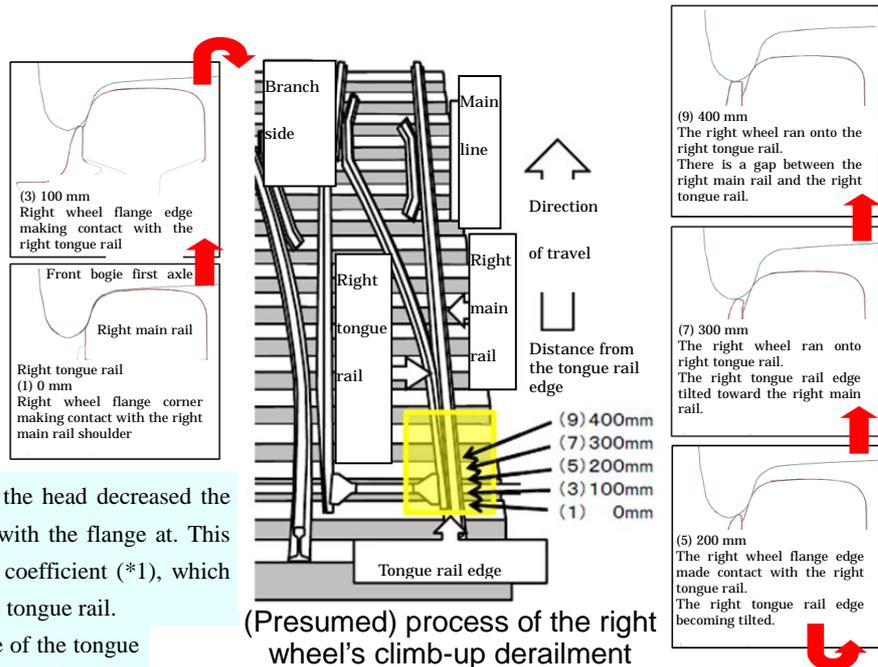
(Presumed) process of the right wheel's climb-up derailment

As described above, it is considered probable that the branch line side of the turnout was prone to producing climb-up derailments. This is due to multiple factors. It is considered probable that this situation caused the vehicle to derail.

Probable causes: It is considered probable that this accident is thought to have the following background. The right wheel of the first axle in the front bogie of the seventh car slid up onto the outer tongue rail of No. 67 curved turnout in the same direction. This forced the train to enter the wrong direction to the main line side. The train was then pulled by its front cars in the branch line, causing the seventh car to become derailed to the right of the branch line rail.

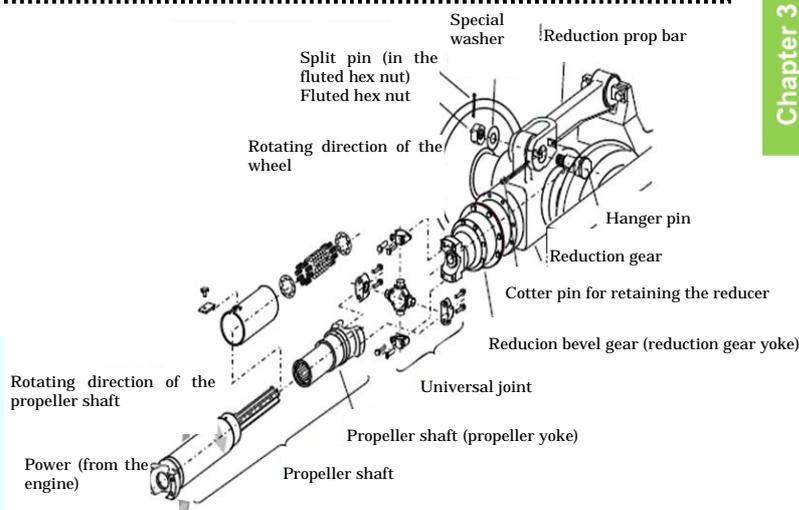
Transmission system in the vehicle

It is considered probable that the reason the fluted hex nuts' hanger pins fell off could be due to the repetitive effects of vibrations during the operation.

The hanger pins for the reduction gear fell off and then the reduction gear and propeller shaft started hanging down. This caused the reduction bevel gear on the universal joint to begin making contact with the propelling axle. After this, it is considered probable that the bevel gear was further dangled, resulting in the universal joint becoming locked and damaged.

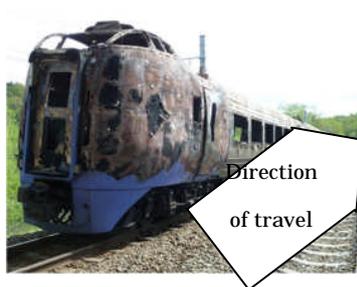
Status of the burnt cars

The universal joint that was damaged could have led to the separation of the reduction gear and the propeller shaft. The external cylinder and the joints of the shaft had then fallen off, and lubricant oil had become scattered from the reducer. The reduction bevel gear dangled down began making contact with the sleepers. On top of this, the damaged reduction gear box then hit the dangled the reduction bevel gear, which is thought to have then caused the rear bogie of the fifth car to be pushed up, resulting in the first axle becoming derailed to the left.

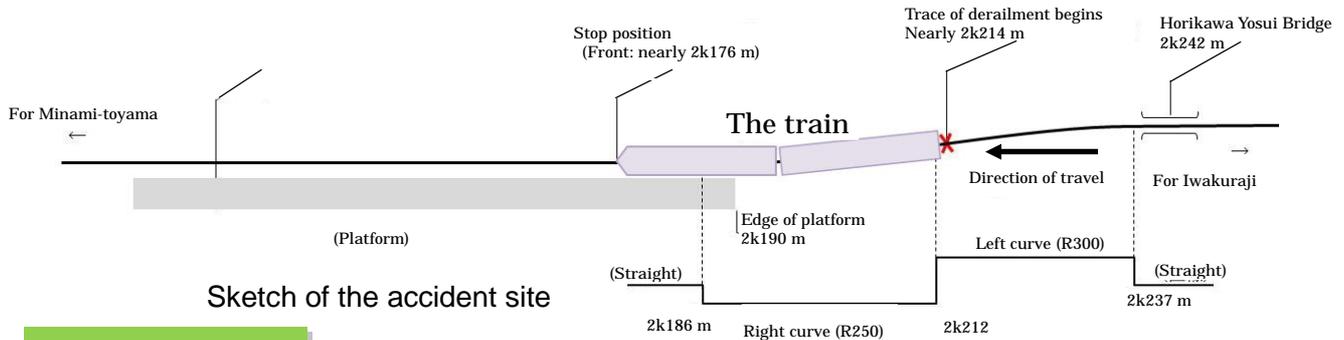
Sketch of the accident site

Summary: On Saturday, July 28, 2012, the driver of a two-car upbound train set noticed unusual sounds and shocks when stopping at Kamihori Station during a one-man operation. The driver applied the emergency brake to immediately stop the train. A check after the stop revealed that all the eight axles of the car had become derailed. There were twenty passengers and two drivers on board the train. No one was killed or injured.

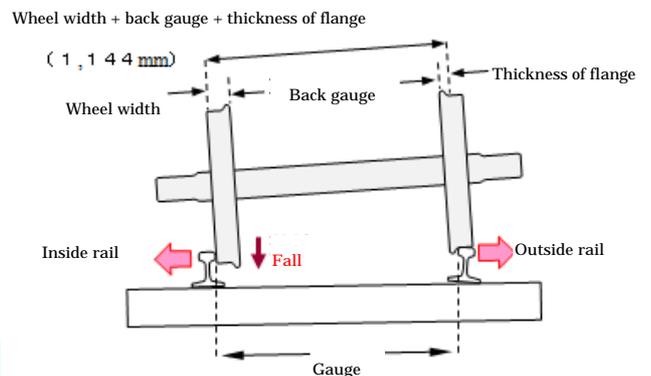
Relationship between the rails and wheelset

Pushing force was applied in the direction from the inside to the outside rail while its wheelsets were running on the curve, probably leading to an enlargement in lateral pressure on the wheels on the outside rail.

The company did not have any knowledge or experience in tightening the fastening bolts. As a result, the bearing capacity of the rail fastening system near the accident site got lower and lower as external forces from passing trains were repeatedly applied on the system.

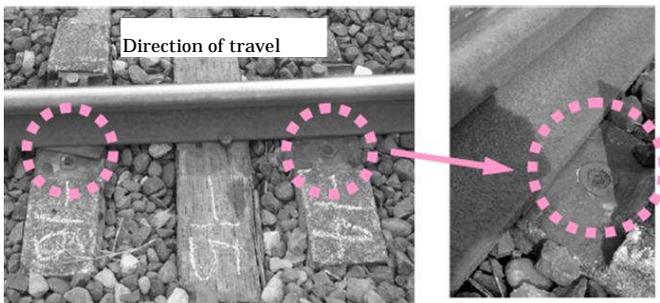
Damage of inserts of rail fasteners on PC

Over a period of two months prior to the accident, the traffic of trains continuously reduced the capacity to bear the rails. As a result, it is considered probable that the irregularity of gauge have increased.

With the significantly weakened fastening force of the rail and the increased the irregularity of gauge, the left wheels of the first axle in the first car fell between the rails from the left rail head. It is considered probable that this caused the irregularity of gauge to become wider toward the right, causing all of the left wheels of the second axle in the first car and behind to fall between the rails near the site.

Probable causes: It is considered probable that, at the outlet-side transition curve of the left-hand curve that is followed by a reverse right-hand curve, the lateral displacement of track (the shifting of track) was larger than allowed by the maintenance criteria. This decreased fastening force of the rail fastening system and made the action of lateral force associated with the running of the train extend the gauge, leading to the derailment of the left wheels between the rails.

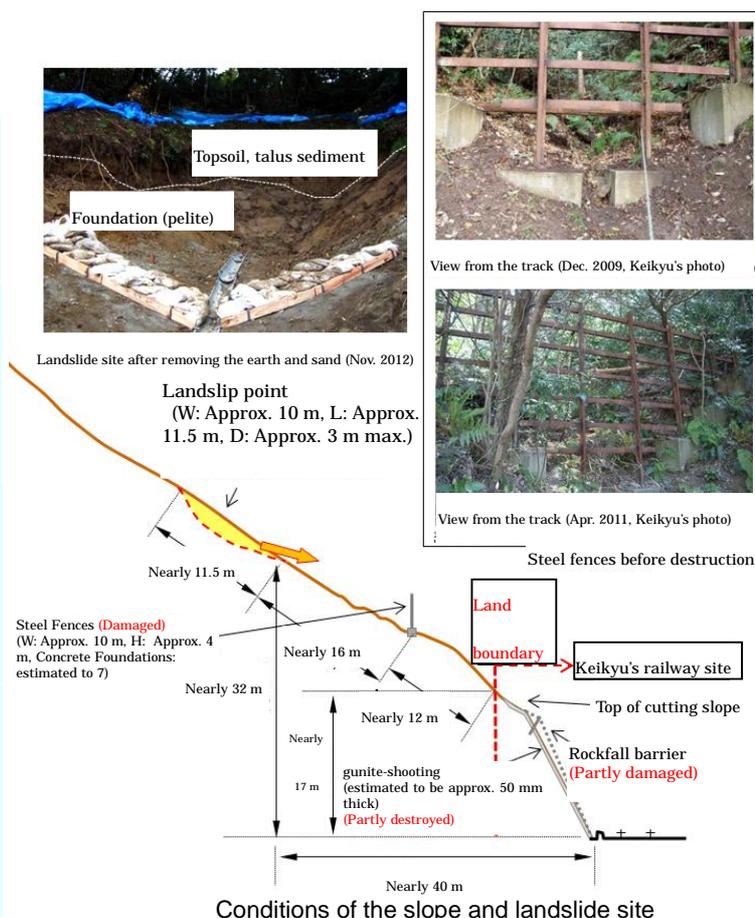
Earth and sand containing large amounts of water from heavy rain flew down from the slope failure nearly 20 m above the steel fences. It is considered probable that the multiple concrete foundations collapsed in the slope or fallen to the bottom of the slope.

It is considered highly probable that the train collided with a pile of earth, sand, and one of the concrete foundations, which had all become accumulated on the track. The front bogie then ran onto the foundation, resulting in derailment, with the bogie jumping up one meter.

Probable causes: It is considered highly probable that this train derailment accident was caused by the accumulated earth and sand, which contained a concrete foundation, flowing down from the collapsed slope face, and then the front bogie ran onto them. It is considered highly probable that the concrete foundation that came into contact with the first car's bogie made the situation even worse. It is considered probable that the cause of this landslide is to be the rise in the level of groundwater in the surface of the slope. It is considered somewhat likely that this happened due to the large amount of rainwater that fell on the surface, as well as on the top of the bedrock layer under the surface, which had possibly become fragile. It is unclear why the steel fences' concrete foundations, which were built on the slope, fell down. This is due to a lack of records detailing the reasons for building the fence, or structural drawings. However, it is considered somewhat likely that the cause was the deterioration of the foundation, in addition to the flow of an amount of earth and sand that was larger than expected in the original plan.
