## Major activities in the past year

#### 2. Aircraft serious incident investigation report published regarding the damage of engine

#### 3. Publication of investigation reports on the derailment accident caused by cracks in a bogie

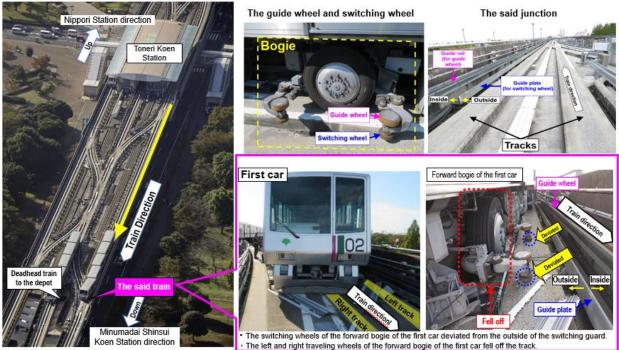
Situation of the accident site

The switching wheel of the forward bogie of the first car of the derailed train deviated outside of the guide plate at the junction and the left and right traveling wheels of the bogie fell off the track to the right side in the train direction and derailed.

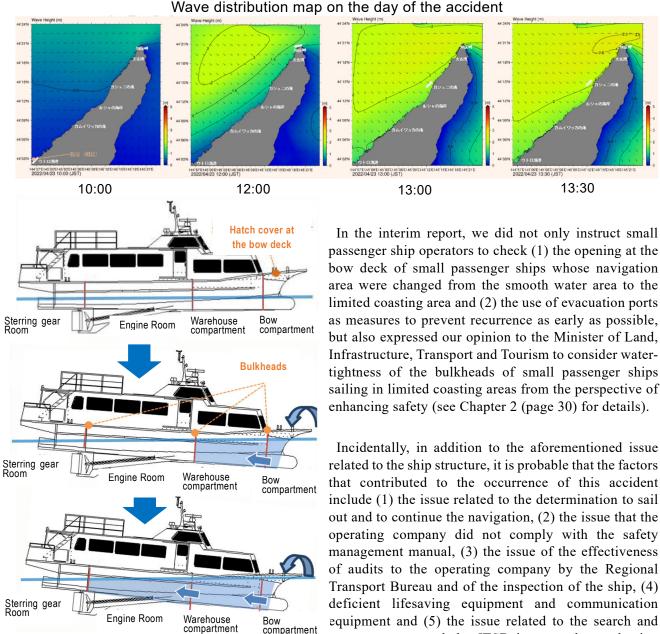
Mechanism from flooding to foundering It is probable that the hatch cover at the bow deck which was not firmly closed was opened due to pitching motions in the situation where the weather and hydrographic conditions were deteriorating, thereby allowing sea water to flood into the bow compartment from the hatch and the flooding to spread to the warehouse compartment and engine room through the opening in the bulkhead.
