JTTSB (Japan Transport Safety Board) DIGESTS

(Issued in December 2017)

Digest of Aircraft Accident Analyses

Injuries suffered in Use of Evacuation Slides during an Emergency Evacuation

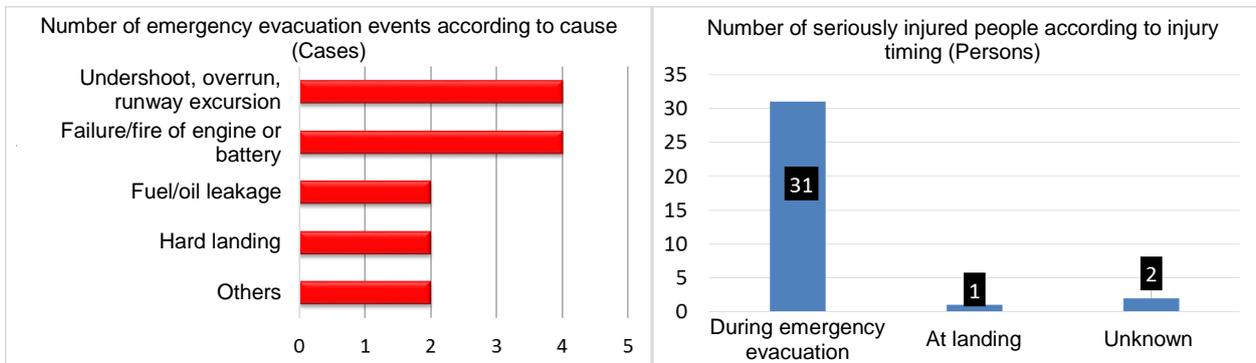
Fig. 1

According to the 14 cases of the accident investigation reports issued by JTSB and its predecessors (Table 1), emergency evacuation procedures were conducted not only in cases that a normal landing was not possible, such as an undershoot, overrun and runway excursion, but in cases that a fire occurred (Fig. 1). In most of such cases, passengers suffered injuries during evacuation (Fig. 2).

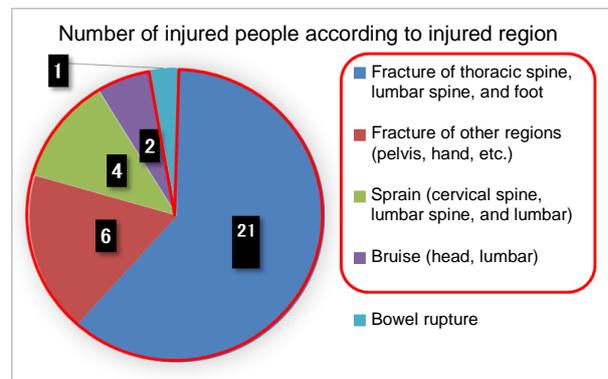
Fig. 3

In this chapter, the injury region of 34 seriously-injured persons, excluding slightly-injured persons, were analyzed and 27 injured person suffered a fracture of the thoracic spine, lumbar spine, pelvis, etc., and they account for nearly 80% of the total. (Fig. 3)

An analysis of the cases where serious injuries occurred during evacuation using evacuation slides revealed that, in each case observed the serious injured suffered in use of evacuation slides, the slides were deployed at a ground with a hard surface, such as a runway, taxiway, and aircraft

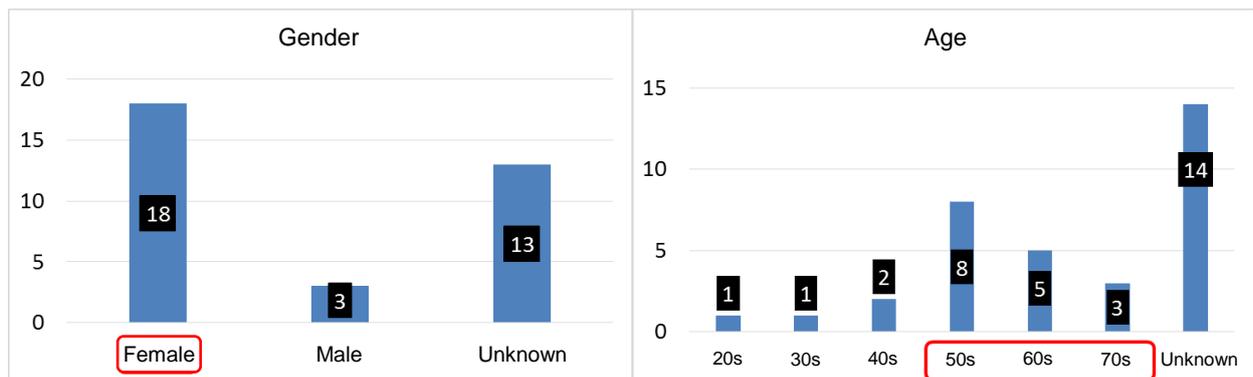
Fig. 4

The gender and age structures of the passengers vary. However, as far as the seriously injured are concerned, the tendency is more females in terms of the male-to-female ratio and people over 50 years old by the age. (Fig. 4, Fig. 5)

There are some medical study reports cited in the investigation report for the accident occurred in an All Nippon Airways aircraft in 1993 (Case (1)) (http://www.mlit.go.jp/jtsb/eng-air_report/JA8096.pdf), one report says that the spines of older people are weaker than those of younger people. And another report says that females suffer rapid reduction in bone mass after menopause, in contrast, males have less of a tendency for bone deterioration due to aging.

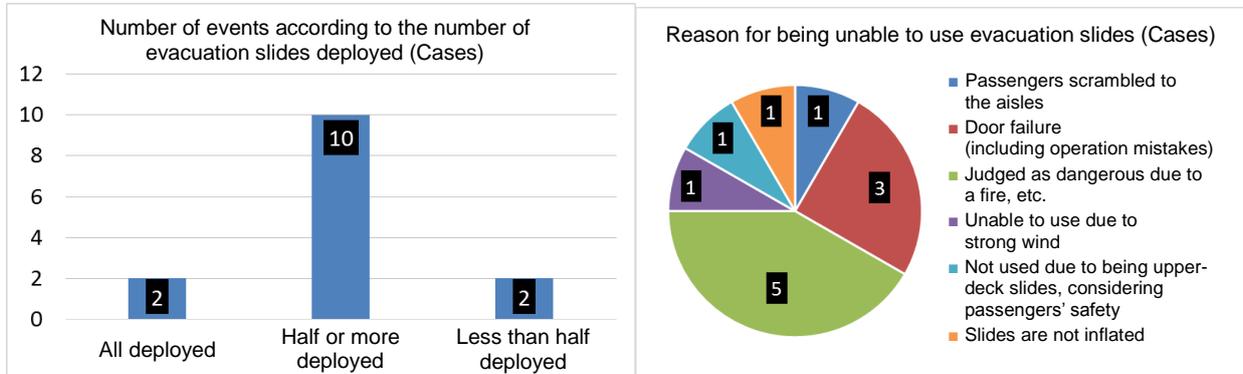
Fig. 6

The number of deployed evacuation slides is also an important factor for smooth evacuation. During an emergency evacuation, some emergency exits are judged as dangerous to use due to a fire, and thus not all slides can be used. (Fig. 6, Fig. 7)

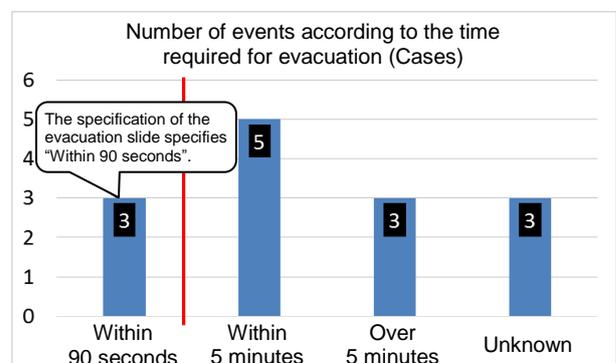
Fig. 8

However, in an actual emergency evacuation, the required evacuation time depends on such factors as the weather at that time, the time zone, the number of evacuation slides deployed and the degree of emergency. (Fig. 8).

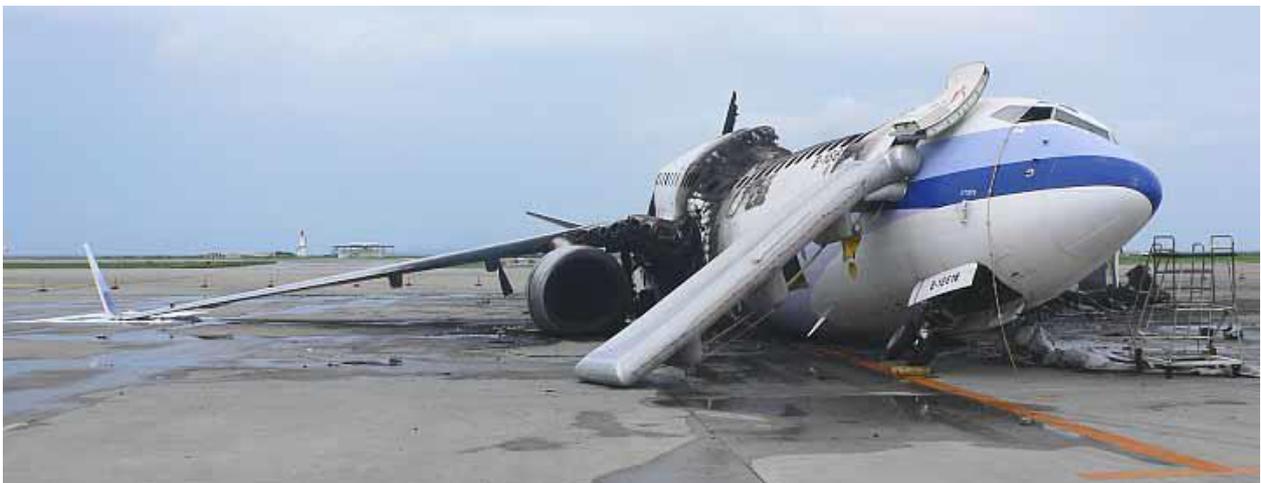
- There were no dead or wounded.
- The time required for the evacuation was 2 minutes and 28 seconds. (from 10:33:52 to 10:36:20)
- The number of evacuation slides used was 4 out of 6.
- In a questionnaire survey conducted for the passengers, about 25% of the respondents said that they saw assistants at the bottom end of the evacuation slides.
- About 60% of the respondents brought their baggage with them when they evacuated. None of them said that they were restrained by carrying their baggage as they evacuated.

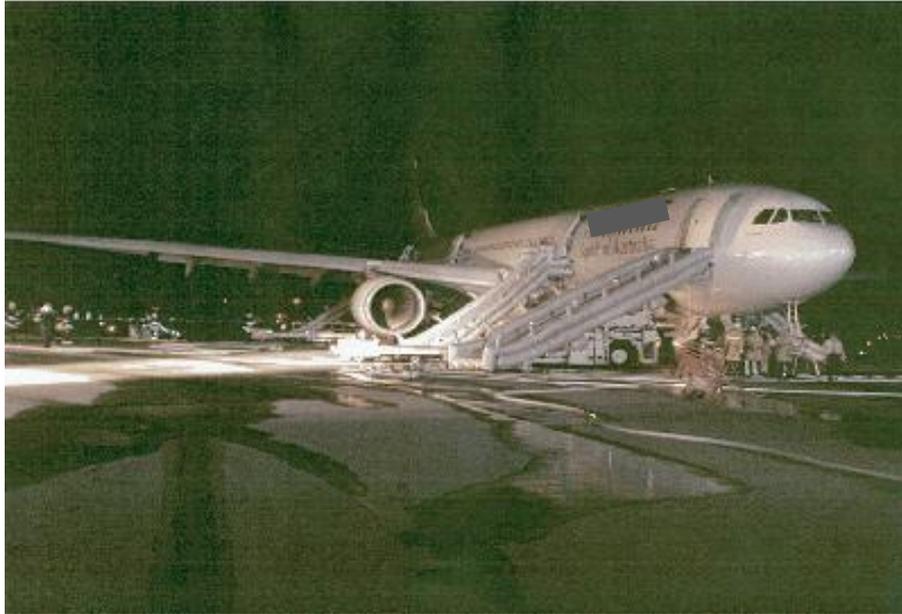
- Female unknown age fractured her pelvis.
On the lower portion of an evacuation slide, the passenger, who was until then held by her parent from behind, slid out of her parent's arms and struck her lower back against the ground.

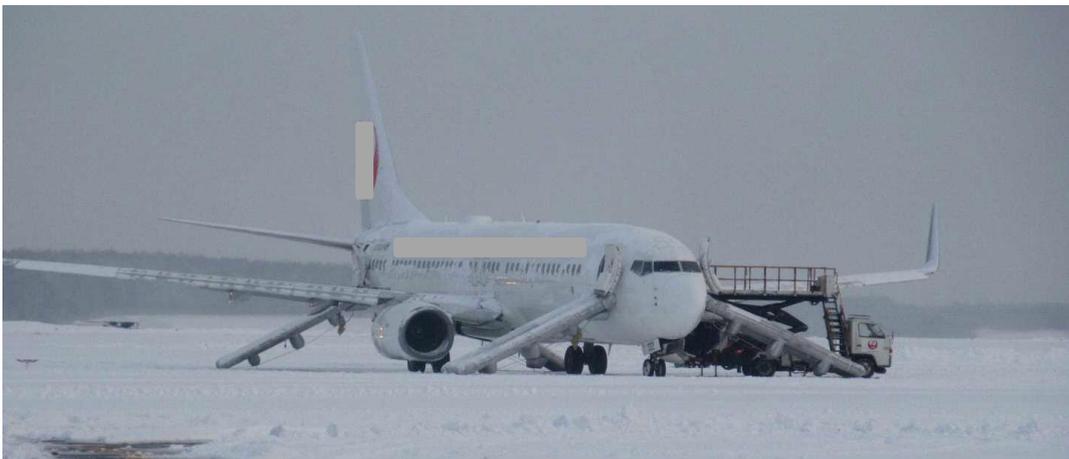
Although two helpers were at the bottom of the evacuation slide, their attention was on an infant following the passenger, so they did not pull the passenger up when the passenger fell down and forward, which caused them to land on their back.

- Revision of the safety video
- Adding the contents to the periodic rescue training carried out by cabin attendants
- Implementation of education concerning the emergency evacuation for the group staff of the company
