3. Case Studies of Collision Accidents between Vessels Resulted in Fatalities or Missing Persons

1 A fishing vessel on a return voyage was navigating with a blind spot toward the bow, and collided with another fishing vessel underway.

2 A fishing vessel continues to navigate with attention to fishing conditions and collides with a drifting fishing vessel

3 Both vessels collided while navigating with keeping course and speed without noticing the other vessel

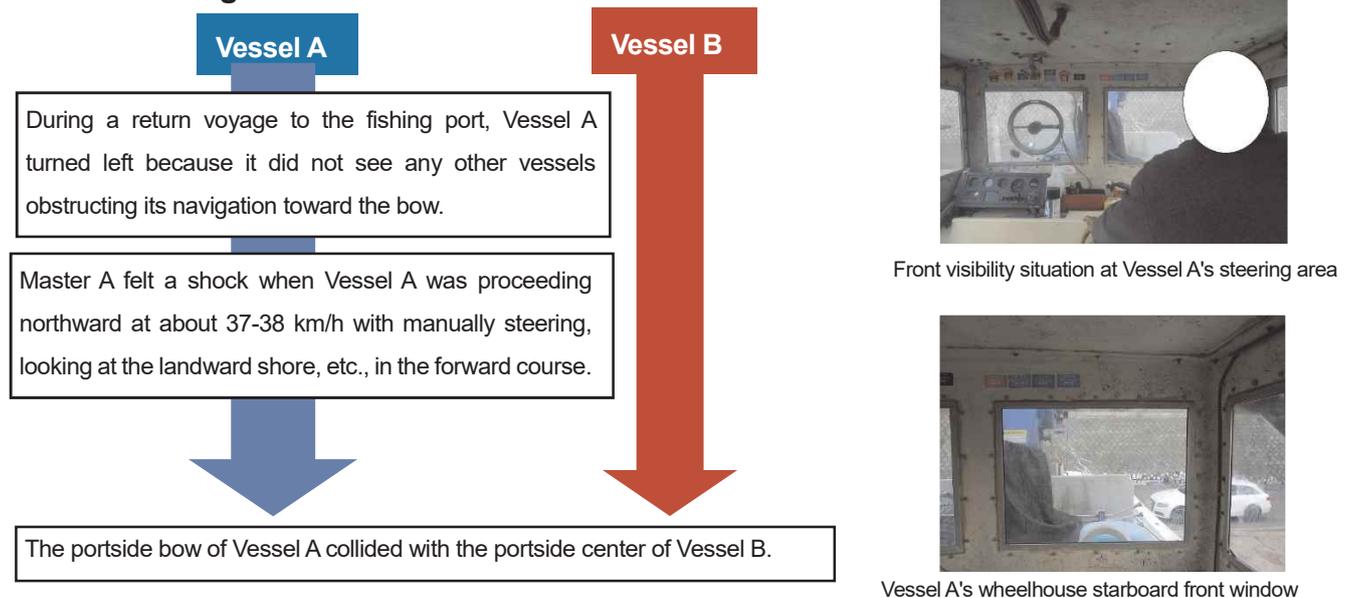
- When Master A stood in front of the helm wheel on the starboard side of Vessel A's wheelhouse, which is the usually maneuvering location, and looked at the forward course, **a wide area in front of the portside was blinded by the crane prop portside.**
- Master A did not accurately understand the blind spot created by the crane prop, and recognized after the accident that **even if he stood at the maneuvering area and kept watch on the forward course as usual, a blind spot would be created in the range of approximately 20 to 30 degrees toward the portside bow.**

Probable Causes : It is probable in this accident that, while Vessel A was proceeding north, Master A **thought that there were no vessels in the forward course that would interfere with navigation**, and continued to **navigate with a blind spot** toward the portside bow, and was unaware that the Vessel was approaching Vessel B, which caused the collision between the portside bow of Vessel A and the portside center of Vessel B.

- After this accident, Master A decided to **assign two persons to watch over Vessel A in order to eliminate a blind spot** caused by the crane in the forward way watch.
- The operator should be on watch **with an accurate understanding of the blind spots** created by the structures on deck.
- When a blind spot caused toward the bow of the vessel, the operator should **keep a lookout to compensate for the blind spot** caused by constantly swinging the bow to the left or right, or by moving from the maneuvering location whenever possible, rather than keeping a lookout from a single location.

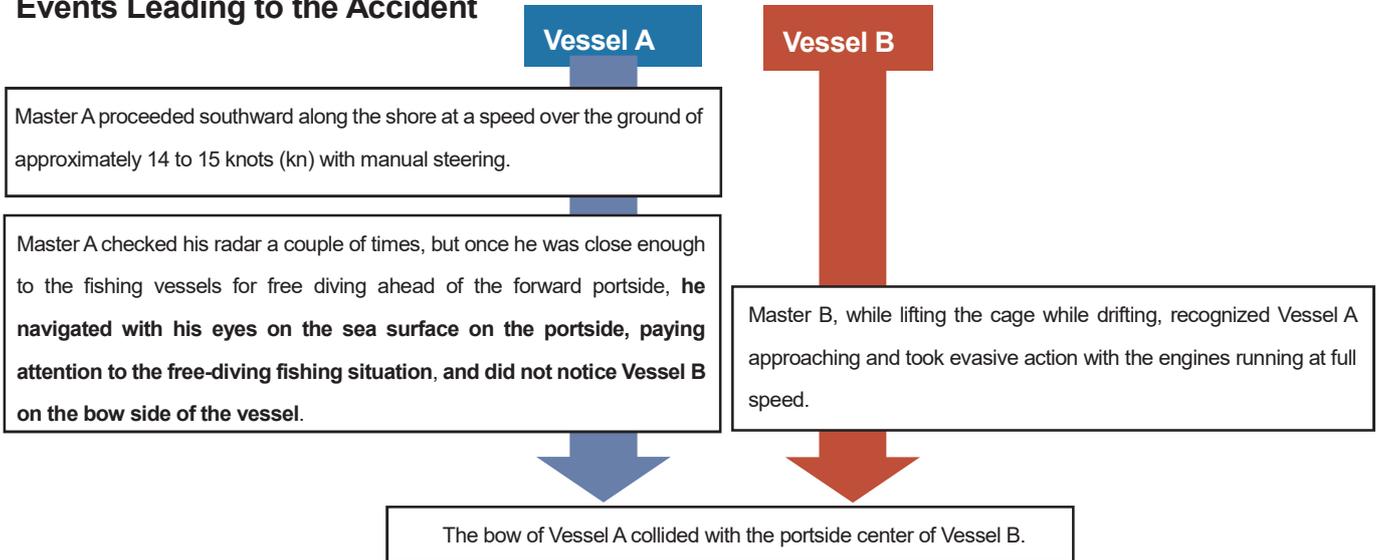
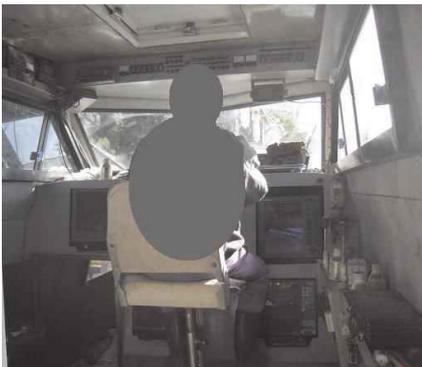
Maneuvering situation of Master A (reproduced)

Probable Causes : It is probable that, Vessel A was collided with Vessel B because while the vessel A proceeding south, Master A **continued to navigate** visually **observing the situation of free-diving fishing** near the portside, and **did not notice Vessel B on the side of bow**, It is probable that while Vessel B was lifting its baskets while drifting, Master B saw Vessel A approaching and took evasive action with full ahead, but Vessel B collided with Vessel A despite this action.

• Keep a proper watch on the surroundings at all times, because **paying too much attention to a particular object may cause you to miss other vessels or objects in the surroundings.**

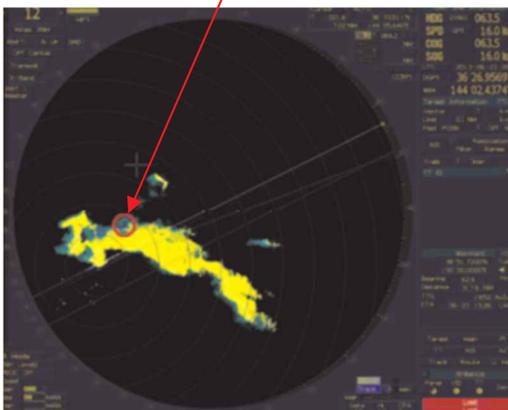
Radar image of Vessel A

(Images of other vessels are not recognized)

- Third Officer A did not notice Vessel B due to **the lack of images of Vessel B on the radar screen affected by the rainfall.**
- Ordinary Seaman B was on visual watch in the lookout room with a blind spot caused by the wall, and did not notice Vessel A because **Vessel A was approaching from approximately 83° on the starboard bow, which was a blind spot caused by the wall.**
- Ordinary Seaman B could see the radar screen, but had no authority to adjust the radar.
- Both vessels **were not conducting acoustic signaling** in the restricted visibility conditions.

Probable Causes: It is probable that the bow of Vessel A collided with the starboard center of Vessel B when Vessel A was proceeding east-northeast and Vessel B was proceeding south east, because either Third Officer A or Ordinary Seaman B **did not notice the other vessel**, because the visibility was restricted due to a shower and they navigated with keeping their course and speed.

- When a restricted visibility condition occurs, the management company of vessel A should **increase the number of bridge duty personnel** and familiarize the crew of the operating vessels with **the acoustic signals to be made** during the restricted visibility condition.
- In the event of a restricted visibility condition, the owner of Vessel B should **report to the master and reinforce the personnel on bridge duty**, as well as **establish a system for acoustic signaling** in the restricted visibility conditions on the operating vessel. It is also desirable to **equip** the operating vessel **with an AIS.**
