AI2015-1

**AIRCRAFT SERIOUS INCIDENT  
INVESTIGATION REPORT**

**KOREAN AIR LINES CO., LTD.  
H L 7 5 9 9**

RUNWAY OVERRUNNING  
KOREAN AIR LINES CO., LTD.  
BOEING 737-900, HL7599  
ON RUNWAY 10 AT NIIGATA AIRPORT  
AT 19:42, AUGUST 5, 2013

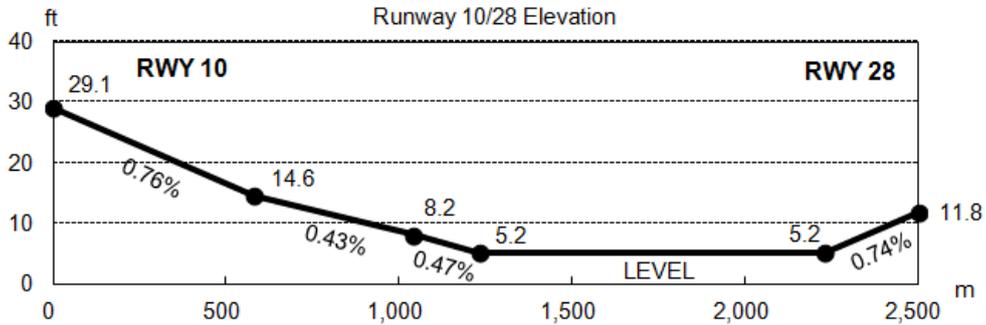
Figure A: Slope of RWY 10/28 (Prepared with AIP information)

45 m wide. The PAPI angle on RWY 10 is 3°, and it is placed on the left side of the runway 541 m from the threshold. As the below figure shows, RWY 10 holds a down slope of 0.21 % in an average between the threshold and the end.

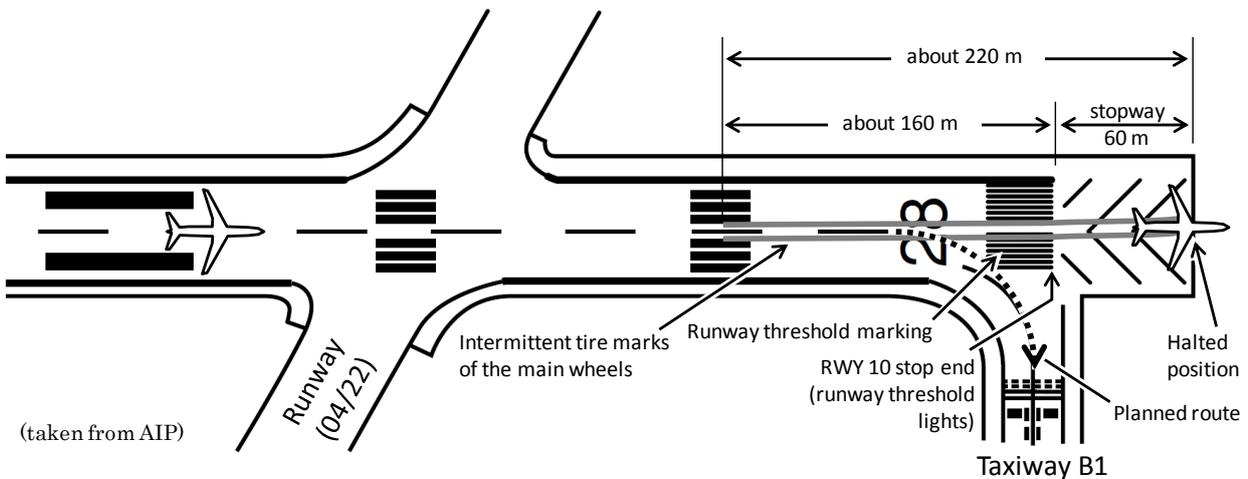
Figure B: Marks left on the runway

The main landing gears of the Aircraft were stayed at the stopway of about 58 m beyond the end of RWY 10, and the nose landing gear came to rest at the spot of about 75 m beyond the end of RWY 10 where was in the grass area. Tire marks in a light color of the main landing gear wheels were found in patches on the runway and the stopway for about 220 m (about 160 m on the runway). One stopway light and three approach lights for RWY 28 were damaged by hitting of the Aircraft wheels.

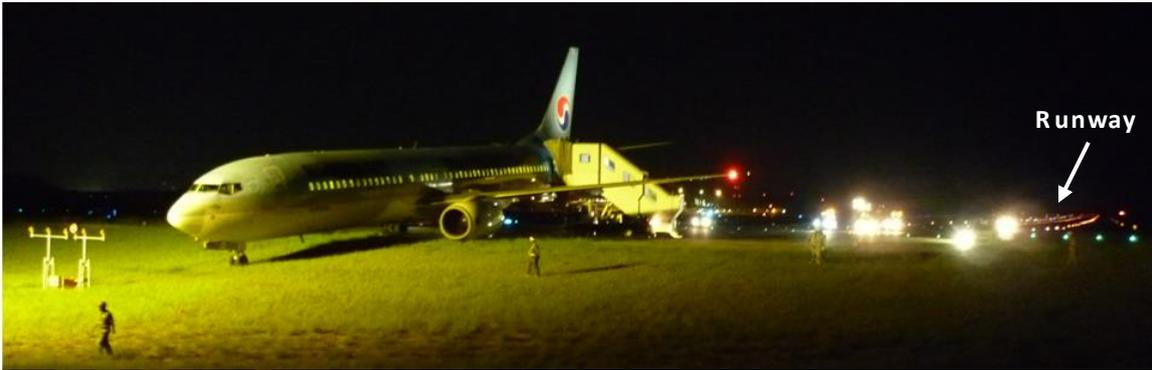
Photo 1 Serious Incident Aircraft

Upon checking the general external condition of the Aircraft, no damage was found on the aircraft, both main and nose landing gears (including the wheels and tires). The depth of tire grooves and the remaining brake pad amount were all within the allowable limits. Self-diagnosis for the anti-skid/auto brake control units was conducted, but no fault was found. Moreover, the thrust reverser operation check was conducted, but no anomaly was found.

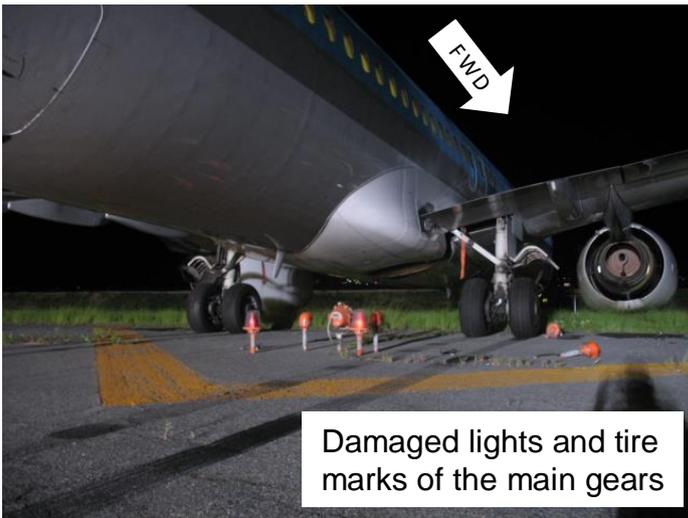
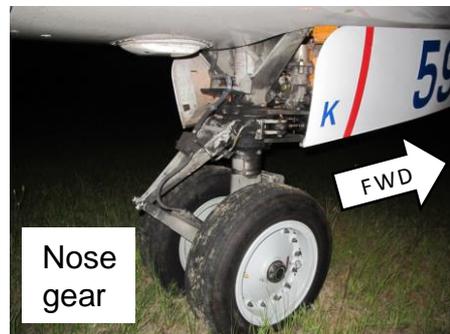
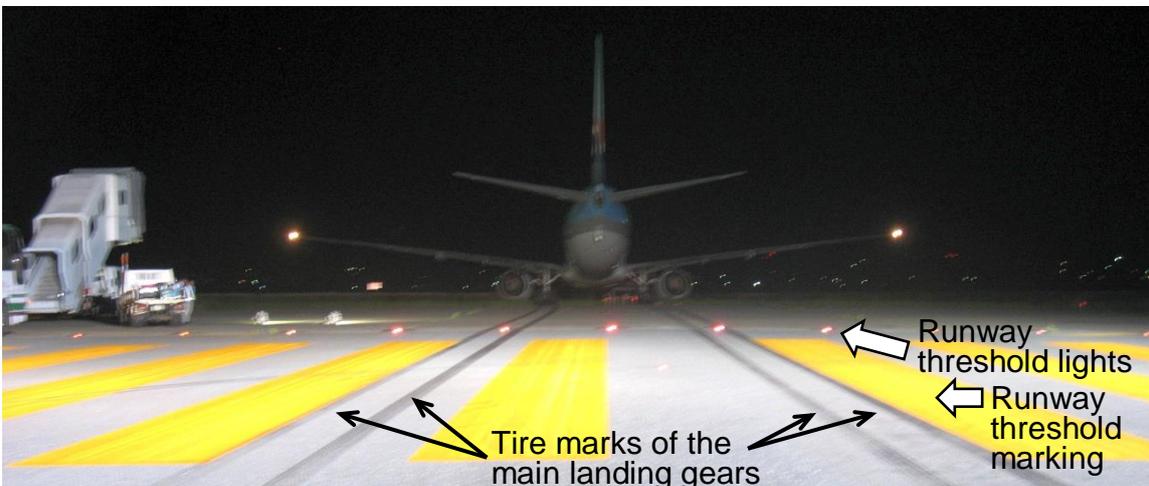
Photo 2 Serious Incident Site

- Three approach lights were damaged
- One overrun light was damaged
