**AIRCRAFT ACCIDENT
INVESTIGATION REPORT**

Setouchi SEAPLANES Inc.

J A 0 2 T G

SETOUCHI SEAPLANES, INC.
QUEST KODIAK 100 (AMPHIBIAN), JA02TG
AIRCRAFT DAMAGE DURING TAKEOFF RUN FROM WATER
AT THE SEA OFF BEPPU CITY, OITA PREFECTURE, JAPAN
AT AROUND 16:20 JST, MARCH 24, 2017

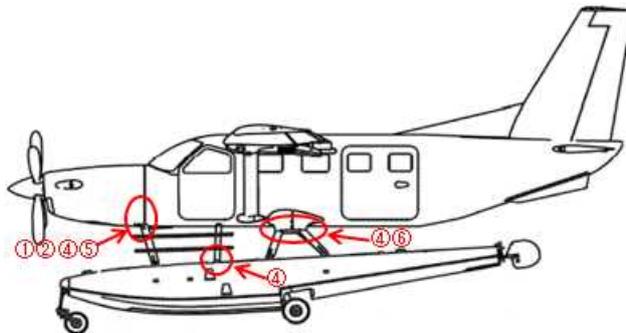
Figure 3 : Damaged parts at left side of the aircraft

- ① Lower parts of engine firewall; Deformed, Damaged
- ② Lower parts of the forward fuselage; Dent, Damaged
- ③ Engine mount frame; Damaged
- ④ Struts of left and right floats; Broken, Deformed, Damaged
- ⑤ Tie rods of left and right floats; Bent
- ⑥ Fairings of left and right floats; Damaged

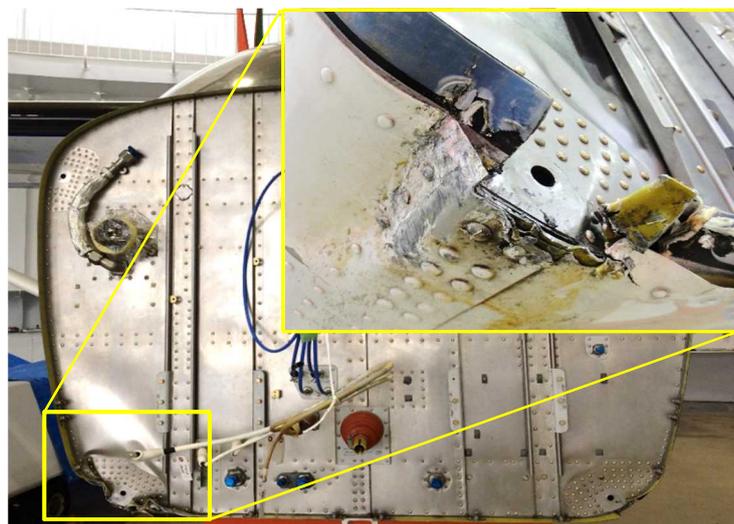
Photo 1 : Damaged area at the lower engine firewall (right-side)

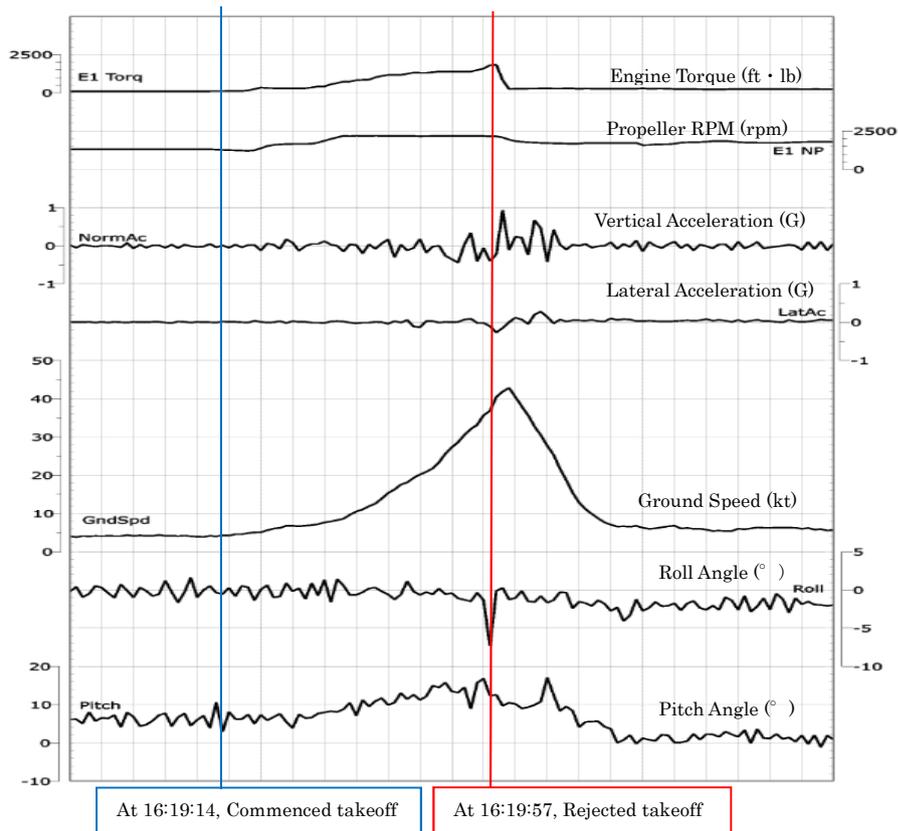
Figure 7 : Recordings of Flight Data

- ① The engine power had reached the takeoff power from water, normally.
- ② The pitch angle of the Aircraft was not stable from right after the commencement of takeoff, it accelerated with ups and downs motion of nose in approximately 4° amplitude, and the pitch-up attitude was recorded +16.84° when the speed reached approximately 36kts at around 16:19:55.

Roll angle was recorded at -7.34° (left wing down) right after then, the reject takeoff at around 16:19:56.

- ③ Vertical acceleration was slightly irregularly fluctuating from right after the commencement of takeoff run from water and was recorded +0.56 to +1.93 G at right after and right before the rejected takeoff from water. (According to the records of flight data shown in Figure 7, the vertical acceleration was displayed in plus or minus by the starting point of 1G as

Based on the records of the flight data, the pitch angle of the plane was unstable from the time to commence the takeoff run from water and was fluctuating at the range of approximately +10° to +16.84°, during the time to accelerate while continuing a pitching motion by 4° amplitude till the time to reach the speed of approximately 36 kt. It is somewhat likely that this pitching motion was caused by crossing the swell which wave length was longer than the float length as described in 2.7 (1)②.

The roll angle of the Aircraft was recorded as -7.34° (the left wing down) right before the rejected takeoff. It is probable that this left wing down was caused because the right float was lifted by wind wave and swell.
