AA2018-4

**AIRCRAFT ACCIDENT
INVESTIGATION REPORT**

**KWANSEI GAKUIN UNIVERSITY
JA05KG**

DAMAGE OF GLIDER DURING LANDING
DUE TO ABORT OF WINCH LAUNCHING
AT ONO GLIDING FIELD, ONO-CHO, IBI-GUN, GIFU PREFECTURE
AT ABOUT 9:21 JST, NOVEMBER 10, 2017

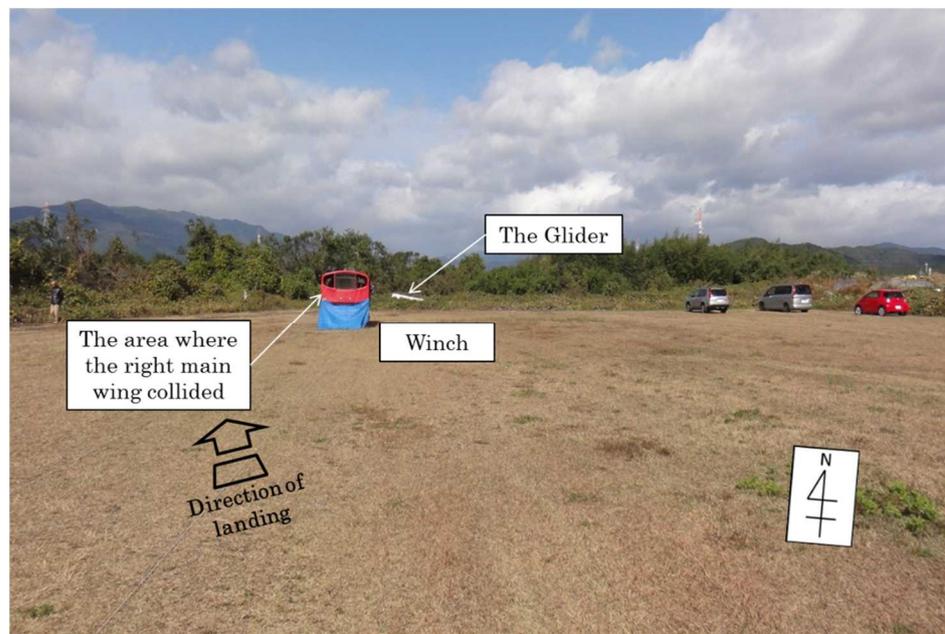
The Winch man saw the Glider climbing little with a very shallow pitch attitude after the lift-off. Soon the Glider appeared to overtake the towline. Upon seeing the Glider releasing the towline with nose-down, the Winch man applied the brakes of the winch and stopped retrieving the tow line. After that, the Winch man saw the Glider approaching toward the winch while pitching up and down, therefore withdrew behind the winch. The Glider once appeared to touch down about 20 m short of the winch, and then a bang was heard. The Winch man found the Glider rolled over with its right main wing broken and stopped upside-down at a point about 50 m across the winch.

Photo 2: The winch and The Glider (The vehicles on the right side parked at the time of the accident investigation.)

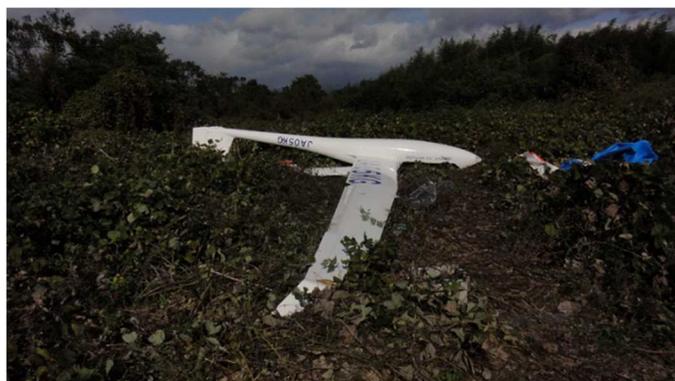
Photo 3: The Glider after the accident

In this accident, it is probable that since the Glider became difficult to control after aborting the winch launching and landing was attempted, the right main wing collided with the winch, and then the Glider was damaged due to the impact force produced when it stopped upside-down.

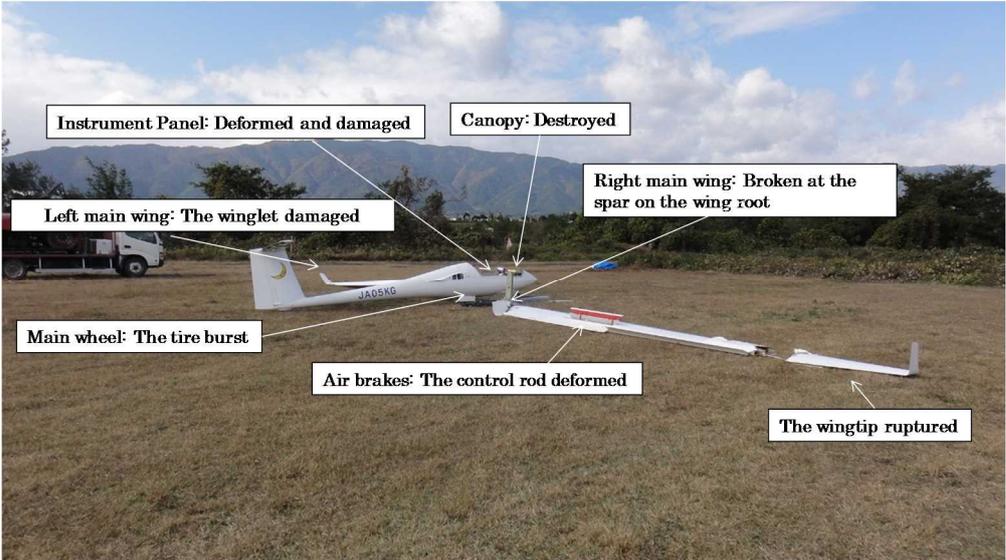
November 10, 2017. (Refer to Figure 1: Accident Site Layout)	
2.2 Injuries to Persons	None	
2.3 Damage to Aircraft	<p>Extent of the damage on the Glider: Destroyed</p> <p>(1) Nose Instrument Panel: Deformed and damaged Canopy: Destroyed</p> <p>(2) Fuselage Main wheel: The tire burst Right main wing: Broken at the spar on the wing root and ruptured at about 1.5 m from the wingtip Air brakes: The control rod deformed Left main wing: The winglet damaged</p>

Photo 4: Damage of the Glider

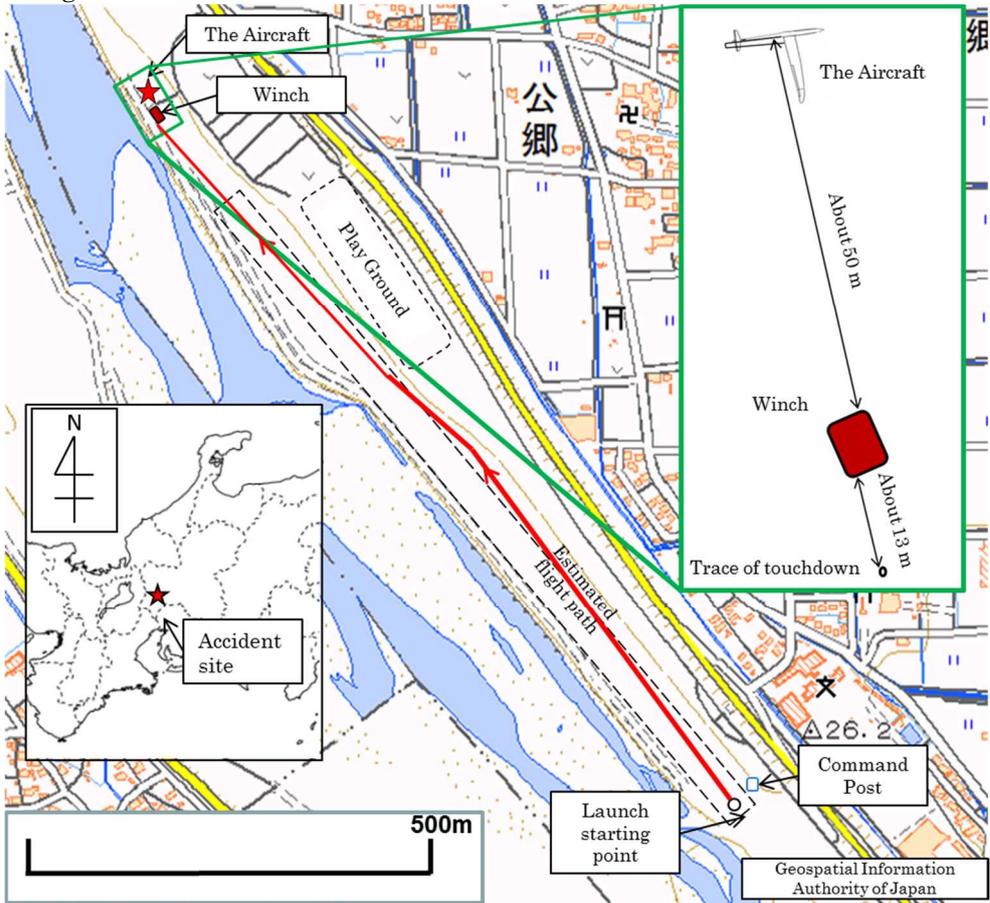
This accident occurred at grassland about 200 m northwest of the runway departure end of the Ono Gliding Field, Ono-cho, Ibi-gun, Gifu Prefecture (Latitude 35°27'18"N, Longitude 136°35'49"E) at about 9:21 on

<p style="text-align: center;">Figure 1: Accident Site Layout</p>
