**AIRCRAFT ACCIDENT  
INVESTIGATION REPORT**

**ILAS AIR SERVICE CO., LTD.**

**J A 1 0 6 Y**

## CRASH INTO SEA SURFACE ILAS AIR SERVICE CO., LTD. ROBINSON R44II (ROTORCRAFT), JA106Y ON SEA SURFACE NEAR THE KOURI BRIDGE, NAGO CITY, OKINAWA PREFECTURE, JAPAN AROUND 15:48 JST, DECEMBER 31, 2013

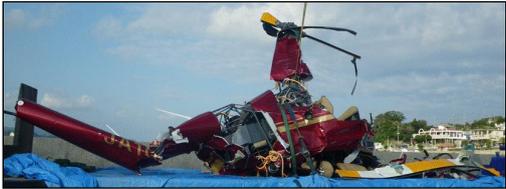
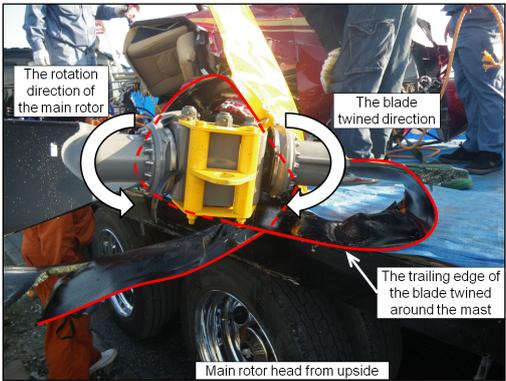
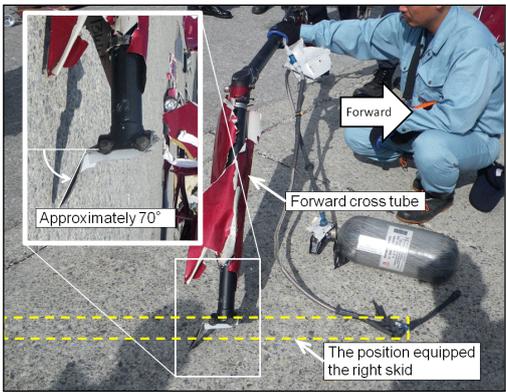
<p>wind speed 2.7 m/s, No precipitation, No sunshine duration, Temperature 17 °C</p>
<p>2.7 Other Information</p>	<p>(1) Detailed Information on Damage</p> <p>The helicopter found on the sea bed about 70 m from Kouri bridge.</p> <p>Details of its damage were inspected after pulled up from the sea. It was destroyed not only skin but also structure except empennage and tail rotor component; especially the cabin front suffered extensive damage.</p> <p>Flight control systems were broken under the front seats. All spark plugs of engine were inspected and not found anomalies. The one of two main rotor blades was broken at 134 cm from the root; on the other hand, another one was twined around the mast 1.4 rotates clockwise when viewed from above with delamination and deformation.</p> <p>The landing gear was lost except the forward cross tube; There are two cross tubes, forward one and after one, between body and skids. A portion of upper part of a skid was remained in the back of the forward cross tube to be connected to right skid; it was bent about 70 degrees on the lower side.</p> <p>(2) The Accident Site Description</p> <p>The accident site was a sea area of about 3 m water depth with high degree of transparency in coral reefs near the Kouri bridge spans between the Kouri island and Yagaji island, where billows did not enter from the open sea.</p> <p>The highest point height of the Kouri bridge is 25 m (about 83 ft) from sea surface (Nearly Highest High-water Level<sup>1</sup>).</p> <p>(3) Survival Equipment</p> <p>The helicopter did not equipped with a lifeboat which shall be onboard when a single engine helicopter transporting passengers as air transport service flies over the sea beyond points where it can make emergency landing to ground by autorotation<sup>2</sup>.</p>

According to the damage that they were not only skin but also frame, especially the cabin front suffered extensive damage and the portion remained in the back of the forward cross tube to be connected to right skid was bent about 70 degrees on the lower side; therefore, it is highly probable that the helicopter crashed into the sea surface with forward roll at the same time when the skids touched the sea surface.

Besides, according to the finding no anomalies in all spark plugs and a main rotor blade twined around the mast in the opposite direction to rotation; consequently, it is highly probable that the engine was operating when the helicopter crashed into sea surface and the main rotor blades beat the sea surface and stopped.
