**AIRCRAFT SERIOUS INCIDENT  
INVESTIGATION REPORT**

**FUJI GLIDER CLUB  
J A 1 0 9 B**

October 25, 2013

RUNNING OFF THE SIDE OF RUNWAY AFTER LANDING  
FUJI GLIDER CLUB  
GROB G109B (MOTOR GLIDER, 2 SIDE BY SIDE), JA109B  
FUJIKAWA GLIDER STRIP,  
SHIZUOKA CITY, SHIZUOKA PREFECTURE  
AT 11:19 JST, APRIL 7, 2012

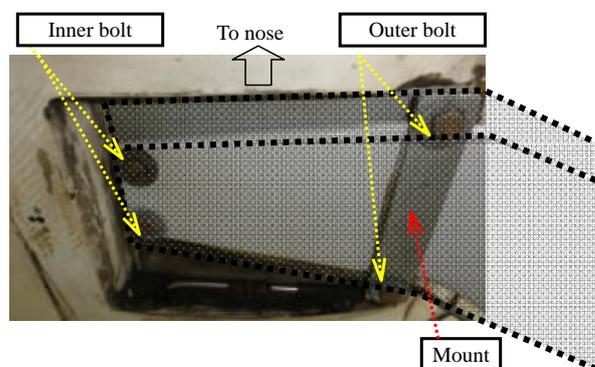
The left and right main landing gears of the glider were each mounted on the airframe using, as shown in the right photo, four bolts, four outboard washers, four inboard washers, two spacers, four nuts (each with a locking system) and a metal mounting plate. (The photo shows the left main landing gear, which was not damaged in the serious incident.)

The two inboard nuts and the front outboard nut from the right main landing gear were found to have come off and fallen inside the airframe with their threads damaged.

Left main landing gear

Left main landing gear mount

Damaged nut

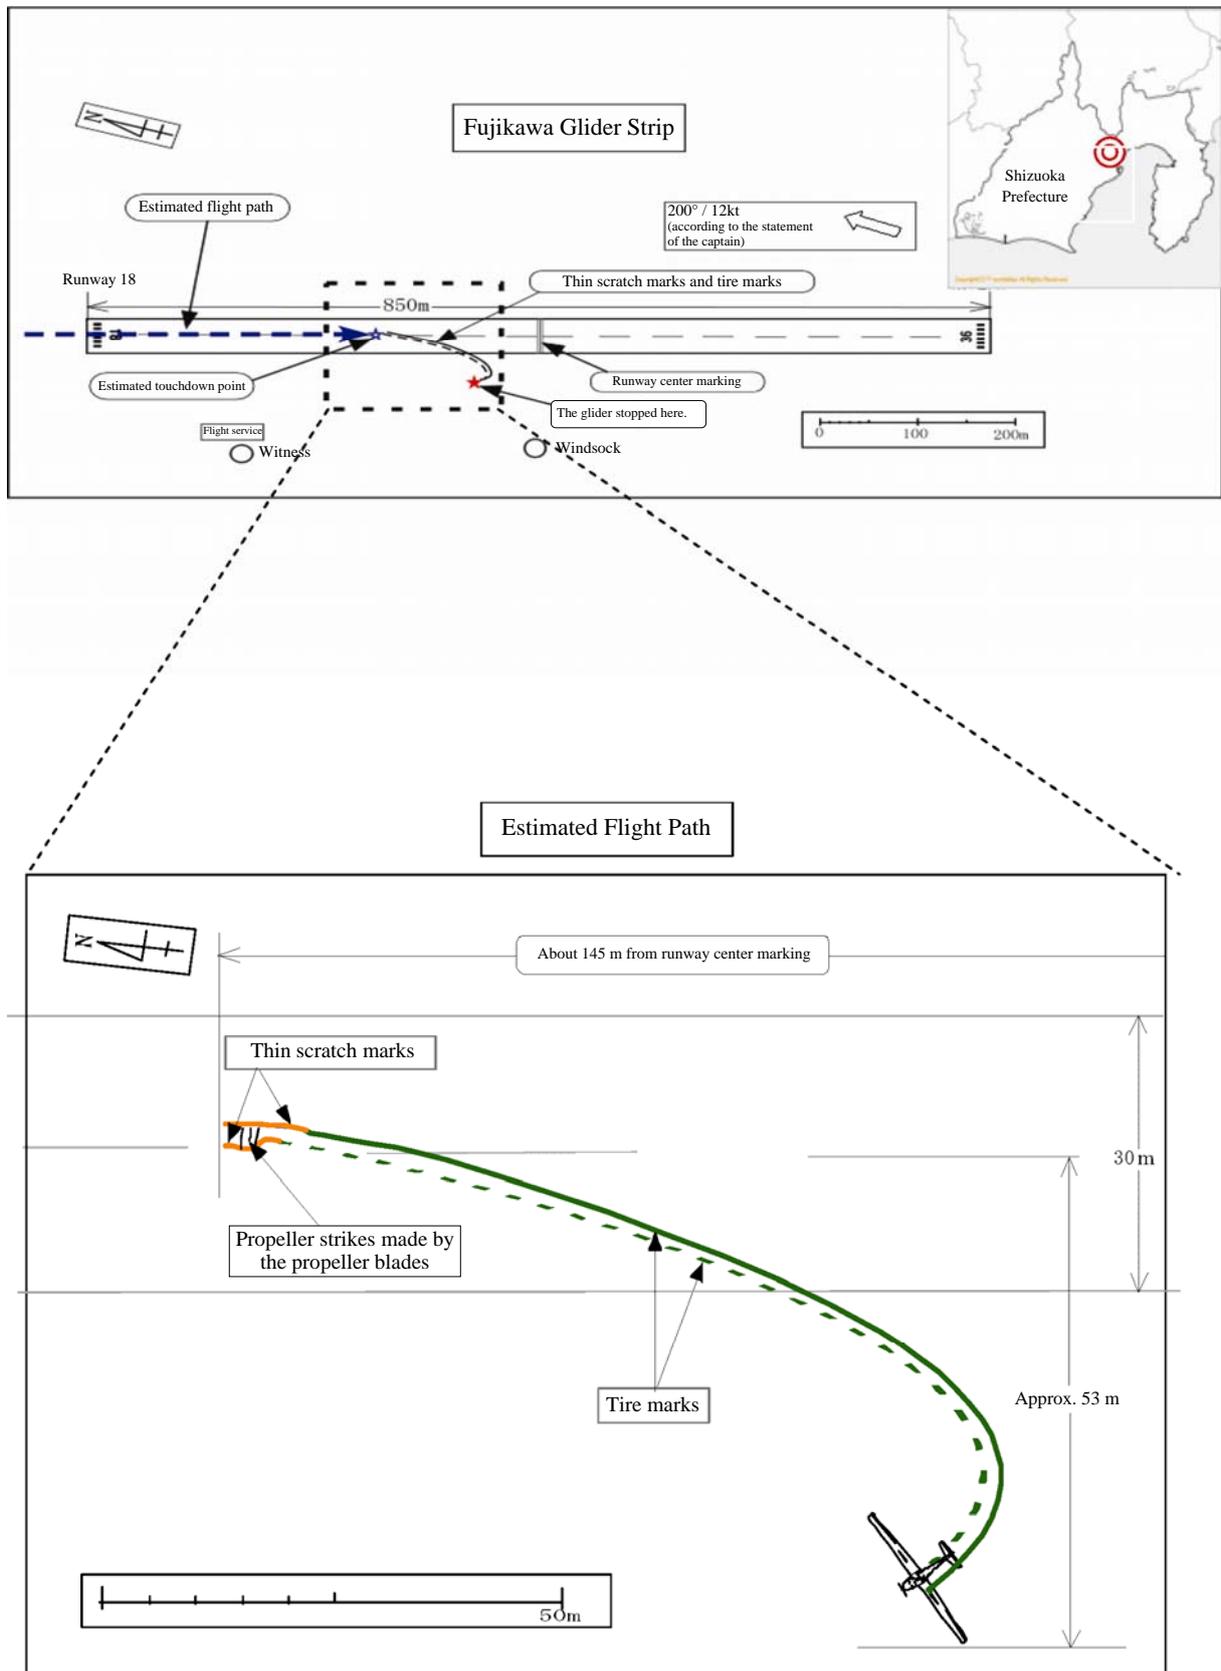
Figure 1 Estimated Flight Path

According to the statement of the captain described in 2.1 (1), it is highly probable that he set the approach speed to 120 km/h, faster than normal, to cope with changeable wind as instructed by the flight manual described in 2.10.2 and that the glider was possible to land safely considering the length of the runway although its flight path was a little higher. It is highly probable that he continued the approach the way he usually did and initiated a flare while the glider was still flying slightly higher than normal. The possible contributing factor for the high flare is rusty flying technique due to: short sessions held only once every month with flying time of only about 30 minutes allocated to each member as stated by the witness in 2.1 (3); more-than-one-month no flying period as described in 2.5; and the first landing attempt of the day when the serious incident occurred.

It is highly probable that the flare reduced the rate of descent and the flight path of the glider became parallel to the ground at higher place, rapidly sinking to the runway. It is highly probable that this was caused by suddenly lost lift due to a reduced airspeed after the flare, and the reduction of the airspeed was affected by fluctuating southerly wind which was becoming stronger as described in 2.7.

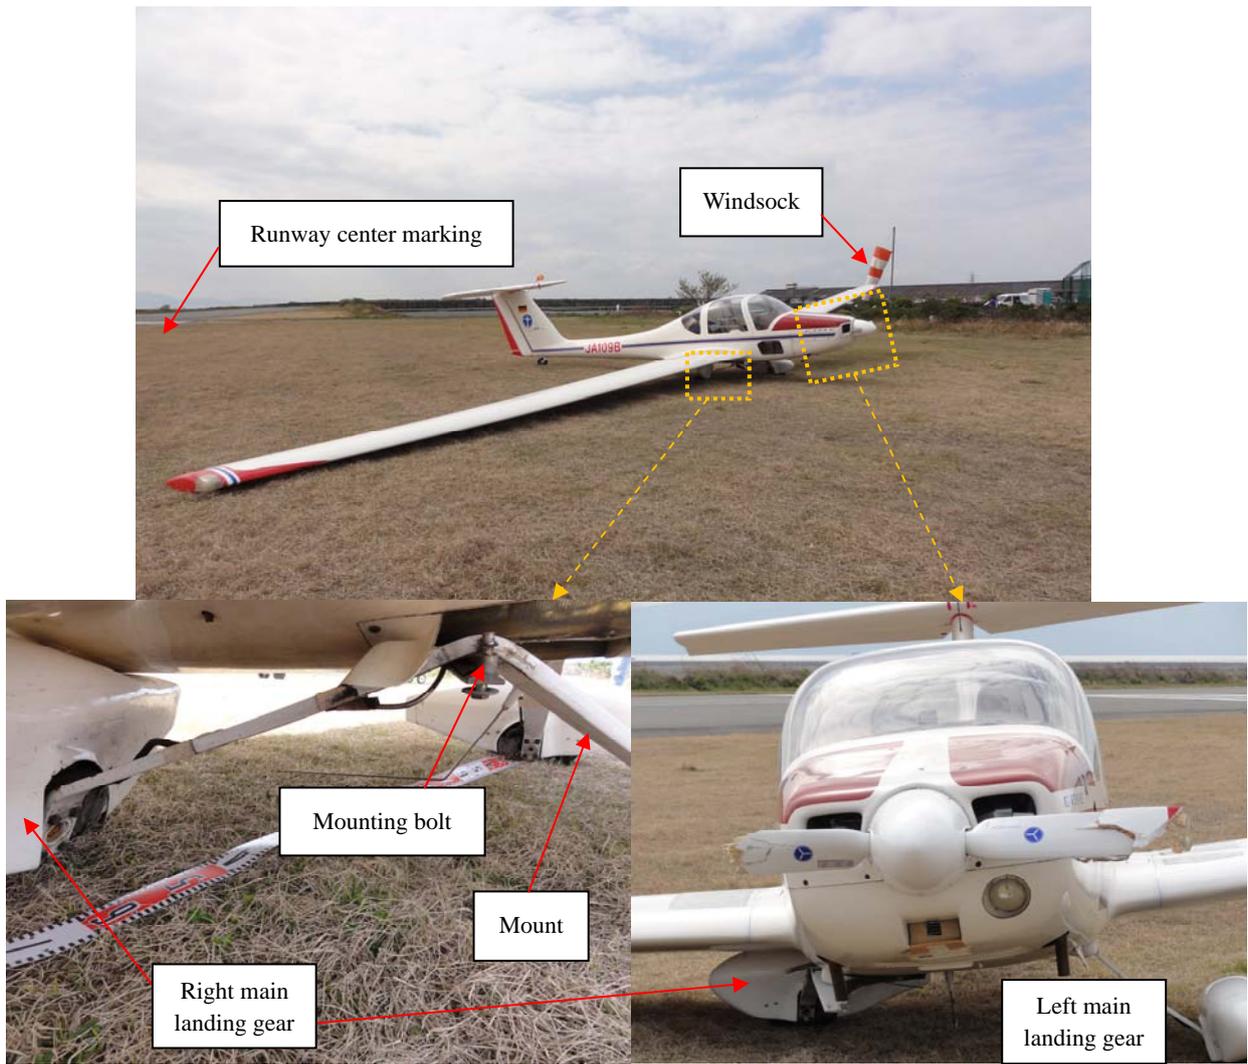
Photo 1 Serious Incident Glider

In this serious incident the glider's right main landing gear was damaged upon landing followed by right veering off the runway and the glider eventually collapsed.

It is highly probable that the right main landing gear's displacement occurred as the threads of the inboard gear mount nuts gave way and slipped out of the bolts, leaving the outboard mount to support the gear followed by the forward outboard nut failure due to the similar reason, causing the gear swivel aft on the aft mount bolt.

It is highly probable that the nuts of lower strength not being the parts specified by the manufacturer sustained damage to the threads, as the tensile load beyond the tensile strength was applied upon touchdown.

The glider was found lying on the ground, with the nose pointing towards 325° and the right main landing gear swiveled around 90° aft on one remaining mounting bolt with the other three mounting bolts missing.

As described in 2.9.2, in comparison with the Specified Parts, the nuts used on the glider exhibited different material components having lower tensile strength (hardness) by about 25%. According to the dimples observed on the fracture surfaces of the threads of the three nuts, it is highly probable that when the glider landed, the nuts were subjected to instantaneous force greater than their tensile strength to sustain thread damage.

When installing aircraft parts, only specified parts must be used. In this serious incident, it is highly probable that the fact that the nuts used were non-specified parts with lower tensile strength as described in 3.4.2, contributed to the occurrence of the serious incident, although it is not clear when and how the parts were installed as described in 3.6. Once installed, the parts such as nuts are not normally checked in subsequent inspections for their legitimacy making it extremely difficult to spot non-manufacturer-specified parts during ordinary maintenance work. Therefore, those who install parts onto the aircraft must be fully aware of the importance of specified parts installation.

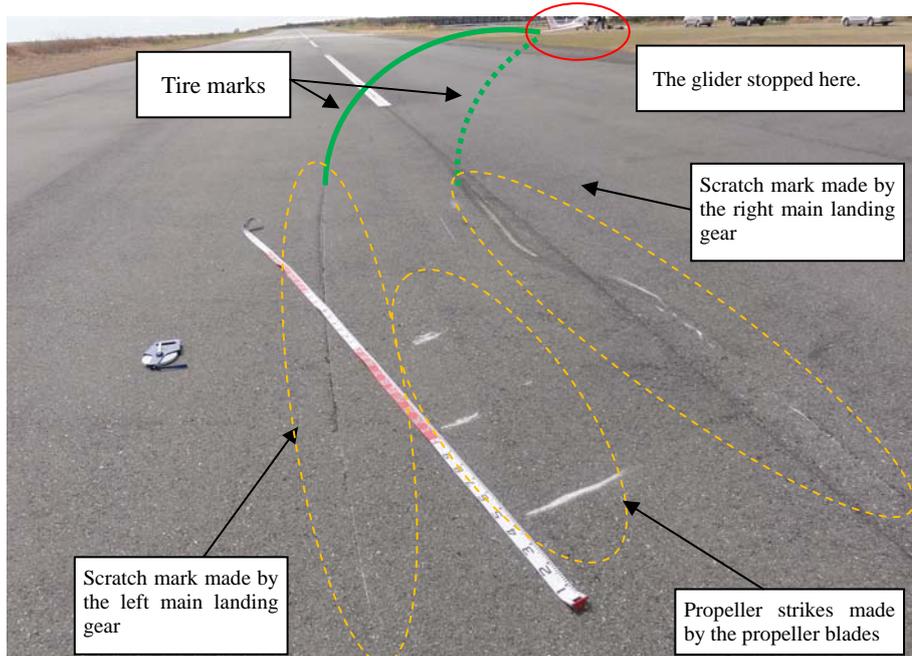
Photo 2 Marks Left on the Runway

Two fine scratch marks were found extending near the runway centerline, starting about 145 meters north of the runway center marking towards the spot where the glider came to a halt. One of the scratch marks, made by the right main landing gear, was found to extend about three meters before curving inboard. The mark was joined with a tire mark, and then the amalgamated tire mark continued intermittently down to the runway border with the grass. The other scratch mark, made by the left main landing gear extend about seven meters, and then replaced by a tire mark, which continued down to the grass. Between the two scratch marks, there were three propeller strikes: ICAO Investigation Manual Pat III about 70 cm apart made by the propeller blades. On the grass were tire marks made by the two main wheels and the tail wheel, extending intermittently down to where the glider came to a halt.

It is highly probable that the scratch marks left on the runway as described in 2.8.2 were made when the bolts on the right main landing gear came off upon touchdown as described in 3.4.2, causing both main landing gears to bend outwards pressing the brake discs against the runway. It is highly probable that the front outboard bolt of the right main landing gear came off, causing the gear to swivel aft with the airframe tilting to the right and that as a result, the tire on the right main landing gear was pressed against the runway, causing the glider to veer to the right. It is highly probable that the glider then ran off the runway and turned right on the grass before coming to a halt.
