**AIRCRAFT ACCIDENT
INVESTIGATION REPORT**

J A 1 2 0 H

January 31, 2014

ROLL OVER UPON TRANSITION
PRIVATELY OWNED
EUROCOPTER EC120B (ROTORCRAFT), JA120H
KAWASHIMA TEMPORARY HELIPAD
KUJUKURI TOWN, SANBU GUN
CHIBA PREFECTURE, JAPAN
AROUND 16:00 JST, SEPTEMBER 15, 2012

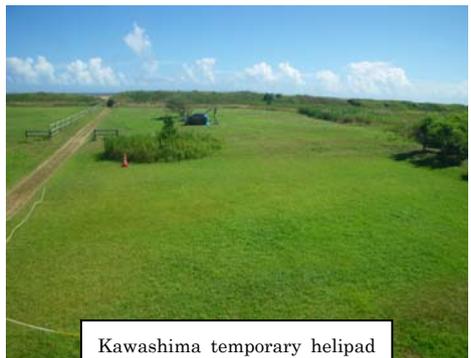
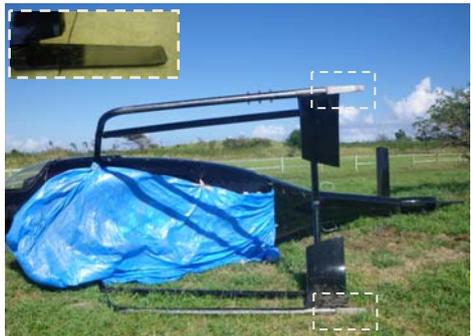
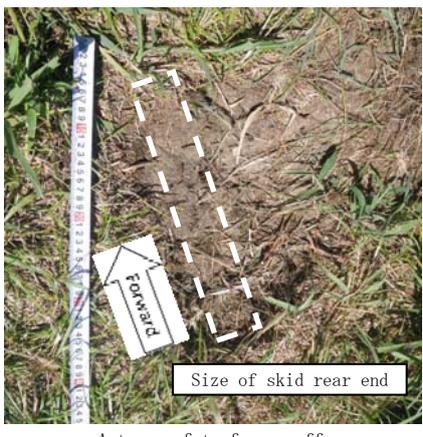
Visibility more than 10 km, Temperature 28°C	
2.7 Other Information	<p>After transporting the helicopter to a hanger, investigators examined major components such as flight control and the engine. No anomalies were found except the damage (cf. 2.3) caused by the accident.</p> <p>The helipad, covered with trimmed grass grown on sand, occupies a corner of the club. It is almost flat with slight ups and downs. The ground is soft enough to allow the rear end of the skid to penetrate grass roots as it is a flat panel. No possible obstacles which trap skids existed. Each skid rear end is fitted with a plate (about 30 cm long, 5 cm wide, 1 cm thick). There was a trace of turf in the size of skid rear end nearly came off on the ground around where the helicopter had settled on.</p> <p>The helicopter has a clockwise main rotor rotation as viewed from above; therefore, the left skid leaves the ground first followed by the right skid. However, the order varies depending on the center of gravity, ground inclination, the control inputs into the wind and other factors.</p> <p>According to the logbook, the pilot experienced 19 landings and take-offs at the helipad by the day of the accident. He stated the hovering characteristics of the helicopter as follows: the right skid rear end touches the ground first while settling; it leaves last during liftoff.</p> <p>The pilot had no experience of post-landing relocation at the helipad on the helicopter before.</p>

<p>A trace of turf came off</p>

<p>In this accident, the helicopter rolled over to the right pivoting around the right skid rear end which was trapped by the grass roots during its transition to a liftoff from the grass helipad and sustained damage.</p> <p>It is highly probable that the pilot's following actions contributed to the occurrence: he raised the collective pitch unintentionally when he tried to wiggle the helicopter to confirm the skid restraints applying rudder inputs, as he sensed the slight rigidity of skids when the helicopter was light on the skids before liftoff.</p>
--
