**AIRCRAFT SERIOUS INCIDENT  
INVESTIGATION REPORT**

**AIR NIPPON CO., LTD.  
J A 1 6 A N**

**AIR NIPPON CO., LTD.  
BOEING 737-700, JA16AN  
NOSEDIVE FROM UPSET (LOC-I)  
AT AN ALTITUDE OF 41,000 FT, APPROX. 69NM EAST OF  
KUSHIMOTO, WAKAYAMA PREFECTURE, JAPAN  
AROUND 22:49 JST, SEPTEMBER 6, 2011**

September 19, 2014

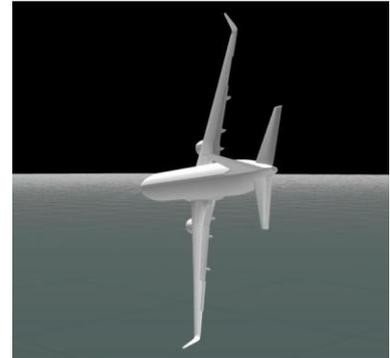
22:48:48 As the Wheel was operated CW, the roll angle changed in the direction to recovery after reaching a peak of about  $-80^\circ$ . However, around when the roll angle reached the peak, the wheel force in the CW direction loosened and a force in the CCW direction about 9 lbs was applied. As a result, the Wheel was turned in the reverse direction and returned almost to the neutral position. Finally, the Wheel was turned to about  $+17^\circ$  CCW beyond the neutral position. The condition with the wheel force in the CW direction loosened was continued for about three seconds. At the same time when the force on the Wheel

Roll halted at about  $-80^\circ$

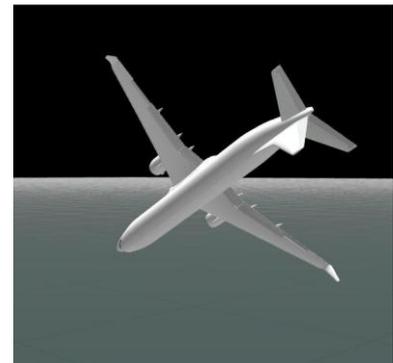
Roll angle at -131.7°

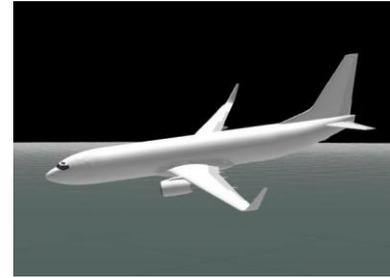
22:49:04 The load factor exceeded the limit load factor (2.50 G) (hereinafter referred to as “the Over-Load”). As of 49:09, it increased to a maximum 2.68 G (through 49:09). [U: Figures 1, 2 and 4]

The attitude when the load factor becomes 2.68 G

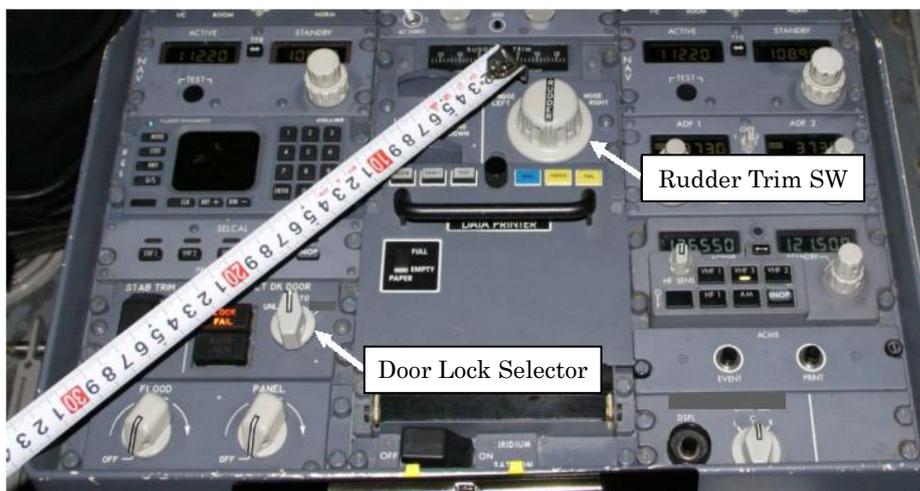
The Rudder Trim SW and the Door Lock Selector (hereinafter referred to as “Both Switches”) are located on the AE Panel with a distance of 20 cm in the center of the left and right pilot seats and behind the throttle lever, as shown in the photo below. At night, they can be made visible as flight crew tune lighting, just like other panels and switches in the cockpit.

Both Switches on AE Panel of the Aircraft

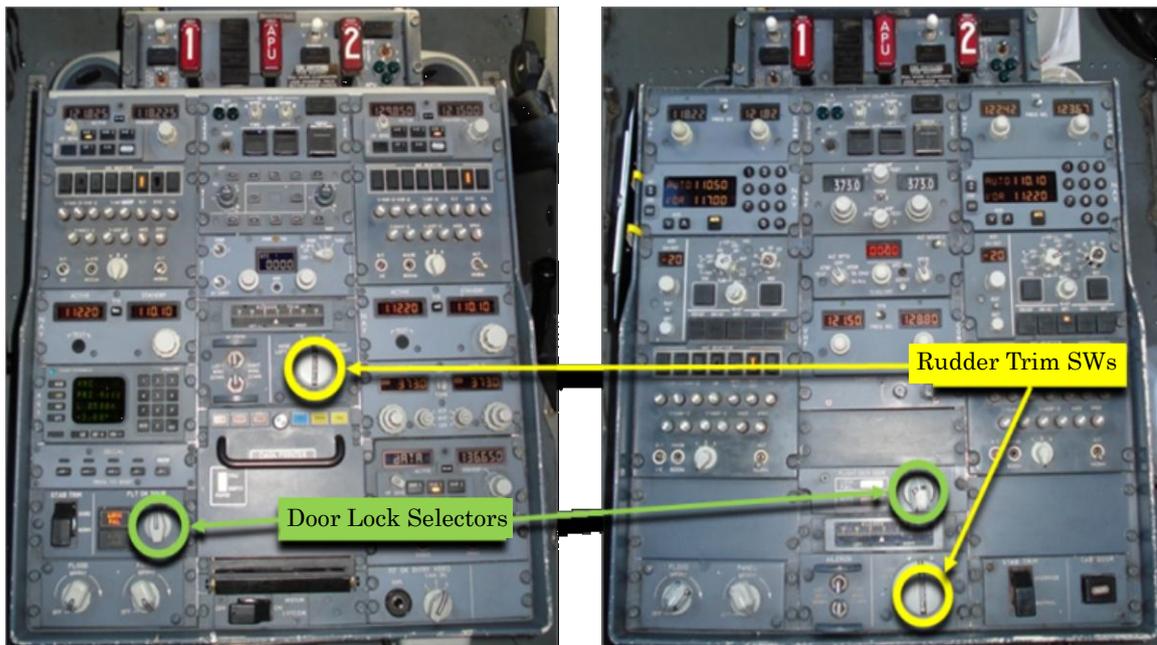
Consequently, it is probable that the erroneous operation resulted from the fact that the Door Lock Selector for the 737-500 and the Rudder Trim SW for the 737-700 had been placed at similar locations.

737-700 (the Aircraft)

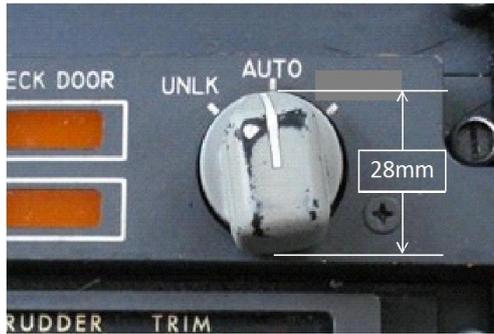
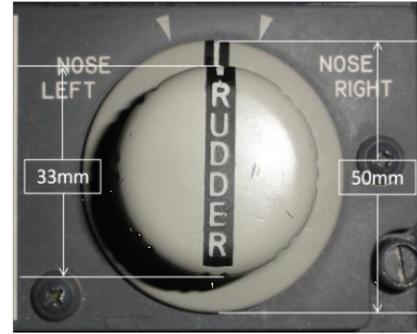
Firstly, these switches have a brim at the bottom. They are so shaped that they can easily receive a force for depressing them. Secondly, in operating these switches, a torque is necessary; therefore, it is probable that the switches are designed with certain size so that they can be rotated while firmly holding them with the thumb, the index finger and the middle finger.

Over view of Door Lock Selector  
(737-500)

Over view of Rudder Trim SW

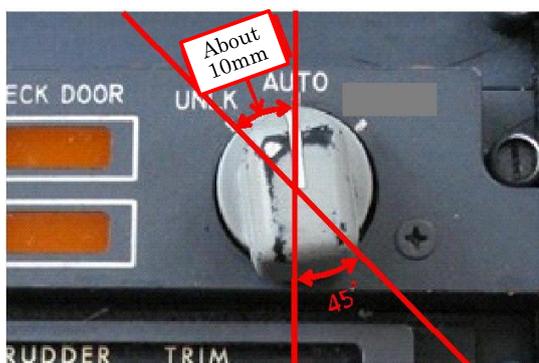
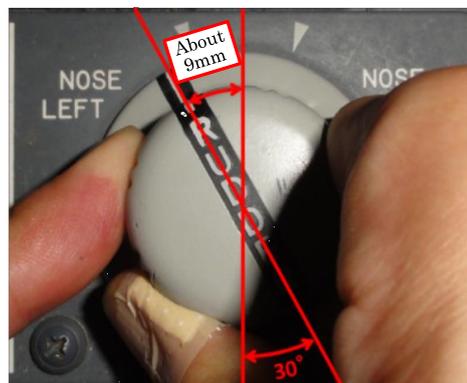
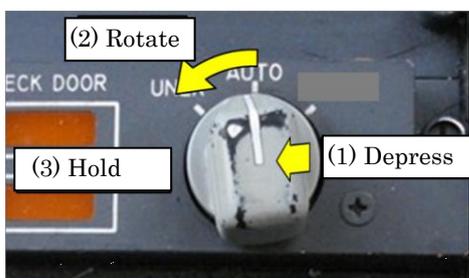
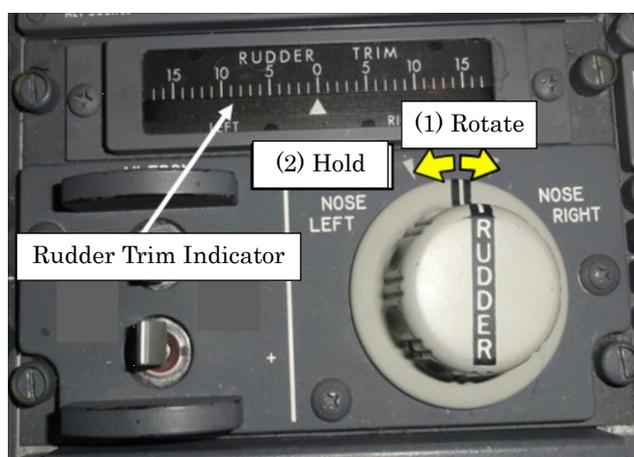
As described above, although differences are accepted in the motion (operability) between the Door Lock Selector for the 737-500 and the Rudder Trim SW for the 737-700, there are some similarities. It is probable that these similarities contributed to the erroneous operation by the FO.

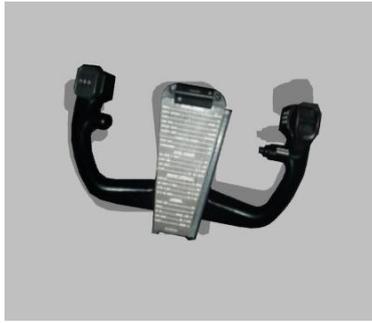
Following his erroneous rotation on the Rudder Trim SW, the Wheel was rotated from about  $-10^{\circ}$  to about  $-22^{\circ}$  on an autopilot command aimed at correcting the attitude and the Column was displaced about  $+2^{\circ}$  (about 3.5cm as described in 2.5.8). According to his statement in 2.1.2 (2), the FO realized the erroneous operation when he looked at his left hand and confirmed the bank to the left when he looked at the PFD in front of him. Therefore, it is highly probable that the FO had not placed his hand on the Control Wheel and Column.

Wheel displaced to -10°

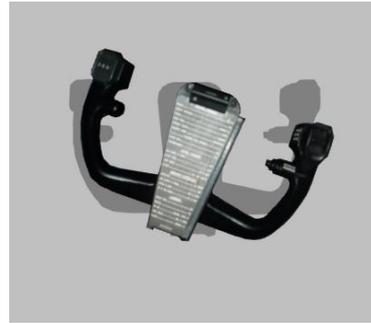
Wheel displaced to -22°

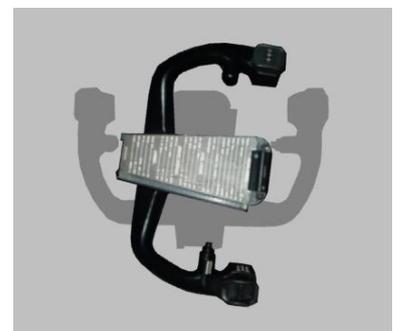
Just before the FO started the reverse operation while loosening the force on the Wheel, as described in Event L at 22:48:47 in 2.1.1, the stick shaker got activated. As described in 2.12.5, the stick shaker will be activated, according to an AOA measurement, when the aircraft is feared to stall. It is probable that the stick shaker was activated in this case involved because the AOA exceeded AOAss as the trigger level for a stall

Wheel operated to  $-97^\circ$
