AA2016-8

**AIRCRAFT ACCIDENT  
INVESTIGATION REPORT**

PRIVATELY OWNED DIAMOND AIRCRAFT  
HK36TTC (MOTOR GLIDER, TWO-SEATER), JA21DA  
DAMAGE TO THE AIRFRAME IN LANDING  
BIEI GLIDING FIELD IN BIEI-CHO, KAMIKAWA GUN,  
HOKKAIDO, JAPAN  
AT ABOUT 11:40 JST, AUGUST 25, 2015

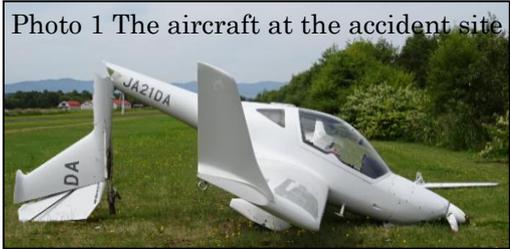
<p>Photo 1 The aircraft at the accident site</p>

2.2 Injuries to Persons	None																		
2.3 Damage to the Aircraft	<p>Extent of damage: Substantially damaged</p> <ul style="list-style-type: none"> <li>• The rear of the fuselage was ruptured (It was not separated due to the control cable, etc.)</li> <li>• Nose landing gear and horizontal stabilizer fell off.</li> <li>• Propeller blades were broken.</li> <li>• The lower part of the nose was broken.</li> </ul>

It is somewhat likely that the aircraft bounced with the reaction from the contact and brought the empennage into contact with the ground, which broke the rear of the fuselage, made the nose landing gear fall off from the installation part, and the aircraft sideslipped to a stop.

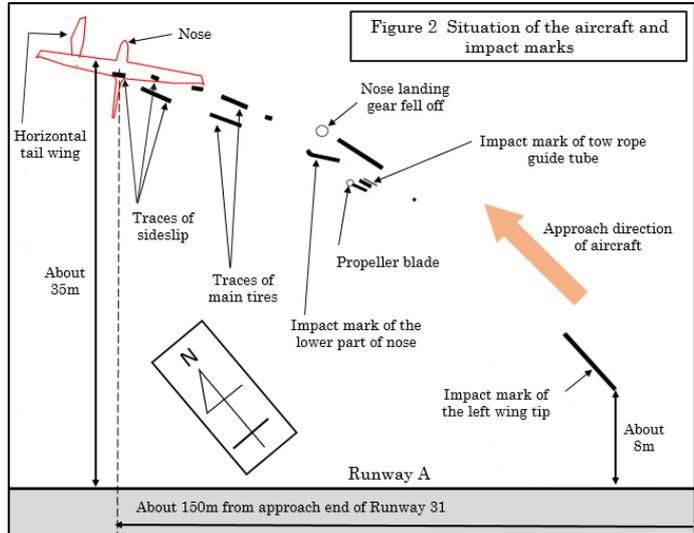
There was an impact mark of the left wing tip at a point about eight meter away from the runway and many impact marks along the extension from the point. In one of the impact marks, one of the broken wooden propeller blade stuck to the ground and, beyond that point, there was the nose landing gear which fell off from the installation part.

The aircraft stopped on the grass about 35 m away from the runway with the nose directed in the north-northeast. In the

surroundings of the aircraft, there were the horizontal stabilizer which fell off and signs of skidding left by main wheels. Soil adhered to the nose and the lower surface of the rear of the fuselage.
