AA2013-1

AIRCRAFT ACCIDENT INVESTIGATION REPORT

J A 2 1 K A

J A 2 3 7 6

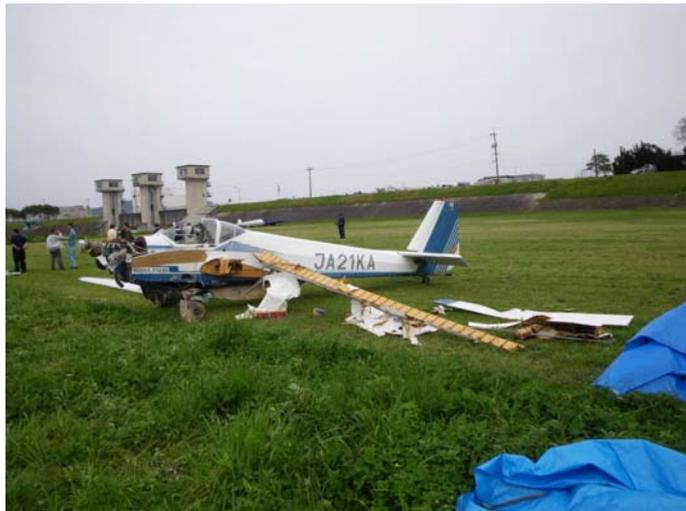
The towing glider ditched into the river from its left wing.
2.2 Injuries to Persons	None
2.3 Damage	<p>Glider Damage</p> <p>Towing glider Destroyed (Left wing and propeller damaged)</p> <p>Towed glider Destroyed (Fuselage damaged)</p> <p>No fire broke out.</p>

Photo1 (A)
Damaged Towing Motor Glider

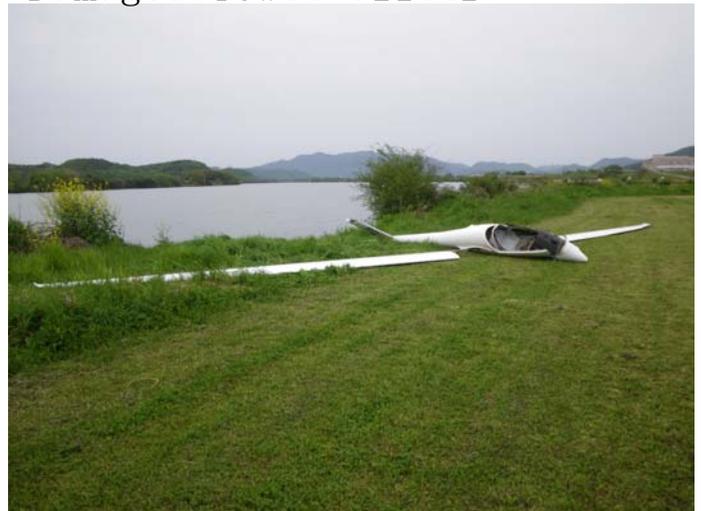
Photo2 (B)
Damaged Towed Glider
