AIRCRAFT ACCIDENT INVESTIGATION REPORT

September 25, 2014

1. PRIVATELY OWNED ROLLADEN-SCHNEIDER LS4-B
(GLIDER, SINGLE-SEATER), JA22WP
2. PRIVATELY OWNED ALEXANDER SCHLEICHER ASK21
(GLIDER, TWO-SEATER), JA22RW

MID-AIR CONTACT INVOLVING TWO GLIDERS
IN THE AIR, APPROXIMATELY 300m OVER
MENUMA GLIDING FIELD
KUMAGAYA CITY, SAITAMA PREFECTURE, JAPAN
AT ABOUT 14:26 JST, SEPTEMBER 14, 2013

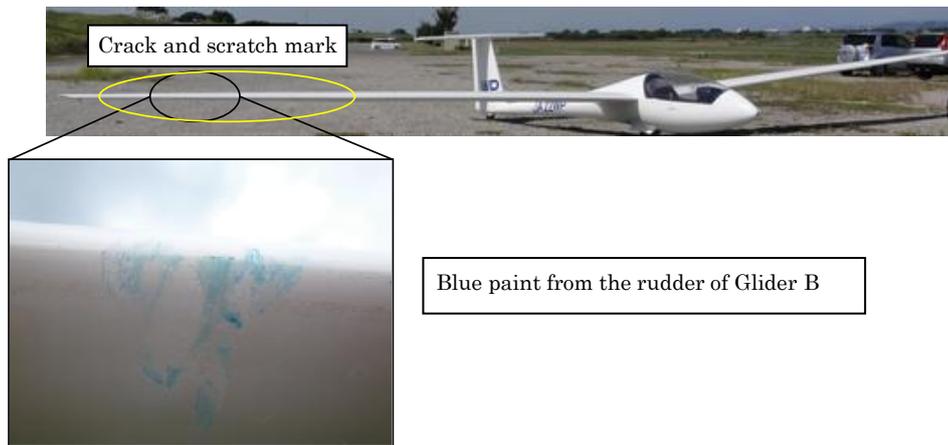
Photo 1: Damage on Glider A

Crack with length of approximately 150 cm along the leading edge in the middle portion of the right wing, and bumpy deformation on lower surface of the right wing.

Blue paint from the rudder of Glider B

Around the location approximately 270 cm from the wing tip towards the fuselage, in length of approximately three cm and width of approximately four cm.

As described in 2.3.1, Glider A had a scratch mark and crack on the lower side of its right wing leading edge and blue paint residue from the rudder of Glider B. On the other hand, as described in 2.3.2, Glider B had a scratch mark on the upper surface of its horizontal stabilizer towards its aft, and damage to the upper portion of the rudder.

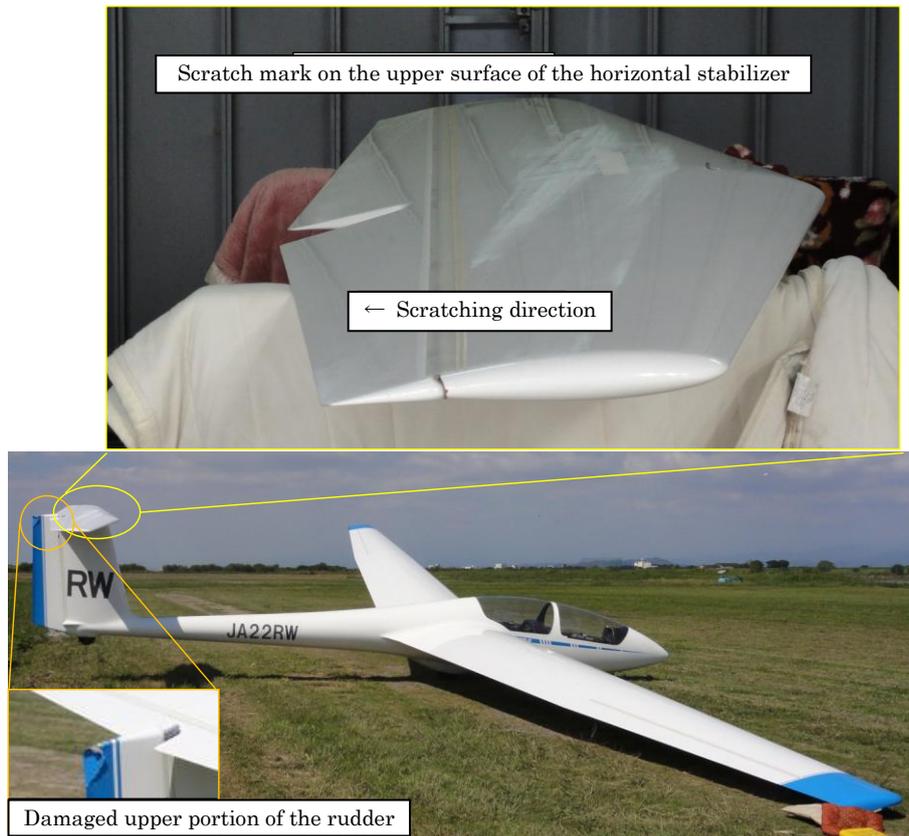
Photo 2: Damage on Glider B

Damage to the upper portion of the rudder (approximately 18 cm in lateral and approximately 13 cm in longitudinal directions).

Scratch mark on the upper surface of the horizontal stabilizer towards its aft (approximately two m in lateral and approximately 50 cm in longitudinal directions).

It is highly probable from this damage that, despite the fact that the right wing of Glider A and the upper surface of the horizontal stabilizer and upper rudder of Glider B came into contact, both gliders survived without major damage, indicating that the contact was relatively minor, and that Glider B was flying faster than Glider A, presuming from the direction of the scratch.

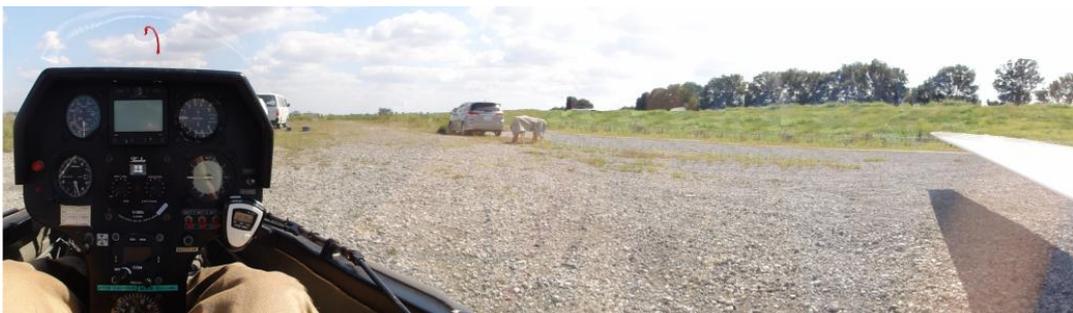
Photo 3: View from Glider A Cockpit

Left and right as well as the upper forward view are good, but the lower forward view is poor since the seat is inclined rearward, and floor and the instrument panel are obstructing the view.

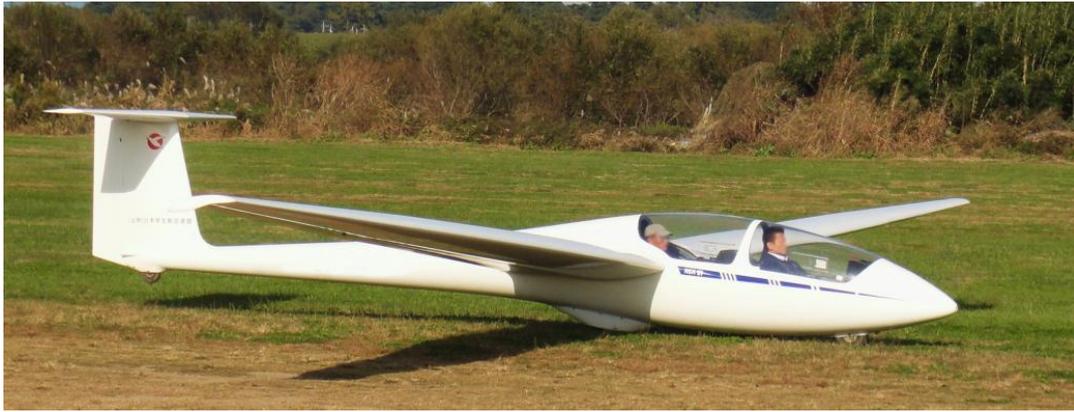
Photo 4: Cockpit Seat Arrangement of Glider B

The rearward view is poor from the front seat because it is obstructed by the occupant in the rear seat, and is similar from the rear seat because of the aft fuselage. In addition, as the glider climbs at a steep angle of approximately 25 degrees during the launching, pilots usually watch the travelling direction under normal conditions.

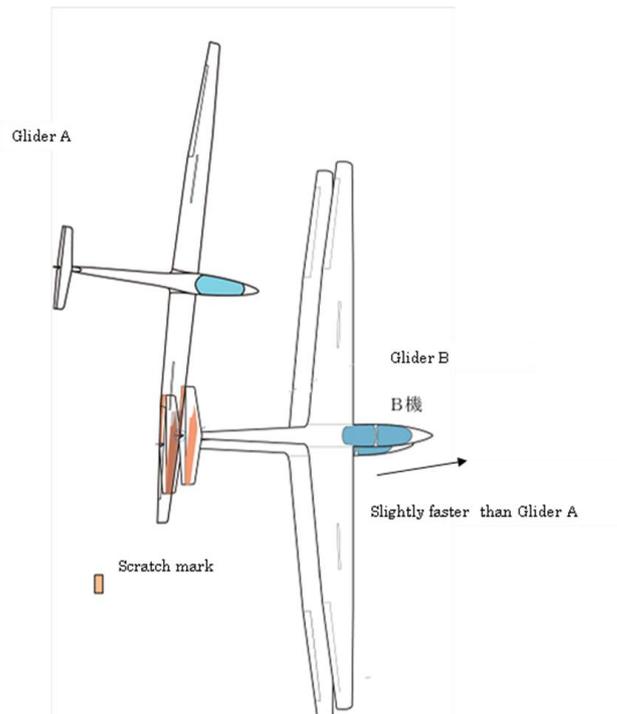
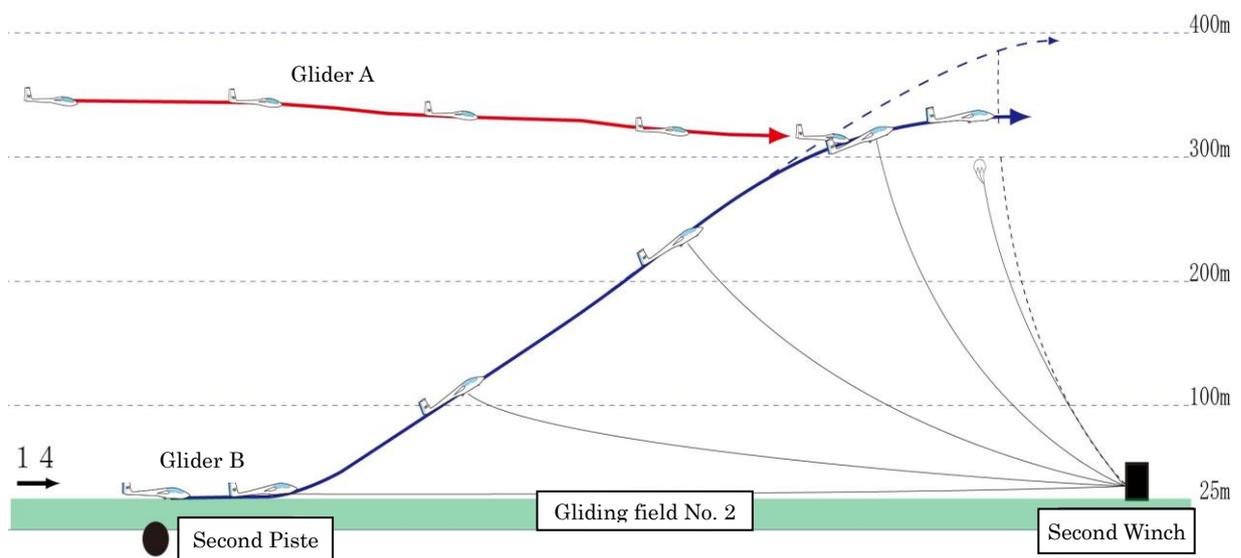
Circumstances during the Mid-Air contact (presumed)

the right wing of Glider A and the tail of Glider B may have collided and structurally failed, disabling the flight controls of both gliders, leading to a major disaster involving fatal injuries of persons onboard of both gliders.

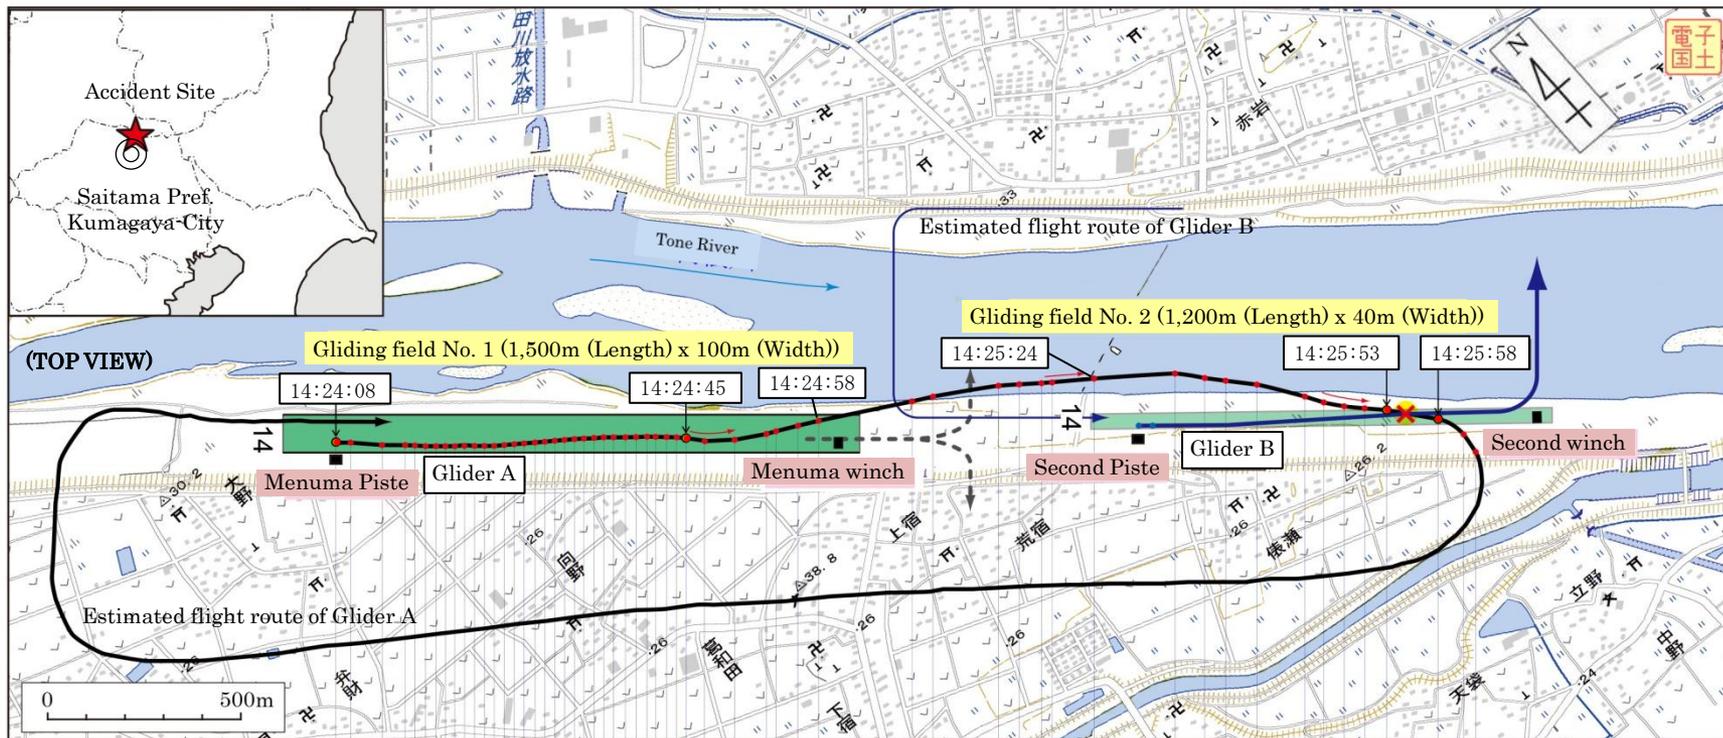
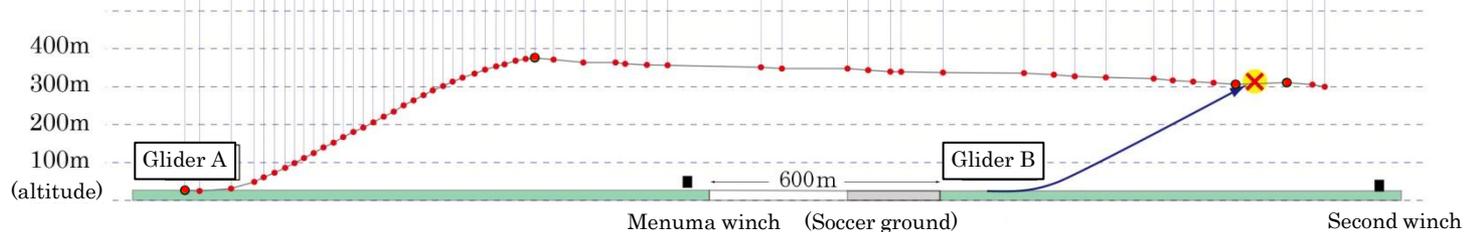
Figure 1 : Estimated Flight Route

14:25:24	At a speed of approximately 98 km/h and at an altitude of approximately 339 m, Glider A slowly turned towards right, gradually descending, and started entering the airspace over the adjacent Gliding field No. 2.

14:25:53	At a speed of approximately 102 km/h and at an altitude of approximately 307 m, Glider A started flying diagonally across the airspace over the Runway where Glider B was being launched.
