AI2019-1

**AIRCRAFT SERIOUS INCIDENT
INVESTIGATION REPORT**

AIRCRAFT SERIOUS INCIDENT INVESTIGATION REPORT

A SITUATION WHERE A PILOT IN COMMAND OF AN AIRCRAFT
RECOGNIZED A RISK OF COLLISION OR CONTACT
WITH ANY OTHER AIRCRAFT
OVER AKASHI CITY, HYOGO PREFECTURE
AT 16:24 JST, NOVEMBER 11, 2017

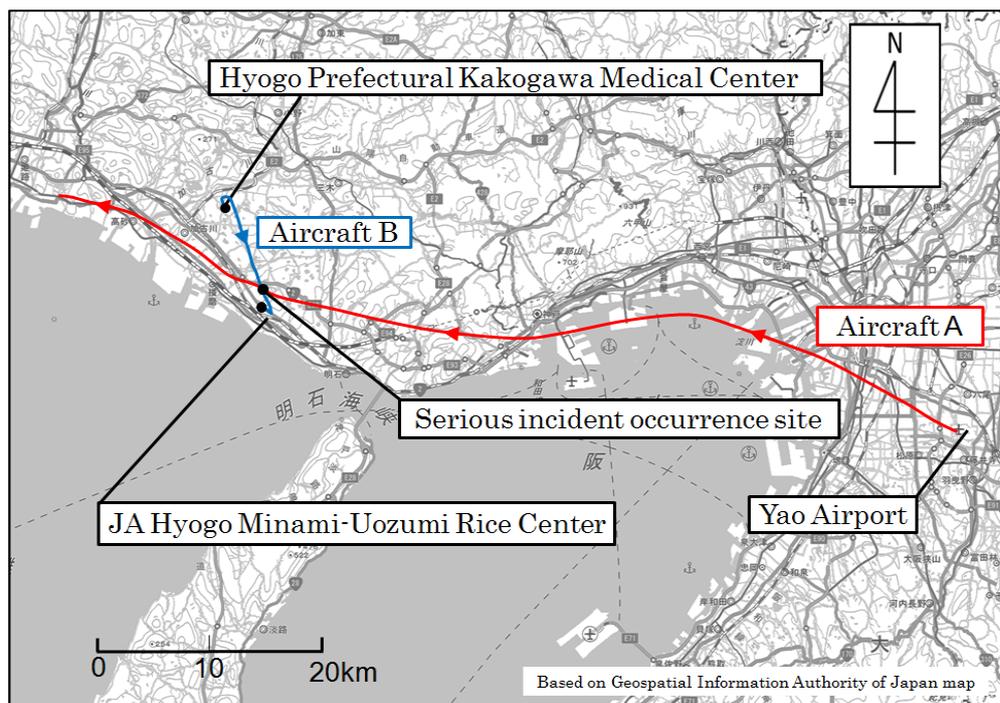
Figure 1: Estimated Flight Route

This serious incident occurred at about 16:24:06 on November 11, 2017, over Akashi City, Hyogo Prefecture.

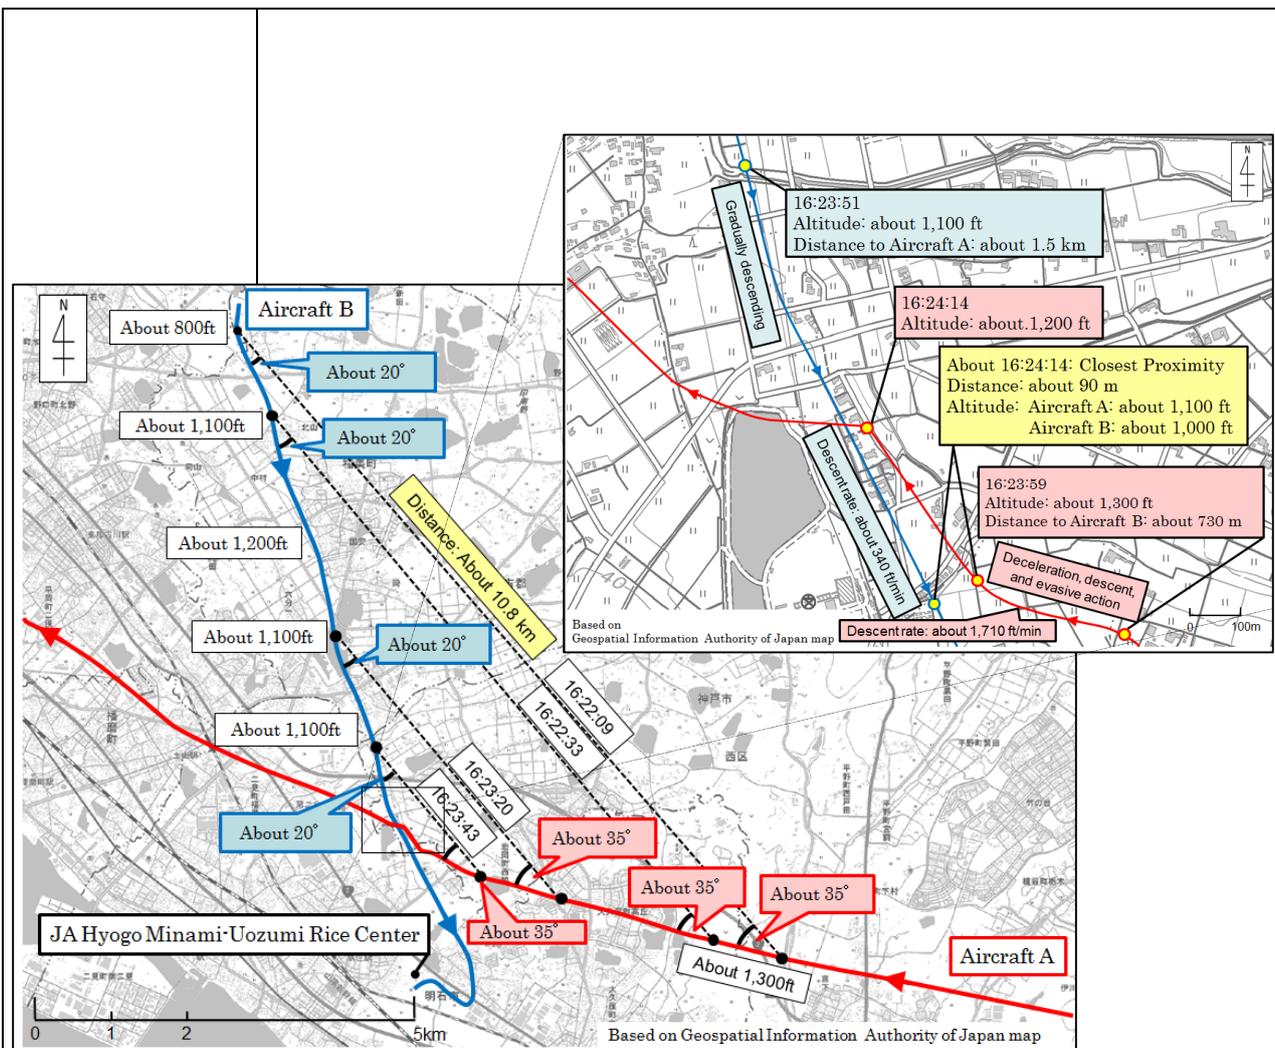
Figure 2: Proximity of Both Aircraft

3.1 Involvement of Weather	None
3.2 Involvement of Pilots	Yes
3.3 Involvement of Aircraft	None
3.4 Analysis of Findings	<p>(1) Weather Conditions</p> <p>The weather conditions, when Aircraft A and Aircraft B approached each other, were visual meteorological conditions (VMC); therefore, it is probable that as the visibility was good, there was no factor, including the position of the sun and others, which would impede the visual identification of the other aircraft.</p> <p>(2) Approaching Situations of Both Aircraft and Visual Identification of the Other Aircraft</p> <p>It is probable that the PICs of both Aircraft were flying while keeping watch outside as usual. It is highly probable that although once the PIC of Aircraft A visually identified Aircraft B, Aircraft A and Aircraft B were flying almost on constant relative angle of a collision course at 16:22:09, with a distance between both aircraft approximately 10.8 km; therefore, the PICs of both aircraft were not able to visually identify each other until just before they approached each other closest at about 16:24:06, with a distance between both aircraft approximately 90 m and their altitude</p>

difference of about 100 ft (Aircraft A: about 1,100 ft, Aircraft B: about 1,000 ft).

According to the statement of the PIC of Aircraft A and the submitted Near Collision Report, Aircraft A reduced speed and climbed while making a right turn during evasive maneuver, and Aircraft B descended while making a quick right turn after approaching from below on the right side of Aircraft A. However, according to the radar tracking records, in fact, Aircraft A changed its heading rightward while descending at a descent rate temporarily higher than that of Aircraft B and started climbing after coming closest to Aircraft B, and Aircraft B was descending from below on the right side of Aircraft A without changing its heading. Based on these records, it is highly probable that to the PIC of Aircraft A, Aircraft B looked as if to approach rapidly from below on the right side of Aircraft A and go descending while making a quick right turn.

It is probable that because the PIC of Aircraft A noticed Aircraft B climbing while making a right turn, it should have been necessary for the PIC of Aircraft A to maintain a lookout forward as well as watch continuously the behavior of Aircraft B until it could ascertain Aircraft B’s heading, and then take evasive action much earlier by considering the reaction time for the aircraft to see and avoid. Afterward, it is probable that as described in “c. How it looks depending on the relative speed” in the AIM-J, because Aircraft B entered the collision course while the PIC of Aircraft A was maintaining a lookout forward, it became difficult for Aircraft A to see how close Aircraft B was approaching; and it was not until just before Aircraft A flew by Aircraft B that the PIC of Aircraft A recognized the collision risk.

It is probable that because both aircraft used different radio frequencies, they were not able to share the position information with each other; therefore, it should have been necessary for both aircraft to make their position report to the ATC facility and the Flight Service Center during flight in order to try to share information and obtain traffic information.

- a) Pilots should maintain a vigilant lookout by accomplishing effective scanning, keeping in mind that it becomes difficult to find stationary objects as the aircraft on a collision course looks stationary.
- b) During flight, pilots should try to share information and obtain traffic information by making its position report to the ATC facility and the Flight Service Center.
- c) When operating in the congested area, pilots should turn on effective and available lights such as anti-collision lights, landing lights and others to alert the other aircraft flying nearby.
- d) Because Simplified Airborne Collision Avoidance System, which can be installed on small aircraft that are not obligated to install the system, has been developed, it is desirable for the aircraft operators to consider installing these systems on their small aircraft.

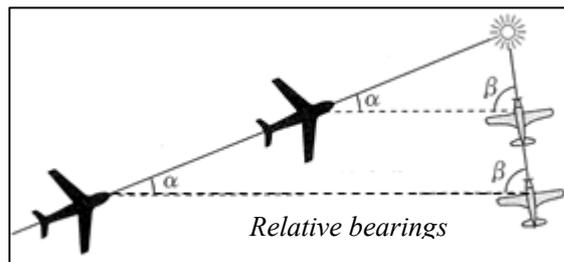
Figure 3: Judgment of Collision Course

As obviously shown in Figure 3, if two aircraft approach with the constant relative bearings (α and β), both aircraft are on a collision course. It is known that human eyes are good at finding moving objects, but poor at finding stationary objects.

Pilots should be aware that finding another aircraft tends to be delayed when the aircraft is on a collision course since the aircraft looks stationary. (Omitted)

It is probable that both aircraft were not able to recognize each other until just before they came closer to each other because both aircraft were flying on a collision course, resulting in delay in visually identifying each other.
