**AIRCRAFT SERIOUS INCIDENT
INVESTIGATION REPORT**

**JAL EXPRESS CO., LTD.
J A 3 4 2 J**

ENGINE INTERIOR DAMAGE
JAL EXPRESS CO., LTD.
BOEING 737-800, JA342J
AT AN ALTITUDE OF APPROXIMATELY 13,000 FT,
ABOUT 37 KM WEST OF TOKYO INTERNATIONAL AIRPORT
AT AROUND 19:42 JST, OCTOBER 20, 2012

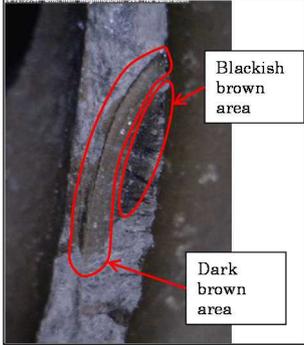
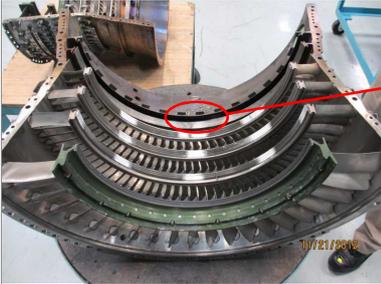
<p>SCAB found in the bottom of the fifth stage HPC casing</p> </div> </div>

the fifth stage of HPC casing.

Such SCAB is generated by the blade tips of HPC coming into contact with the casing during normal operation, and might be discovered by the normal maintenance work; however, the SCAB had about four times the thickness of the SCAB found by normal usage.

According to the examination of the Manufacturer, the material of the SCAB was the same as the material of the fifth stage blades of HPC.

The engine manufacturer conducted a design change to widen the clearance between the fifth stage blades of HPC and the casing on February 28, 2014.

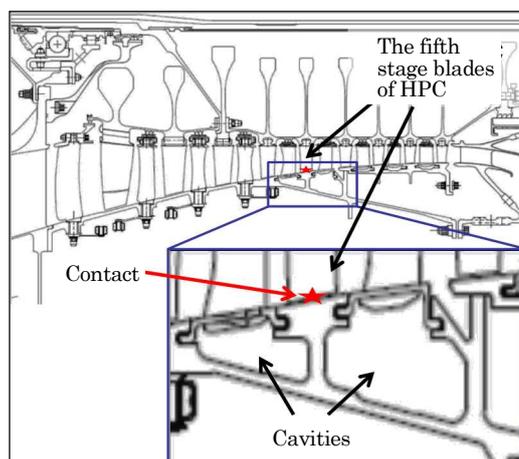
There are two cavities in the casing around the fifth stage blades of HPC, and traces of accumulation of liquid were found at the bottom of these cavities and in the latter stages HPC casing leading to cavities.

bleed air) at an angle approximately 45, 135, 225 and 315 degrees circumferentially (0 degrees at top), and traces or residue of dried liquid was found in only the lower two ducts at an angle approximately 135 and 225 degrees.

According to component analysis by the Manufacturer, the component of traces of liquid found at the bottom of the HPC casing was mainly water, and it showed somewhat likely that the liquid is rain water or seawater.

According to the Manufacturer, it was confirmed that water can accumulate in the cavities near the bottom of the HPC casing around the fifth stage if the water infiltrates around the fifth stage of HPC. Moreover, during a short-duration engine test, where water was injected from the aft side of the fan into the engine interior, water accumulated in the cavities near the bottom of the HPC casing around the fifth stage during rotating with a motor (dry-motoring) but water did not accumulate in the cavities when the engine was not rotating.
