**AIRCRAFT ACCIDENT
INVESTIGATION REPORT**

**EXCEL AIR SERVICE INC.
J A 3 5 0 D**

DAMAGE TO AIRFRAME IN DITCHING EXCEL AIR SERVICE INC. EUROCOPTER AS350B3 (ROTORCRAFT), JA350D ON THE SEA NEAR 41 KM NORTHWEST OF NAHA AIRPORT, JAPAN AROUND 15:26 JST, JUNE 7, 2018

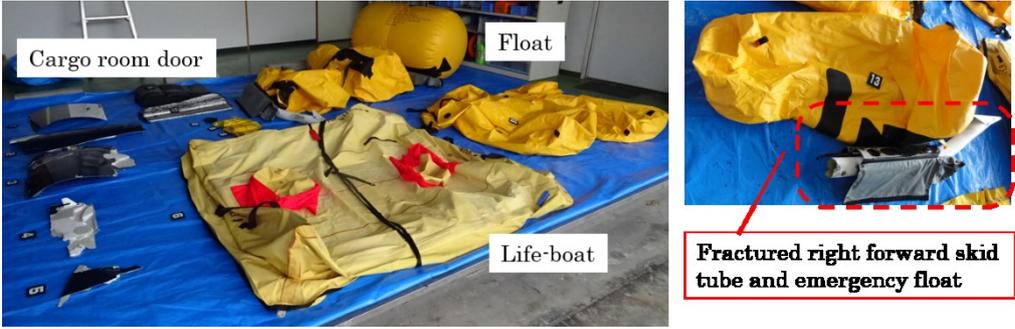
<p>2.2 Injuries to Persons</p>	<p>Pilot: Seriously injured</p>
<p>2.3 Damage to Aircraft</p>	<p>Extent of damage to the helicopter: Supposed to have been destroyed from floating wreckage gathered because the airframe sank in the sea.</p> <ul style="list-style-type: none"> ● Landing gear: The attached section of forward float of the right skid was fractured, and float was fractured and detached. ● Lower part of fuselage: Under cowl was fractured. ● Aft fuselage on the left: Cargo room door was destroyed. <p>Damage to all the rest could not be identified because the airframe had sank in the sea.</p> <div style="text-align: right;">

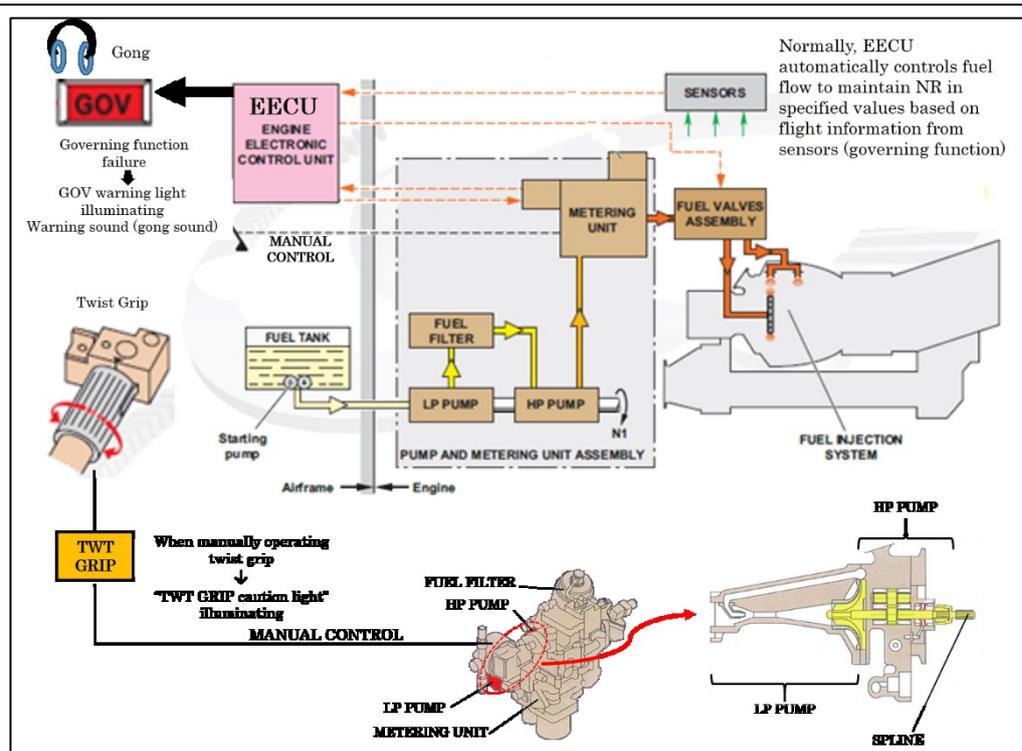
Figure 4: Pump and metering unit assembly (governor system)

3.1 Involvement of Weather	None
3.2 Involvement of Pilot	Yes
3.3 Involvement of Aircraft	Yes
3.4 Analysis of Findings	<p>(1) Estimated Causes of the Malfunction of the Aircraft</p> <p>From the maintenance history of the helicopter and the statement of the pilot, it is probable that the helicopter did not have any abnormality until GOV warning was activated.</p> <p>It is somewhat likely that the engine of the helicopter was not shut down, but was under low output condition because the abrupt veering to the right along with GOV warning illuminating and the reduction of NR occurred during the flight using AP, and the pilot was able to maintain NR at around 370 rpm by slightly lowering CP. It is probable that, when GOV warning is activated, the possibility of occurrence of the NR reduction and right veering is low because the fuel flow is fixed at the value before the occurrence of failure in the event of simply sticking of metering valve or malfunctioning of engine control</p>

system. To the contrary, in the event of malfunction of low pressure pump or high pressure pump in Pump and Metering Unit Assembly, it is probable that the engine output is reduced and veering to the right occurs due to reduced fuel flow. It is somewhat likely that the engine output did not follow manual operations of the twist grip because the malfunction hindered sufficient adjustments of fuel flow. However, it could not be determined in which section of the aircraft the malfunction occurred and what caused it because the helicopter sank in the sea and the record of the engine data could not be obtained.

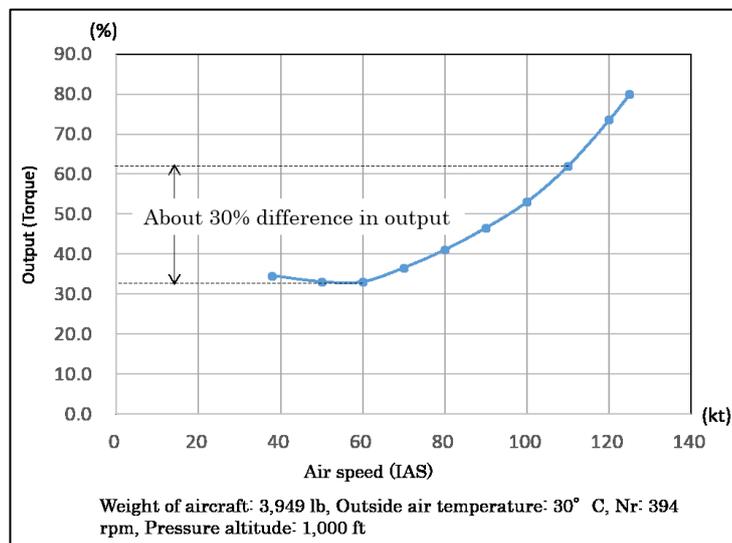
Figure 7: Output required for level flight

Maintaining NR in a normal operation range (green arc line) requires confirmation of flight parameters in emergency control and subsequent operations in accordance with such parameters, and it is possible that NR would be easy to maintain by extra output brought about by deceleration, if in cruising flight. Figure 7 shows about 30% difference by comparing an air speed of 110 kt with 60kt, which is close to the best climb rate speed. From this, it is somewhat likely that it was feasible to maintain level flight by maneuvering deceleration at first, as far as reduction of the output was within about 30%, and even in the situation of more reduced output, emergency control could have been performed with more time available to do so.

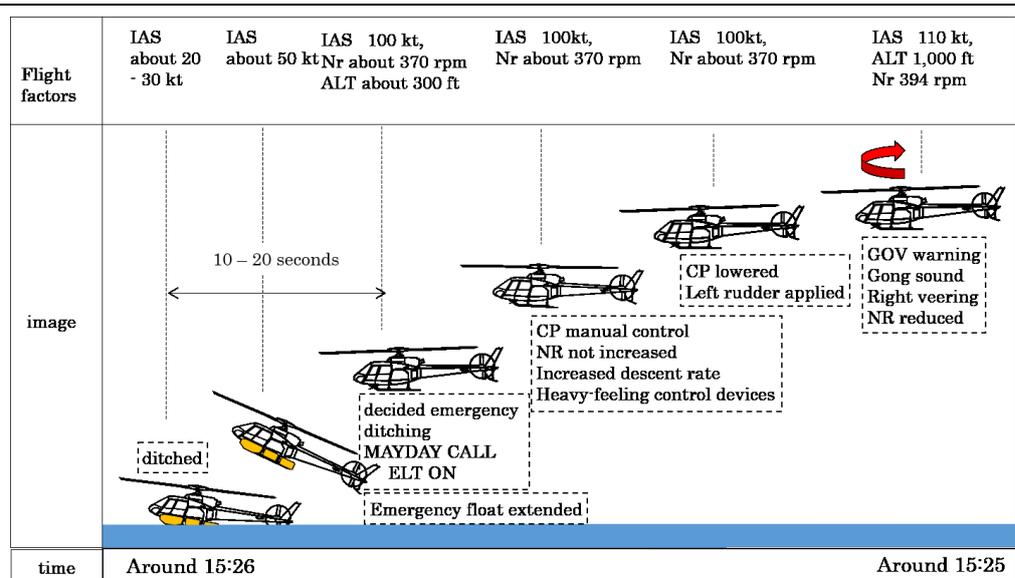
Figure 8: From GOV warning activation to ditching of JA350D

It is probable that the pilot decided to ditch for emergency, sent distress message in a short period of time with operating deceleration, extended the Emergency Float, manually activated ELT and operated emergency ditching; however, due to the late descending operation, the helicopter ditched at an air speed of 20 to 30 kt and at an excessive descent rate.

Due to this, it is highly probable that the helicopter sank in the sea with the Emergency Float and the airframe damaged.
