**AIRCRAFT ACCIDENT  
INVESTIGATION REPORT**

**FIRST FLYING CO., LTD.  
J A 3 7 2 1**

November 27, 2009

FIRST FLYING CO., LTD.  
CESSNA TU206F, JA3721  
SHIKI-CHO, YAO CITY, OSAKA PREFECTURE, JAPAN  
AT ABOUT 10:08 JST, AUGUST 19, 2008

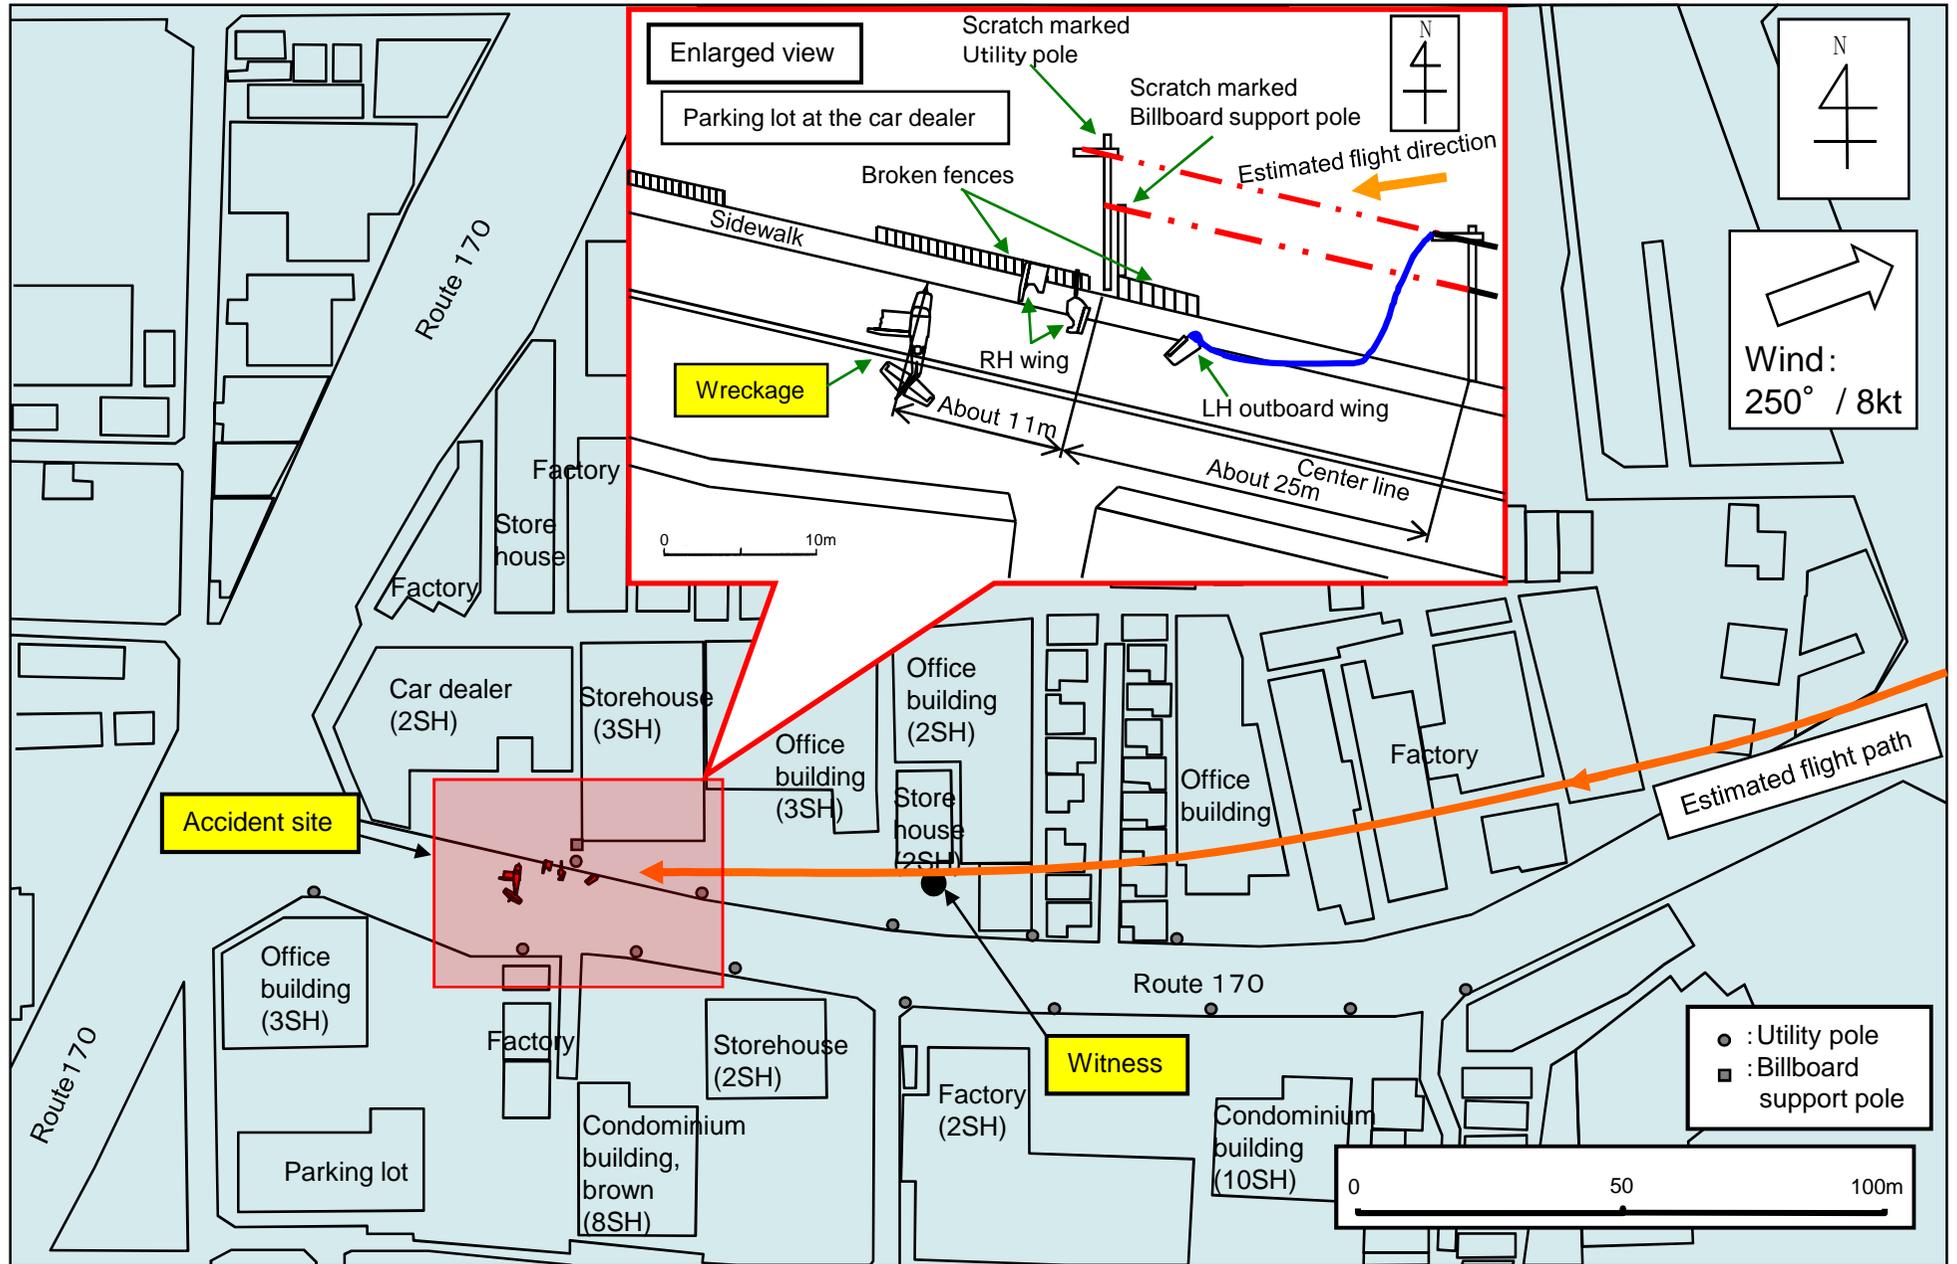
Figure 2 Sketch of The Accident Site

The Aircraft was found resting stationary on National Route 170, about 900 m east of the approach-end threshold of Runway 27 of the Airport, with the nose pointing to the north.

The road on which the Aircraft made its emergency landing runs east-west with warehouses, workshops, a car dealer, apartment houses and other buildings in the vicinity. There are utility poles standing along both sides of the road. Six of the Overhead lines on the north side poles were broken, and the separated outer portion of the Aircraft's left wing was found entangled in the hanging electric lines.

A utility pole to the west of the broken Overhead lines had scratch mark at a height of about 3 m and the square support pole of a billboard about 1.2 m to the north of the utility pole had scratch mark at a height of about 2 m, respectively, and there were white and light-blue paint remainings on these scratch marks. The billboard was broken. Of the two fences located on the east and west sides of the utility pole, the east fence showed signs of being pushed toward the south from above and the west fence was damaged with separated portions of the right wing resting on it. Broken pieces of the airframe were found scattered all over the area.

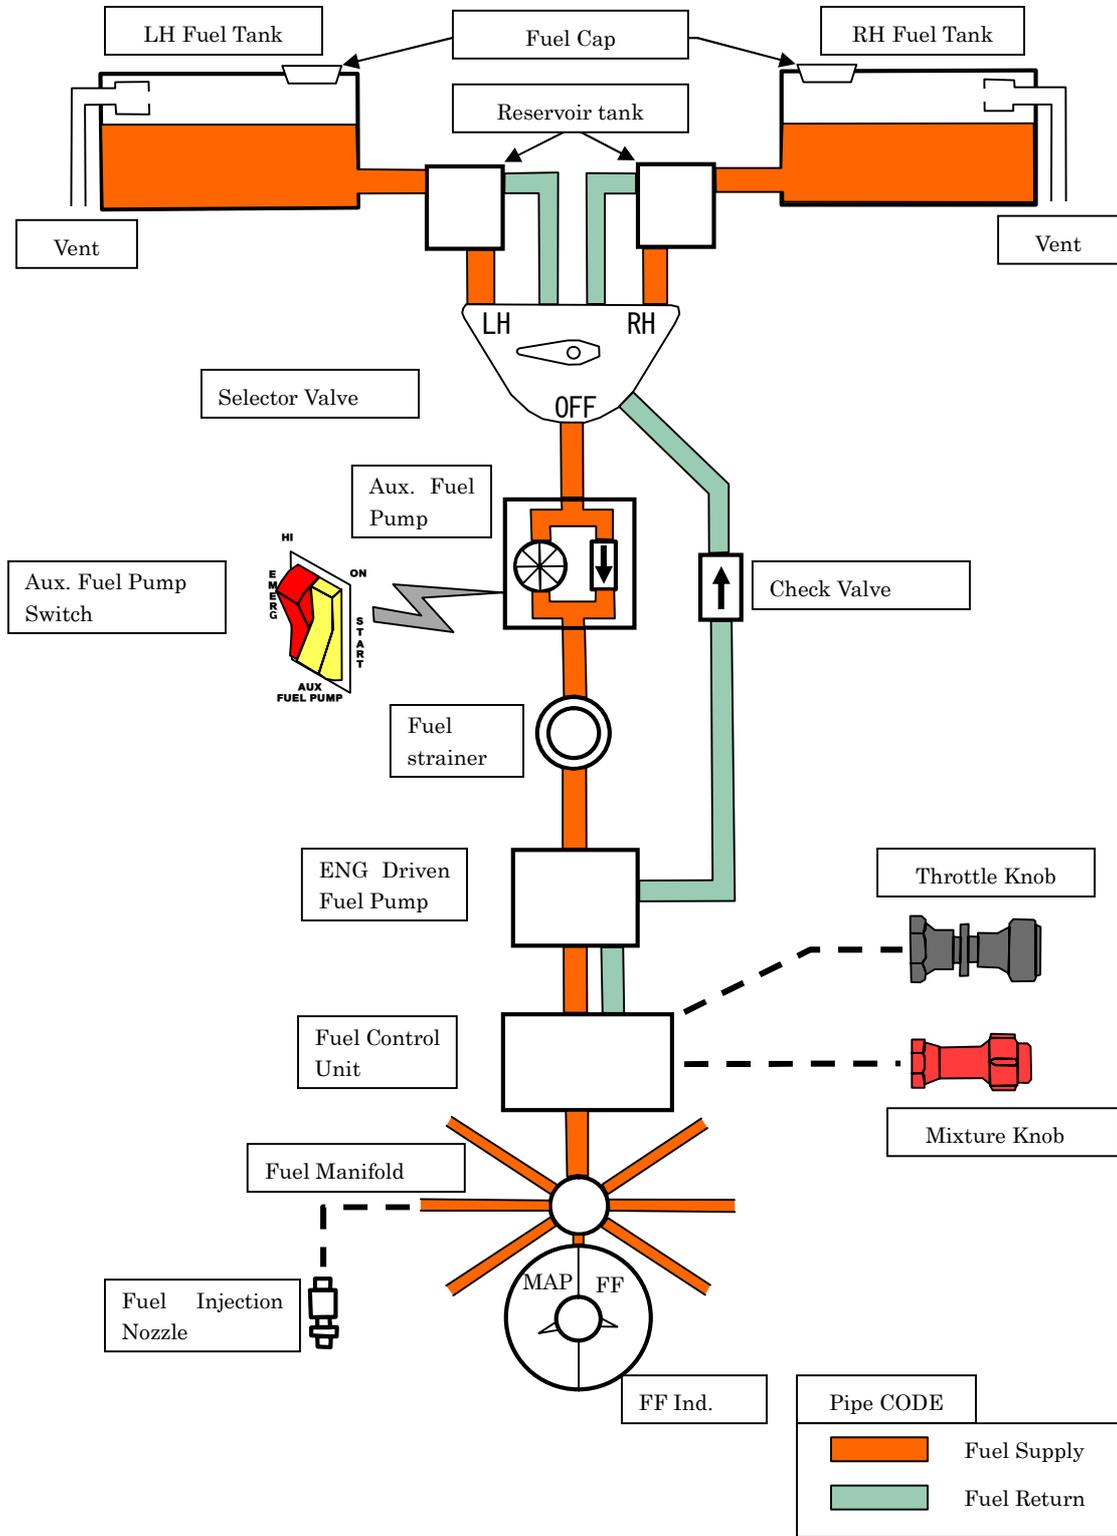
Figure 3 Fuel System

Regarding the technical inquiry placed to the manufacturer about the Captain’s control operations described in 2.1 (1), the manufacturer responded to the effect that it is considered probable that setting the auxiliary fuel pump to ON on the base leg caused flooding of the intake manifold with fuel.

Under conditions in which the Aircraft's engine is running normally during an approach for landing, there is no need to take anti-vapor-lock actions and the auxiliary fuel pump should be left in the OFF state. However, it is considered highly probable that because the Captain set the auxiliary fuel pump switch to ON as suggested by his boss' advice and the fuel flow rate increased, therefore, the fuel/air ratio turned excessively rich as described in 2.10.1, preventing fuel from igniting and eventually causing the engine to stall.

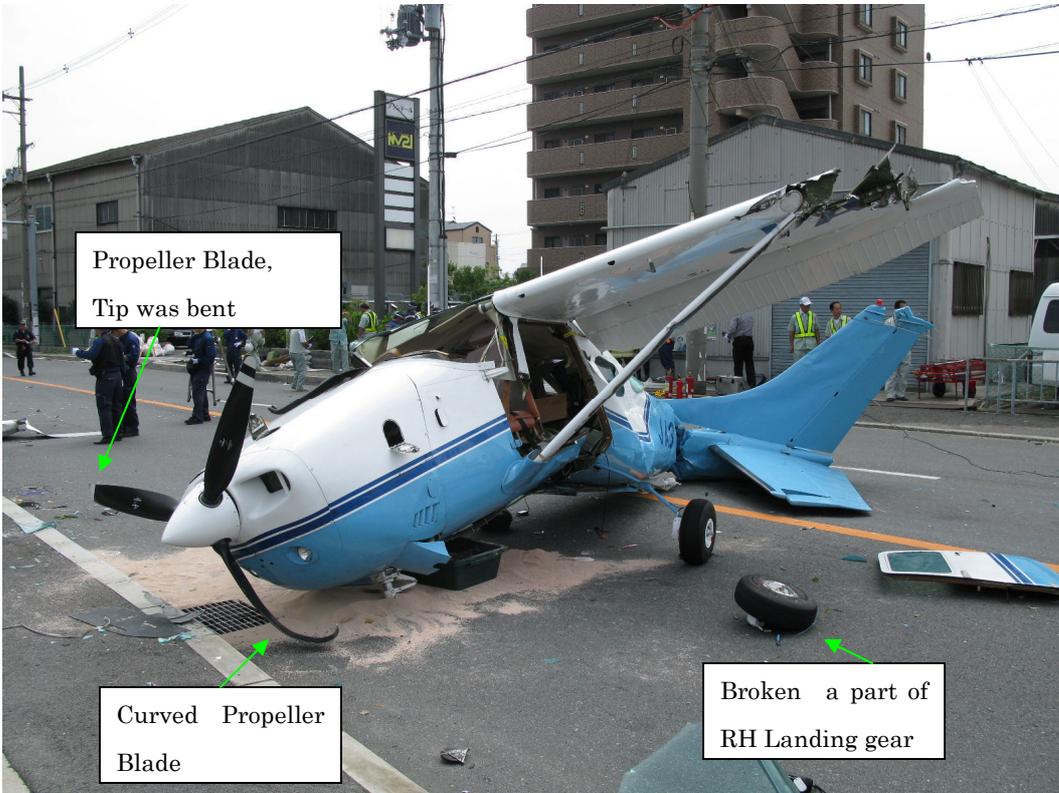
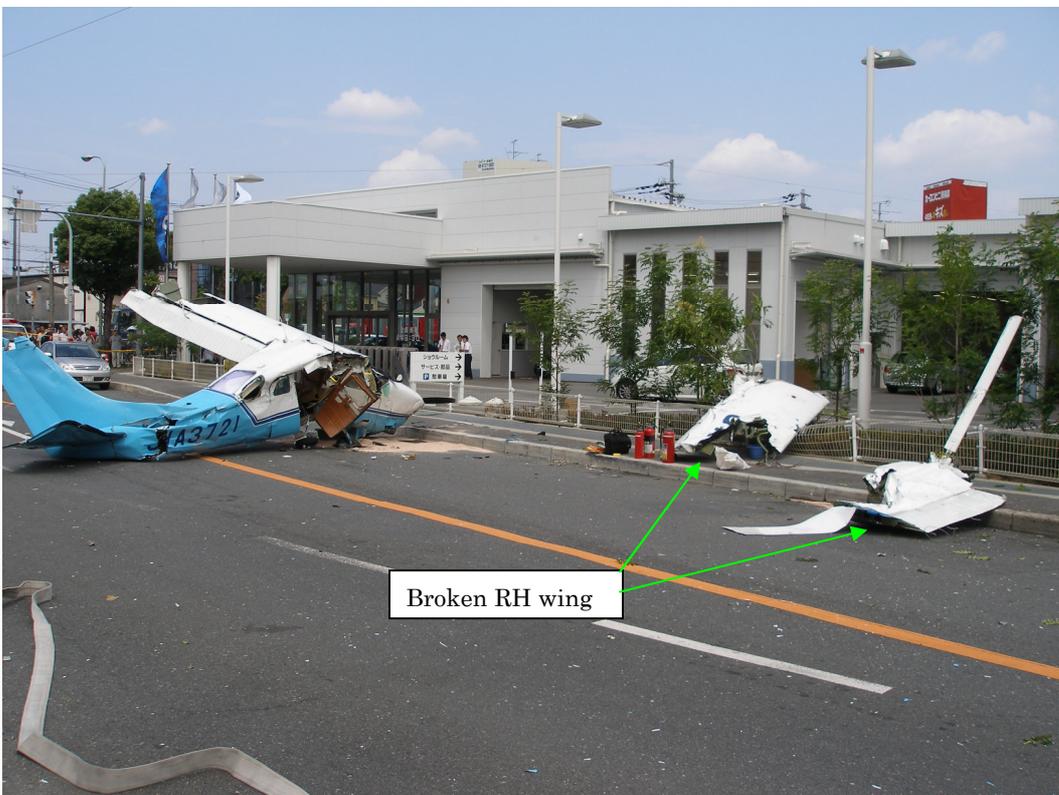
# Photo Accident Aircraft

The fuselage was bent to the right at a point near the main landing gear mountings and bent to the left at a point forward of the horizontal tail. The right bottom surface of the nose was dented and the exhaust pipe was broken. The left and right frames for the cockpit front windshield had broken off and fuel was found leaking from the fuel supply line running through the left frame.

The outer portion of the left wing had broken off at the strut mounting. The outer wing portion was found lying on the ground, entangled in broken Overhead lines.

The right wing had broken off at its joint to the fuselage. The detached right wing had further split into portions at a point near the strut upper mounting and the leading edge of each split half had a square indent. Fuel was observed leaking from the vent.

There were damages to the right horizontal tail structure, the vertical tail structure and the top end of the rudder.

The gear spring of the right main landing gear was found bowed and the wheel was detached. The fork of the nose landing gear had broken off and the wheel was detached.

The lubricating oil cooler was deformed and the No. 5 (right foremost) cylinder head and the right exhaust manifold were dented. One of the three propeller blades was bent aft at a point about 8 cm from the blade tip; the second blade showed an abnormally large pitch angle and was entirely bowed aft; and the third blade remained intact.

With regard to the breakage of the right main and nose landing gears and the dent of the engine's No. 5 cylinder and right exhaust pipe, it is considered highly probable that these were caused by the impact produced when the Aircraft, after hitting the utility pole, fell with the fuselage tilted to the right and hit the road surface and other objects.
