**AIRCRAFT ACCIDENT
INVESTIGATION REPORT**

TOHO AIR SERVICE CO., LTD.

UNCONTROLLED CRASH INTO THE GROUND

EUROCOPTER AS350 B3, JA508A

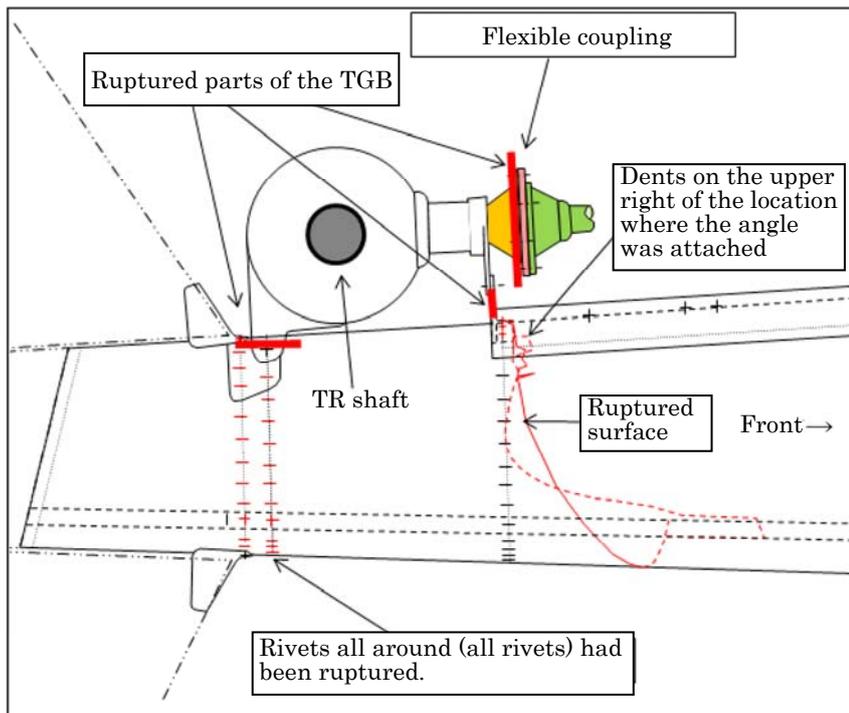
(Ruptured Tail Boom)

The tail boom was broken at an immediately fore part of the flange that was connected to the fuselage, and was damaged by fire. The tail boom was also broken at an immediately fore part of the bracket that supports the front part of the TGB (near the flexible coupling) and had separated from the back part of the tail.

On the upper side of the ruptured surface that had detached from the tail, continuous dents were seen from the upper left to the upper right of the area where the angle was attached, which resulted from being hit by the protruding portion of the flexible coupling while it was rotating. In addition, there were ruptures beginning from the left and right ends of the cutting section where the dents described above were found, as though the surface had been torn apart. The rupture on the right developed diagonally to the front, and continued up to near the section where the outer shell was overlaid, about 20 cm ahead of the upper cutting surface and on the lower left. The rupture on the left initially developed diagonally downward and then in a forward direction. It continued up to about 8 cm ahead of the end of the rupture on the right, where it fell apart towards the left as though it had been torn off.

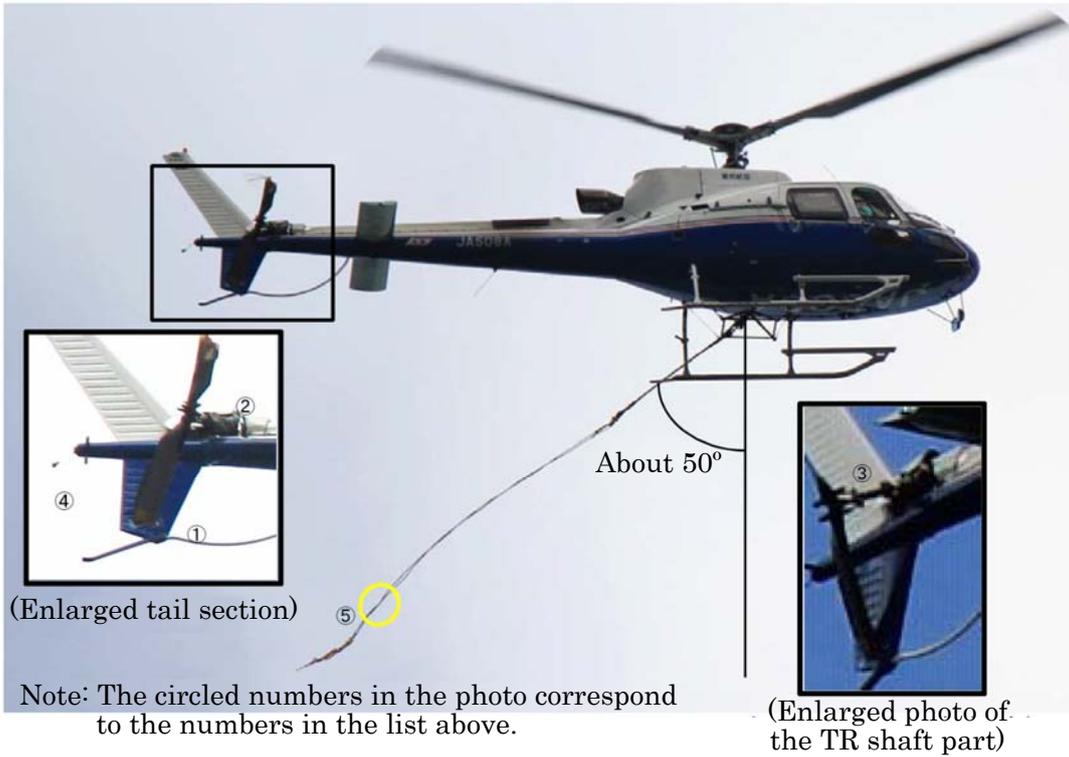
(Photos of the Helicopter taken by the Witness)

As described in 2.1 e., two photos of the Helicopter flying over near Lake Miyagase had been taken about four minutes before the crash, which showed the following conditions:

- ① The TR blades had stopped turning. The upper blade was broken at about half the length of the wing and material that appeared to be fiber was fluttering in the wind from the upper end. The lower end of the bottom blade had dug into the lower vertical stabilizer.
- ② The cover of the TGB was cut near the flexible coupling.
- ③ The TR shaft had tilted backward.
- ④ The tail lamp had come off, and was hanging from the tip of an electric wire.
- ⑤ The seven-meter sling cable that was suspended from the Helicopter was fluttering backward in the wind at an angle of about 50°. The steel wire part had been bent backward and the section near the lower end had drooped slightly downward due to the weight of the hook. A portion about one meter from the lower end had twisted abnormally. (This is where the bend and the strand that was cut off were observed in the wreckage investigation.)

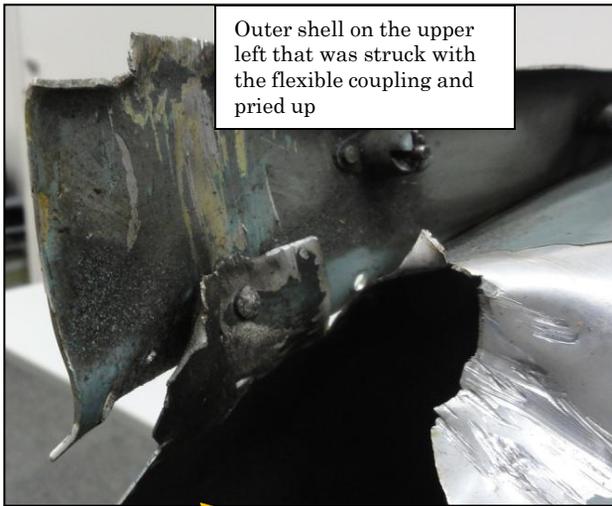
Outer shell on the upper left that was struck with the flexible coupling and pried up

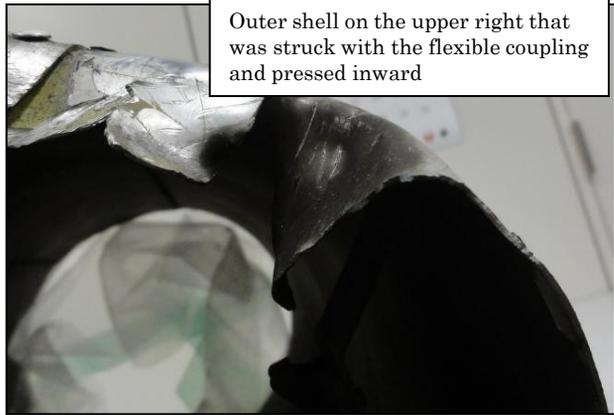
Outer shell on the upper right that was struck with the flexible coupling and pressed inward

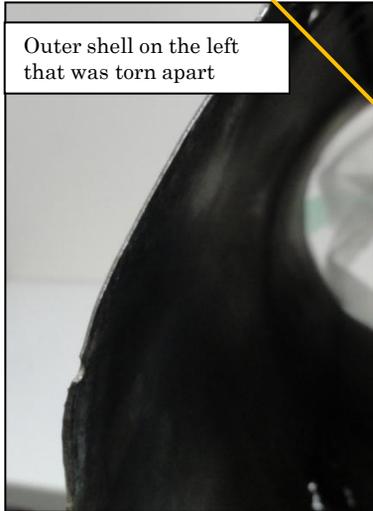
Outer shell on the left that was torn apart

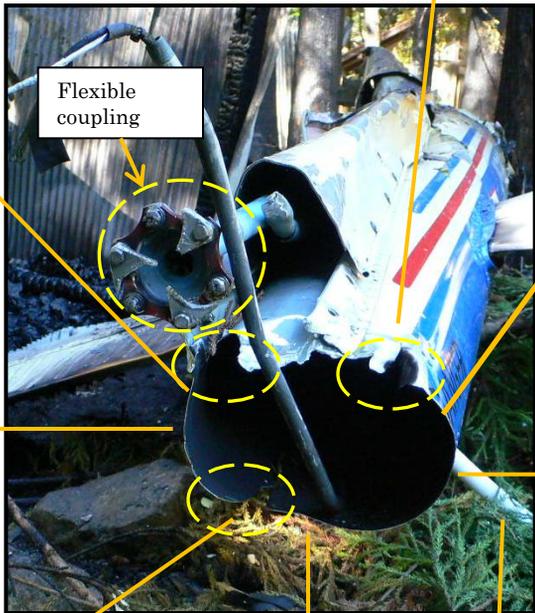
Flexible coupling

The TR drive shaft had detached at the flexible coupling section and there were many circumferential scratches on the external side of six protruding parts of the flexible coupling.

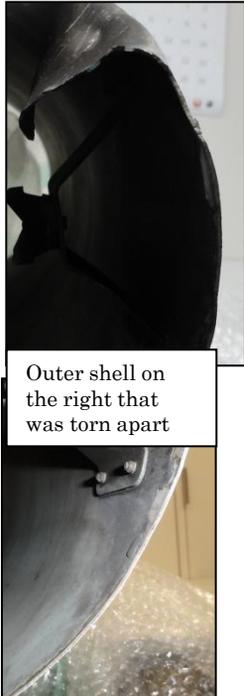
Outer shell on the right that was torn apart

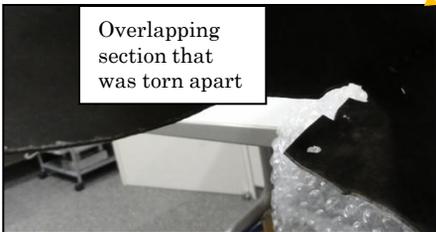
Overlapping section that was torn apart

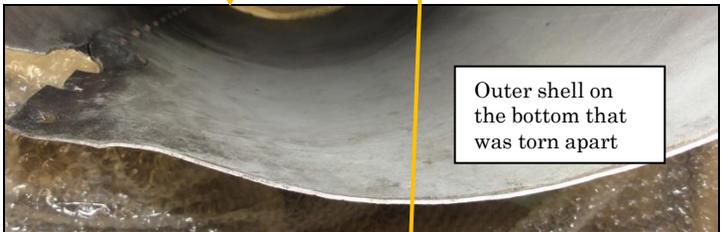
Outer shell on the bottom that was torn apart

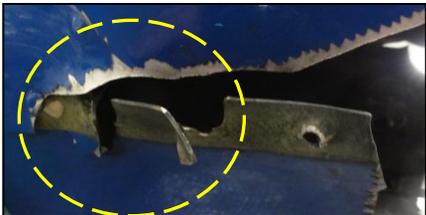
Rivets on the overlapping section that were pulled out, along with the outer shell, from the inner outer shell

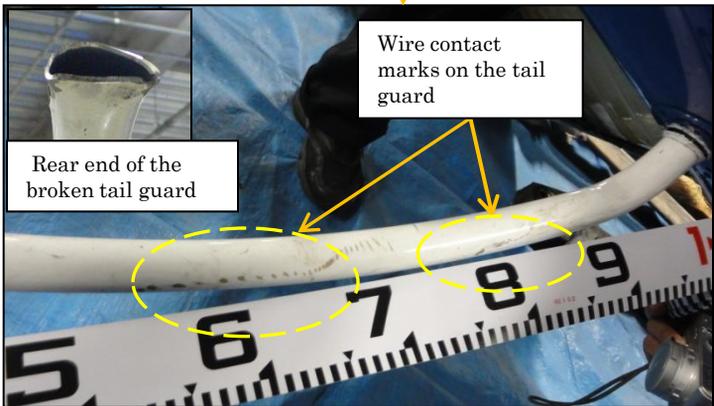
The tail guard was bent downward at an immediately fore position of the section to which the lower end of the vertical stabilizer had been attached. Its surface was crushed vertically and had ruptured. In addition, there were wire contact marks 15 to 25 cm and 30 to 45 cm from the front attaching portion.

Rear end of the broken tail guard

Wire contact marks on the tail guard
