**AIRCRAFT ACCIDENT
INVESTIGATION REPORT**

PRIVATELY OWNED PZL-BIELSKO SZD-50-3 PUCHACZ

(GLIDER, TWO-SEATER), JA50KM

SAKAE-TOWN, INBA-GUN, CHIBA PREFECTURE

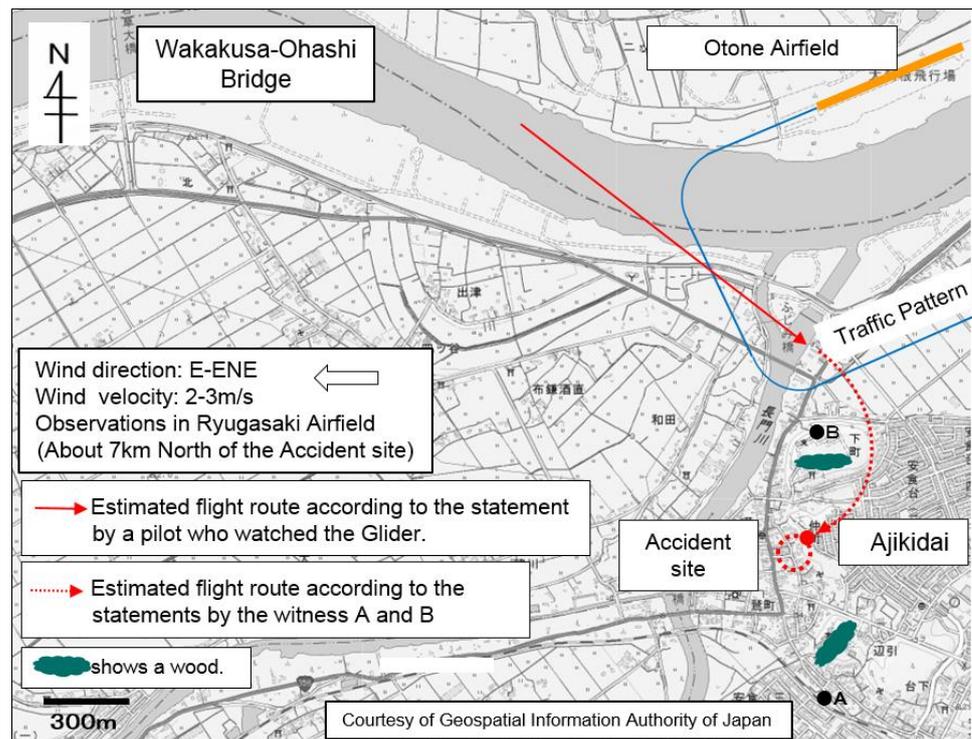
Figure 1. Estimated Flight Route

The pilot who took off from the Airfield following the Glider at 12:06, watched it flying at an altitude of about 1,500 ft between Wakakusa-Ohashi bridge and the Airfield during his flying toward the right base leg of the runway 07 in order to land at the Airfield. After that, the pilot saw that the Glider was flying toward Ajikidai at the south of the Airfield, when his aircraft was almost at the final leg of the runway 07.

A witness A who was at about 600 m south of the accident site saw that the Glider was flying in a posture that the nose was so low while rotating on its fuselage, but he could not see the following scene, because a wood hid the Glider from his eyes.

A witness B who was at about 400 m north of the accident site saw that the Glider was diving while showing its wings surface, but she did not remember whether it was rotating or not. She could not see the final scene

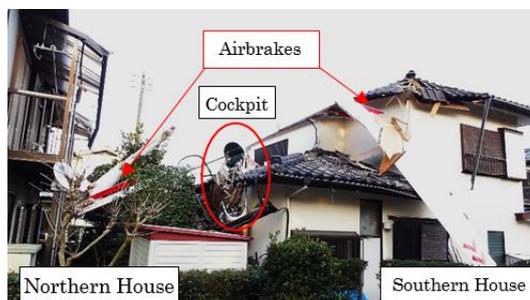
Photo1. Accident Site (View from the west)

The right wing was found at scattering from the site of the southern house to the south of the site of the northern house. A part of the south side roof and the veranda on the second floor of the northern house were damaged (See Photo 1). The broken pieces of the Glider remained on those two houses and a narrow area between them.

(2) Damage on the Glider

The left main wing of the Glider was broken at about 5.8 m from the wingtip, and the right main wing was bent upward near the outside of the airbrake*2. In addition, both airbrakes were extended.
