**AIRCRAFT ACCIDENT
INVESTIGATION REPORT**

**SCHOOL JUDICIAL ORGANIZATION
KIMIGAFUCHI GAKUEN (SOJO UNIVERSITY)
JA 5304**

March 29, 2018

AIRCRAFT DAMAGE CAUSED BY BELLY LANDING SCHOOL JUDICIAL ORGANIZATION KIMIGAFUCHI GAKUEN (SOJO UNIVERSITY), BEEHCRAFT 58, JA5304 AT AROUND 10:26, JUNE 29, 2017 NAGASAKI AIRPORT

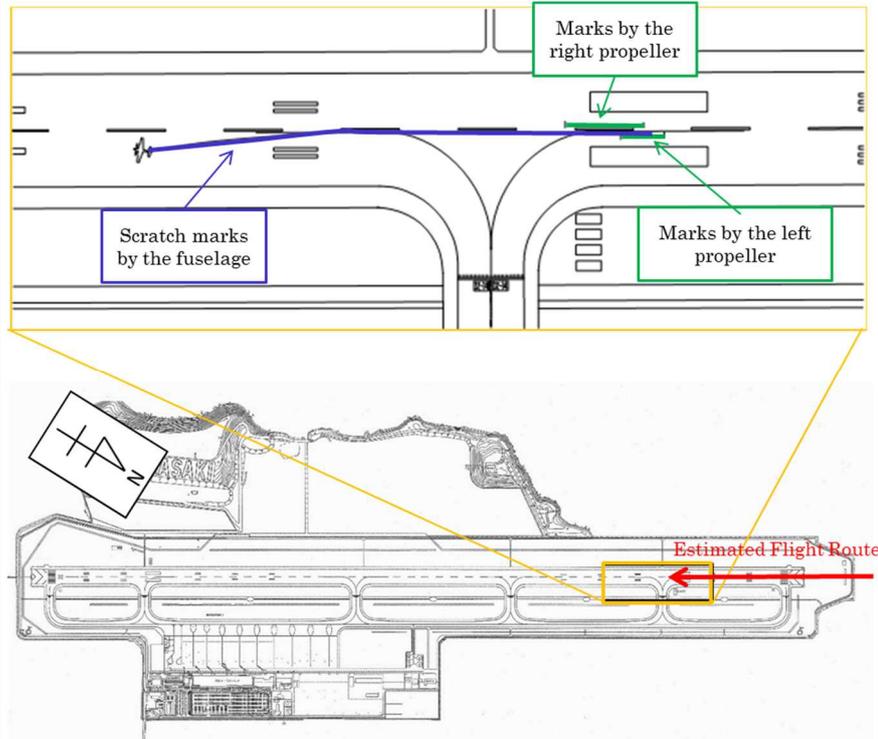
Fig 2 Accident Site

Scratch marks which were caused by the propellers and the Aircraft, were starting from about 260 m before the stop position of the aircraft and were continued to the stop position of the Aircraft.

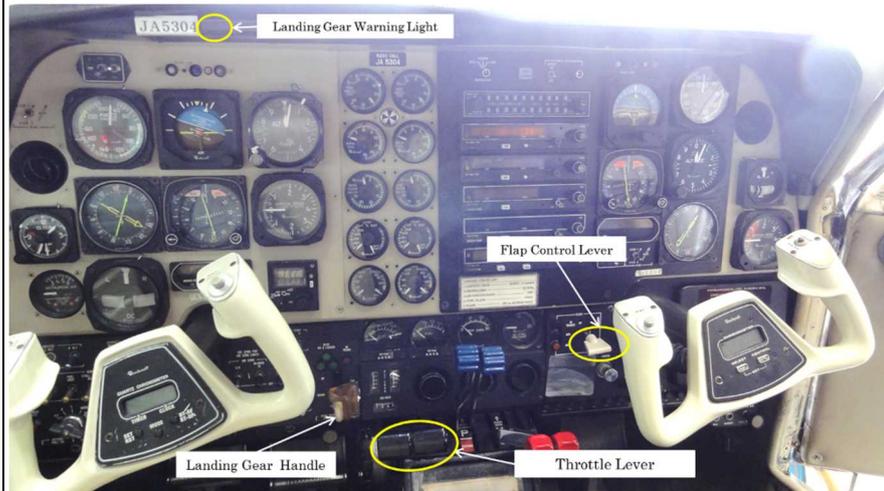
Photo 5 Cockpit

At the time of investigation, the Landing Gear Handle was at down position, it was confirmed that the detention mechanism worked normally as moving Landing Gear Handle up and down.

At the time of investigation, it was confirmed that there were no problems to activate a warning horn as changing the flaps position and throttle position with landing gear up.
