AA2017-6

AIRCRAFT ACCIDENT INVESTIGATION REPORT

**Japan Airlines Co., Ltd.
J A 6 5 8 J**

JAPAN AIRLINES CO., LTD.
BOEING 767-300, JA658J
CABIN ATTENDANT INJURY
BY THE SHAKING OF THE AIRCRAFT
ABOUT 21 NM (ABOUT 39 KM) EAST-SOUTHEAST
OF KAGOSHIMA AIRPORT
AT AN ALTITUDE OF ABOUT 17,000 FT (ABOUT 5,200 M),
AT ABOUT 13:21 JST, NOVEMBER 10, 2016

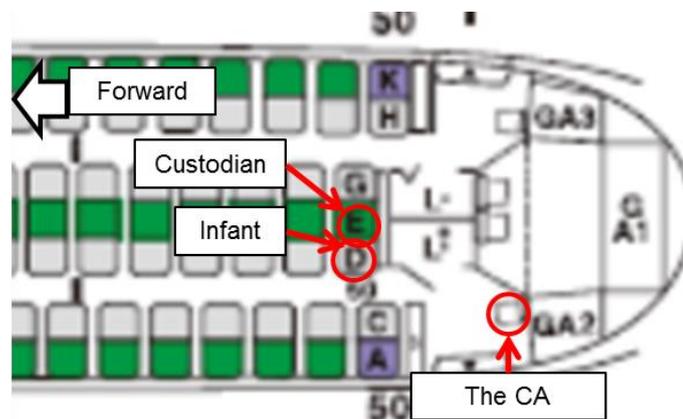
Fig 1 Seating diagram of rear cabin

dangerous if the situation stayed as it was and the shake was not so strong at the time, the CA attempted to stand up and call out again with unfastening the seat belt and holding on the right shoulder harness. At that time, the CA felt the Aircraft was tilted to the right and had strong shakes at the same time, and the CA fell backward to the right side floor of the jump seat with a feeling of slight float of her body. The CA stood up from there and returned to her jump seat. As the seat belt sign was turned off after some time, then, the CA left her jump seat and reported the situation of the fall to the chief cabin attendant after the CA confirmed the infant secured. After that, because the CA felt a pain at the bruised portion, the CA sat in a rear jump seat and took a charge of announcement services.

During the takeoff climbing at the time of the seat belt signs to be turned on, the CA found the infant crawling out of the hands of the custodian to the vacant next seat and called out to for the custodian's attentions loudly, but it is highly probable that the situation of the infant was not improved. It is probable that the CA judged that the infant would suffer the serious consequence unless taking appropriate action, so as an urgent correspondence, when she tried to stand up in order to be closer to call out and unfastened her seat belt, she lost balance, fell backward to the floor at right of the jump seat and suffered the injury.

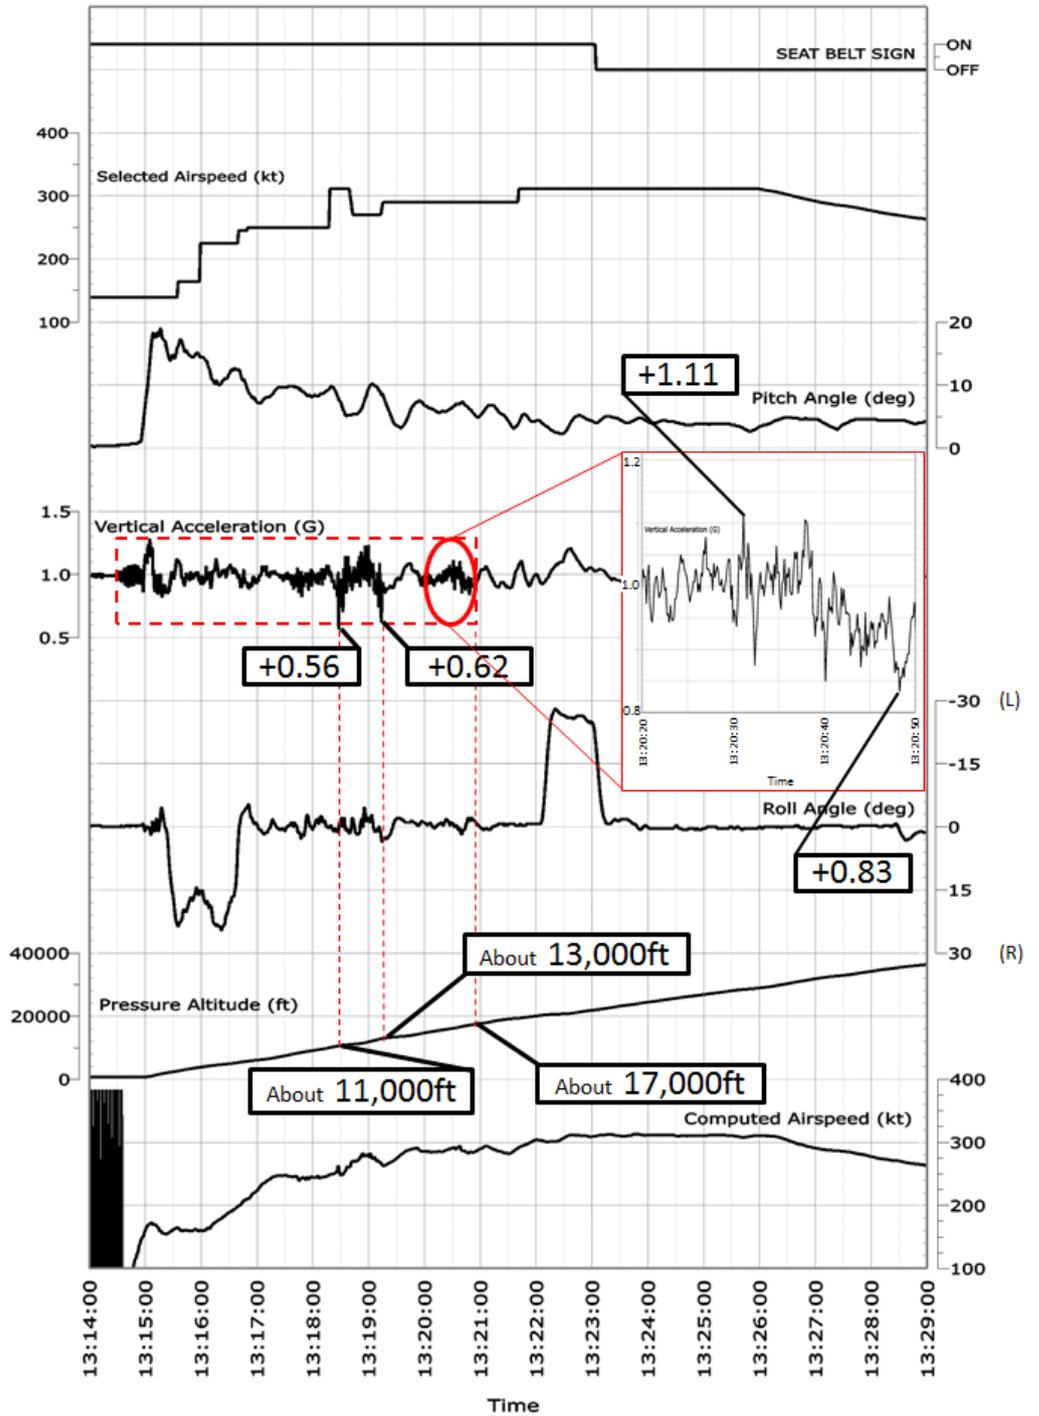
Fig 2 Records of flight data recorder

(5) According to the records of the flight data recorder as shown in Figure 2, the short cycle vertical acceleration which was indicated by the red broken lined frame started to change after the takeoff of the Aircraft and the change was increasing from the time at an altitude of about 11,000 ft after three minutes 27 seconds from the takeoff to the time at altitude of about 13,000 ft after four minutes 15 seconds from the takeoff. This change of the short cycle vertical acceleration calmed once at 13:19:15 which was about four minutes 15 seconds from the takeoff, however, 77 seconds after that time, as indicated by the red circle, it began to increase again from at around 13:20:32, and the vertical acceleration was changed from +1.11 to +0.83 then it stopped at around 13:20:50.

was recorded in the flight data recorder was caused by the shake of the aircraft due to the turbulence generated around the Stratocumulus.

The CA stated that she found the infant crawling out of the hands of the custodian to the vacant next seat at around six minutes after the takeoff when the shaking was calmed, however, it is probable that it was occurred while the change of vertical acceleration was calmed once at around the time after four minutes and 15 seconds from the takeoff which was recorded in the flight data recorder, to the time when the change of vertical acceleration began to increase at 5 minutes 32 seconds (13:20:32).

The increased change of the vertical acceleration which continued till five minutes and 50 seconds (13:20:50) after the takeoff and it is somewhat likely that the CA attempted to stand up at around this time.

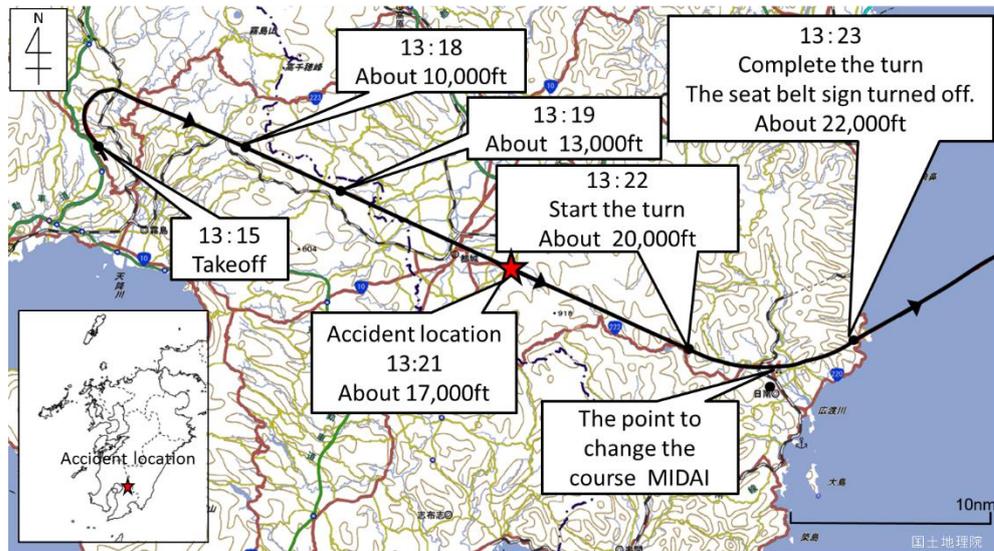
Fig 3 Estimated flight route

The accident occurred at about 13:21, on November 10, 2016, about 21 nm east-southeast of Kagoshima Airport (31°42'21" N, 131°07'07" E), at an altitude of about 17,000 ft.
