AIRCRAFT ACCIDENT INVESTIGATION REPORT

**AERO ASAHI CORPORATION
MCDONNELL DOUGLAS MD900 (ROTORCRAFT)
JA6757
ATSUGI AIRFIELD, AYASE-CITY
KANAGAWA PREFECTURE
AROUND 11:21 JST, SEPTEMBER 14, 2004**

January 26, 2007

**Aircraft and Railway Accidents Investigation Commission
Ministry of Land, Infrastructure and Transport**

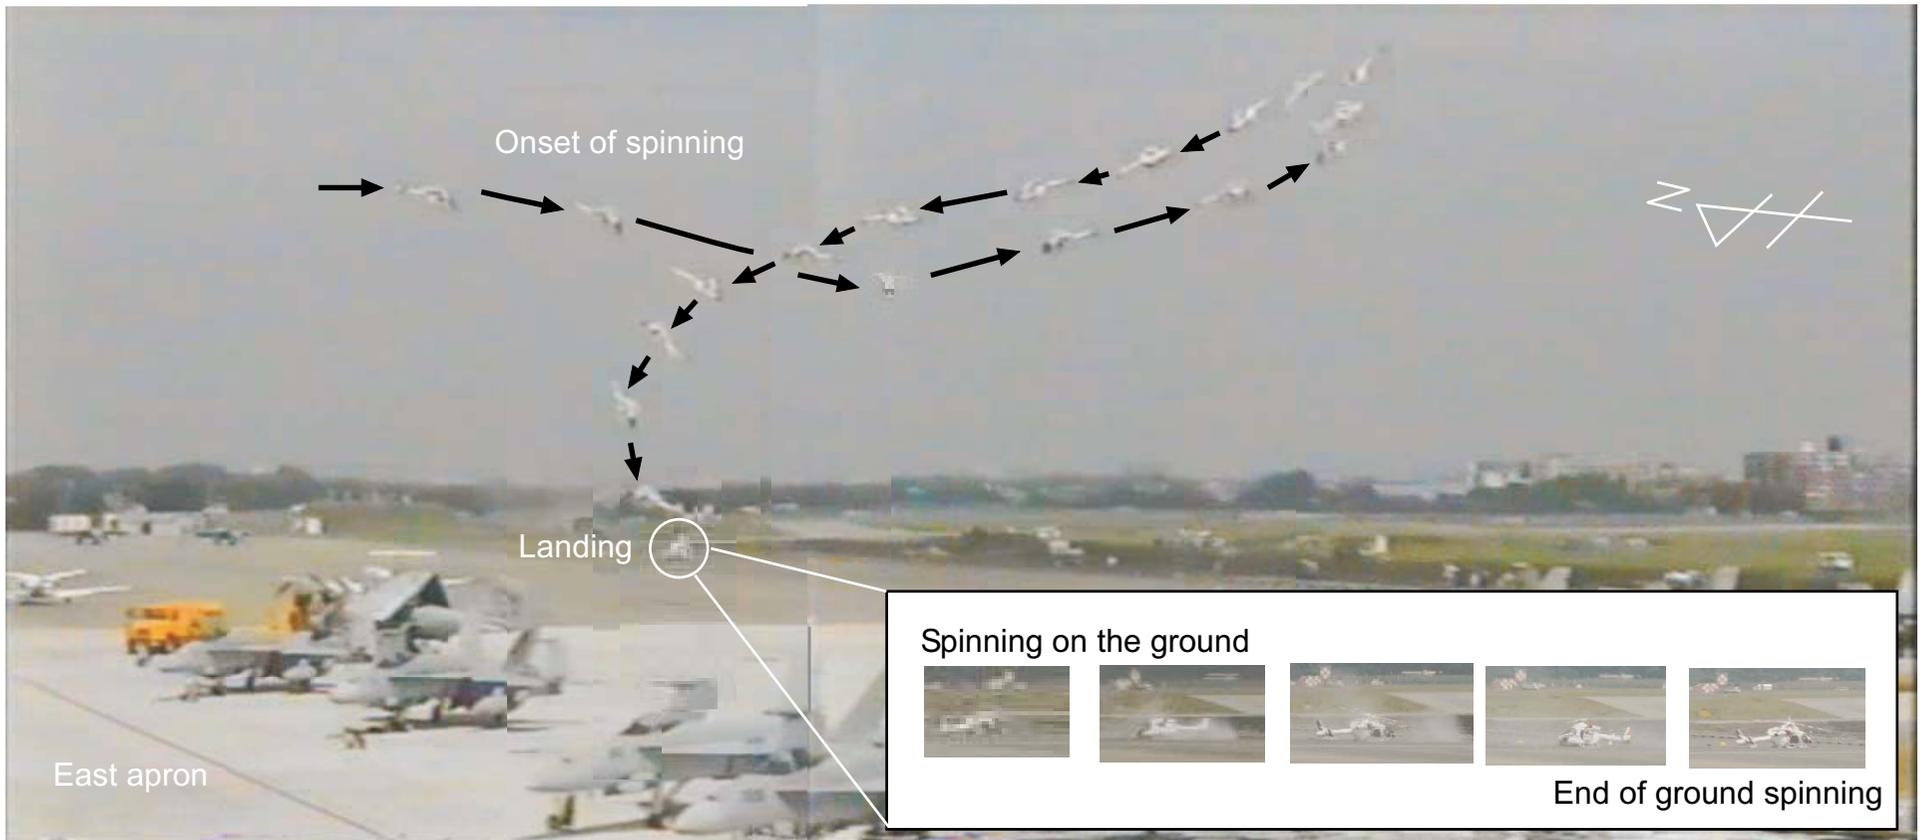
Figure 2 Aircraft spinning before/after landing

The investigation of this case confirmed that the spinning begins at the airspeed less than 80kt in level flight. On the other hand, the rotorcraft flight manual states that "*Touchdowns made into the wind between 20 and 30 KIAS, may provide good directional control at reduced power (collective) settings.*", however, detailed procedures to reach the touchdown is not stated. The manufacturer should illustrate the missing procedures.

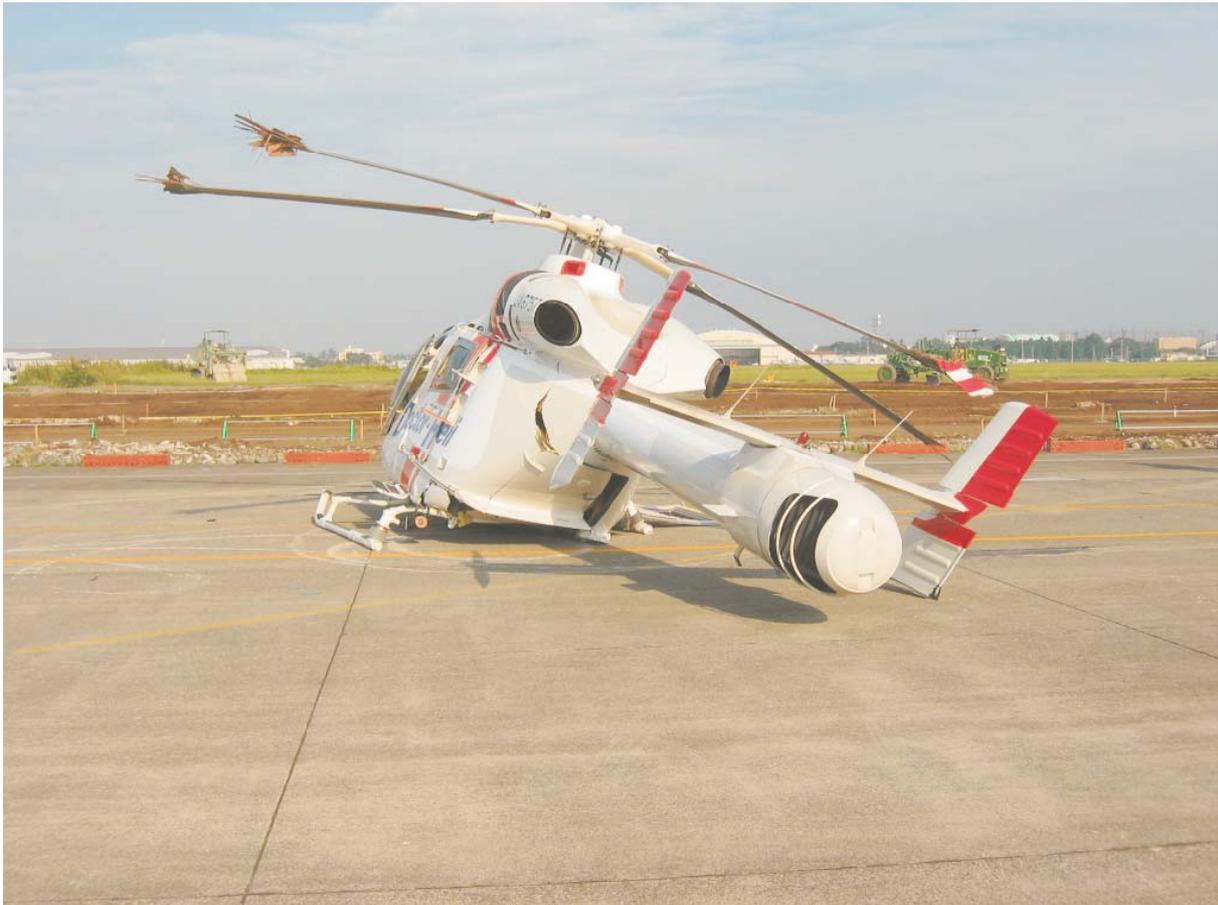
Picture 1 Accident helicopter

(1) Fuselage and tail boom	Damaged
(2) Skids	Damaged
(3) Main rotor blades	Damaged

(1) Fuselage: Its lower and right aft portion were damaged and cracks were found in upper fwd portion and tail boom attaching point. No fuel leak was found

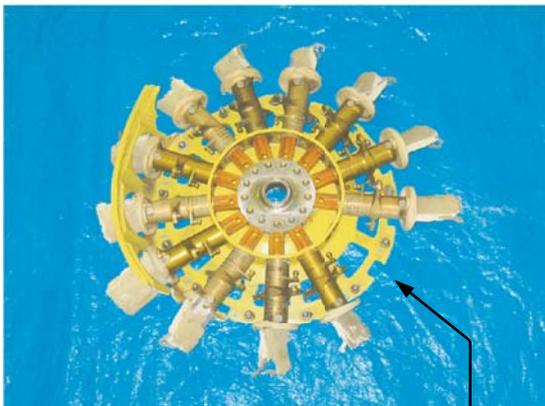
Picture 2 Damaged NOTAR fan

(5) NOTAR fan: Among 13 fan blade assemblies, one assembly was fractured and was found in the jet thruster section located at aft end of the tail boom. The T-T strap of the

assembly was fractured. Remaining fan blades were all damaged. (6) NOTAR fan drive shaft: It was fractured into three portions. The flexible coupling at the transmission side was broken and anti-flail device built in the coupling to be mentioned in 2.12.3, was detached. Driveshaft-side part of the broken flexible coupling had no scratch marks on it. (7) Fuel line: Fuel line to No.2 engine was fractured at frangible valve on the engine deck. No fuel leak from the fuel tanks was found. (See Figure 5, Pictures 2, 3 and 4)

Due to fracture of the T-T strap, one blade fan assembly was detached from the fan hub. Its blade was considered shattered into pieces and caused other blades to be shattered. The shattered pieces were considered trapped between rotating and non-rotating parts of fan assembly, causing a temporary seizure of the fan hub.

One blade assembly is missing due to fracture of the T-T strap

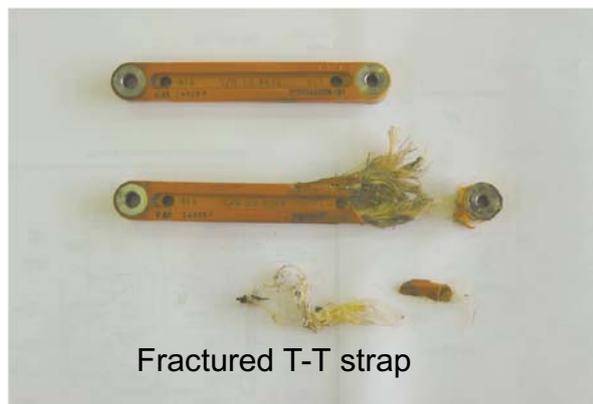
Picture 3 T-T strap

The fractured T-T strap's part number is 900R3442009-101 and serial number is LK0024. Its total time in service was 1,735 hours 31 minutes, with remaining service time of 764 hours 29 minutes.

Given the facts stated below, it is estimated that the T-T strap was fractured in the area where the composite material is closest to the edge of the spool as the result of the fatigue caused by the repetitive strains which gradually degraded the strap's integrity.

The probable cause of the rupture of a T-T strap is estimated that repetitive large compression and shear strain generated in the area where T-T strap composite material is closest to the edge of the spool, was not considered at the time of its design, lead to fatigue of the material from that area and degraded the strap's integrity.

(3) Take actions to inspect T-T straps for layered fiber fractures and for longitudinal cracks using X-ray radiograph, if fractures or cracks are found, to remove the strap from service.

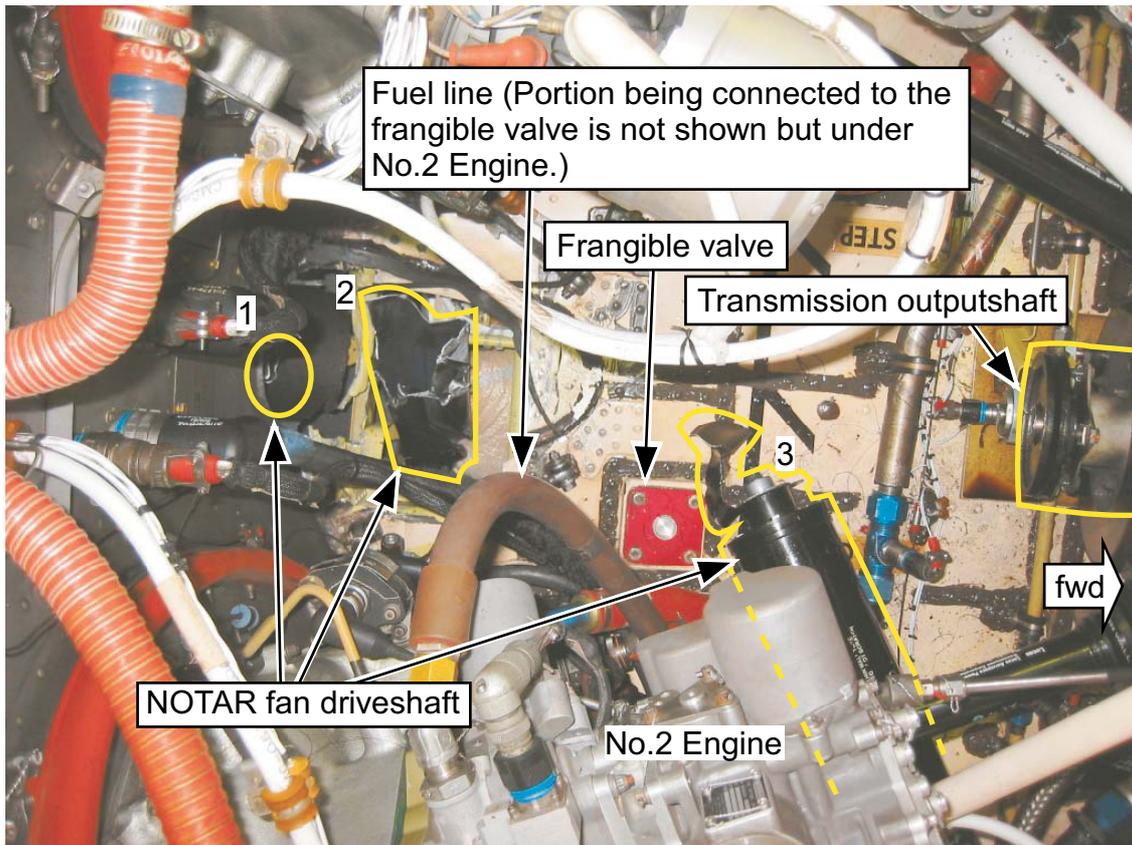
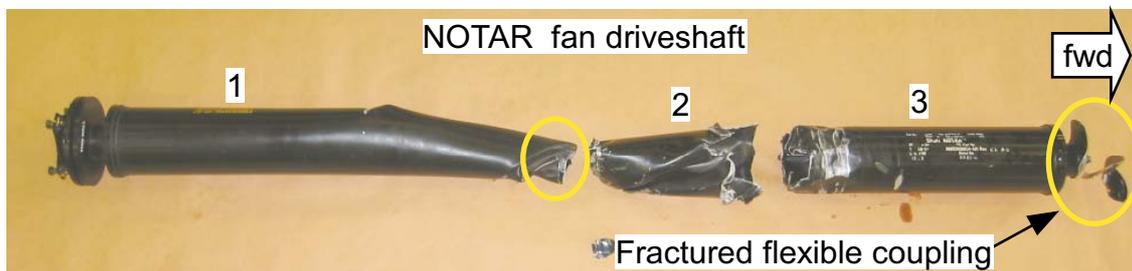
Picture 4 Engine deck

At this moment transmission-side flexible coupling was fractured and anti-flail device kept the driveshaft turning, however, it is estimated that the driveshaft, turning at very high rpm with rotating inertia was twisted and fractured at mid-length. Forward half of the driveshaft kept turning with its anti-flail device connected to the transmission, while its rear end wobbled and hit nearby parts. It is estimated that forward half of the driveshaft was fractured into two pieces during this sequence.

As stated in 3.4, it is considered that forward half of the driveshaft wobbled around and fractured the No.2 engine fuel line at the frangible valve while it was connected to the transmission with anti-flail device.

As a result No.2 engine was considered to have failed due to fuel starvation. No fuel leak occurred because the fuel line's built-in self-sealing mechanism worked properly.

NOTAR fan driveshaft was fractured into three parts, 1,2 and 3. Part 1's fwd portion (circled area) is observable in the upper photo.

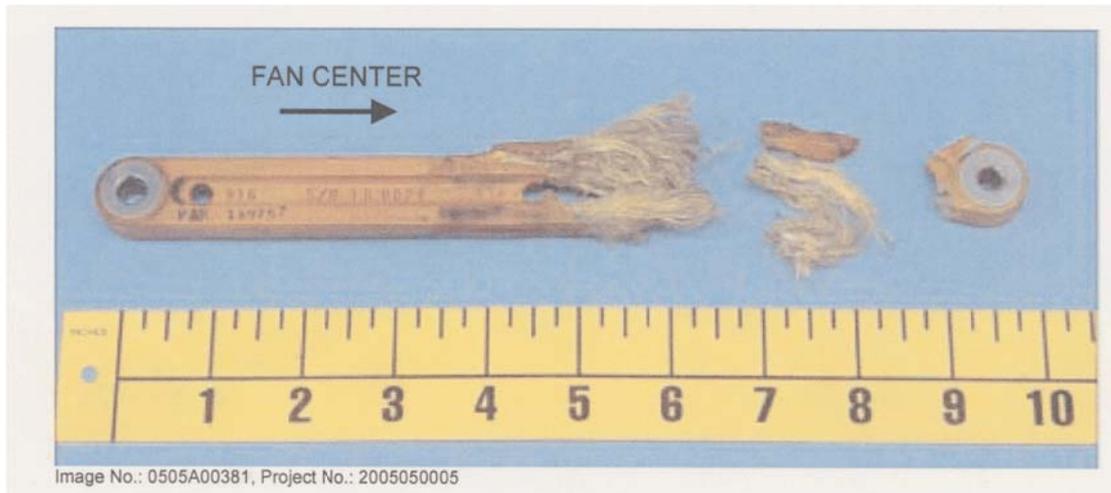
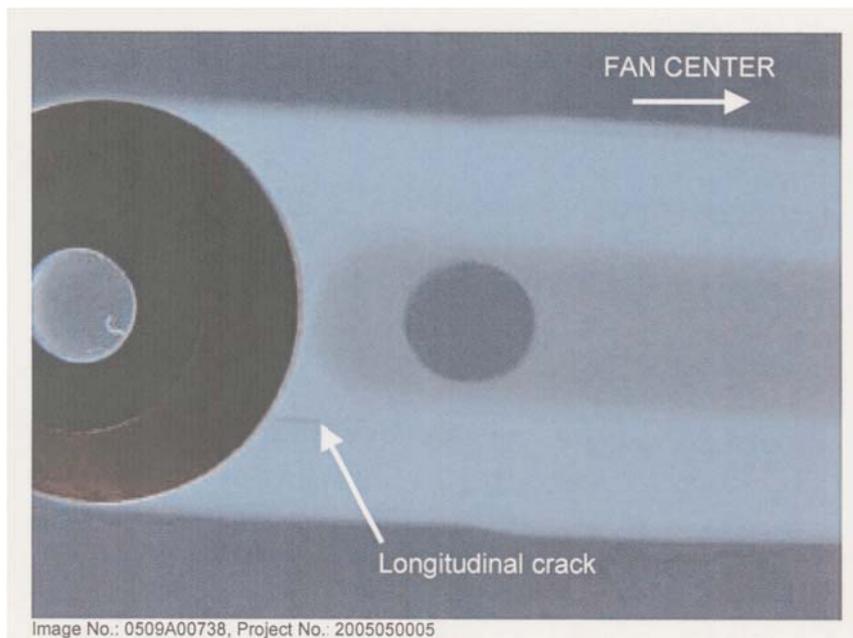
Picture A Fractured T-T strap

a. Examination of two fracture surfaces of the fractured T-T strap showed that there are three flat areas where a groups of fibers were cut at the same location, . Each flat fracture area is labeled “Area 1”, “Area 2”, and “Area 3” as shown in picture C. Area 1 and Area 2 are point symmetric about the longitudinal centerline of the strap. In the area being point symmetric to Area 3 shows no similar flat fracture area, however, some fibers were fractured there.

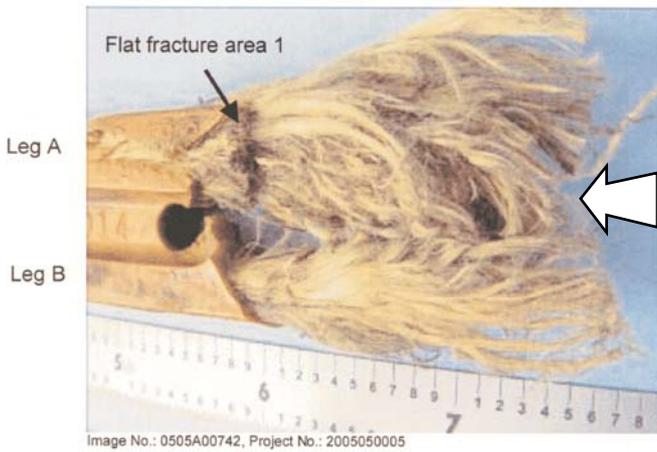
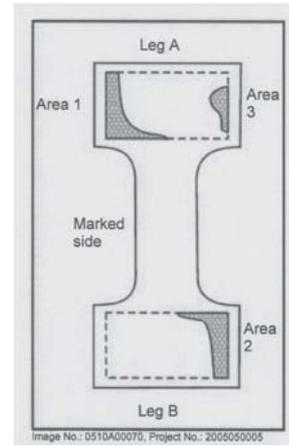
Picture B X-ray picture, fractured T-T strap

b. As stated in 2.11(3), radiograph analysis revealed shadows along longitudinal direction of strap and shadows perpendicular to this are estimated that they are the result of cracks and fractured or kinked fibers, respectively.

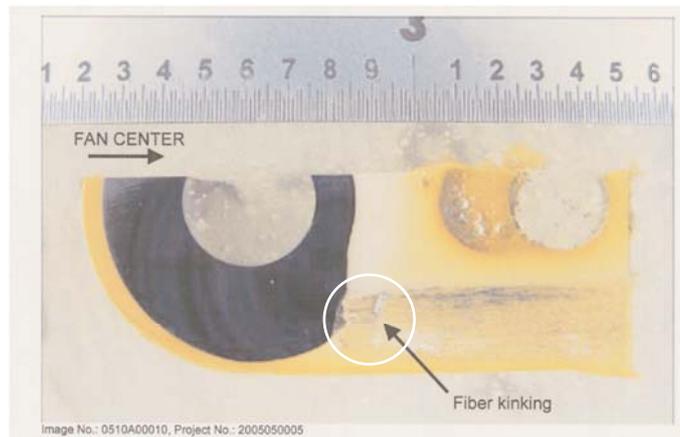
Picture C Closer view of the fractured fibers Schematic drawing of the strap fracture seen in the direction of arrow

a. As stated in 2.11(4), in the area where the composite material is closest to the edge of the spool, there exists a group of fractured fibers at the same position making a flat area, kinked fibers, and cracks.

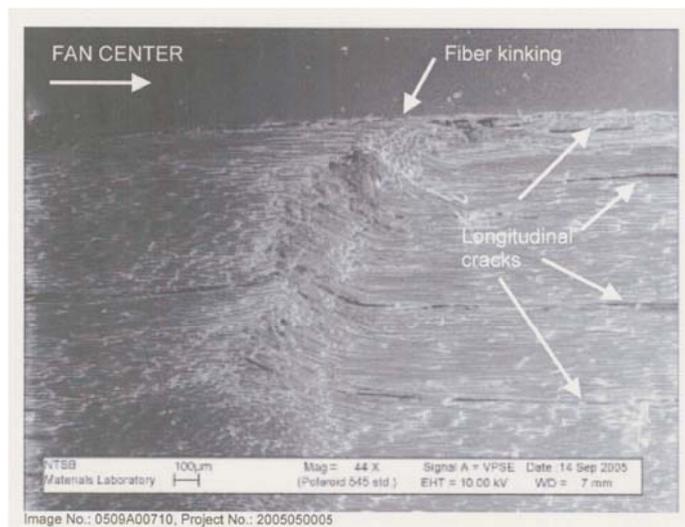
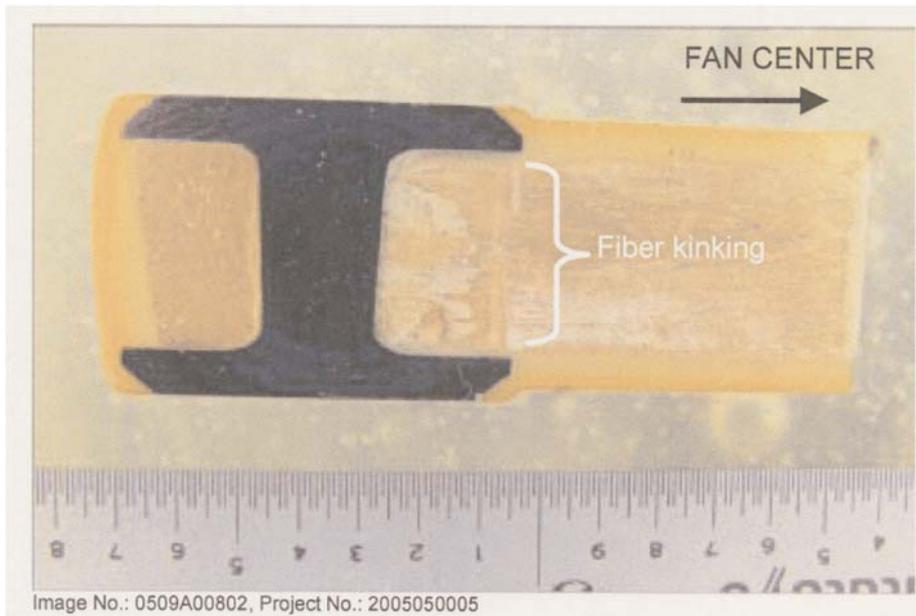
Picture D Cross section in a plane nearly perpendicular to the spool axis

In the piece sectioned perpendicular to the spool axis, fiber kinking⁵ was observed at the location corresponding to the location where the fibers closest to the spool hub intersected the edge of the spool flange. The fiber kinking was observed extending across most of the fiber-reinforced area. Several longitudinal cracks were also observed in the same region.

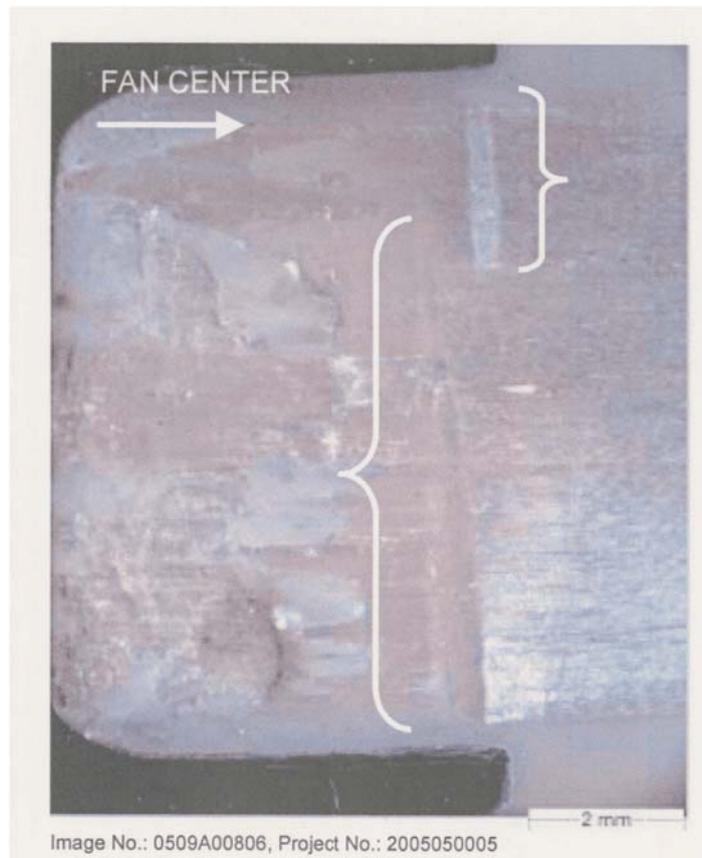
Picture F Cross section in a plane parallel to the spool axis

In the piece sectioned parallel to the spool axis, transverse fiber kinking was observed at the location corresponding to the location where the fibers are closest to the spool hub intersected the edge of the spool flange. (5)Finite element modeling of T-T strap
