**AIRCRAFT ACCIDENT  
INVESTIGATION REPORT**

**J A 6 7 9 6**

**Japan Transport Safety Board**

**JAPAN COAST GUARD  
BELL 412 EP (ROTORCRAFT), JA6796  
NEAR SANAGIJIMA, TADOTSU- CHO, NAKATADO- GUN,  
KAGAWA PREFECTURE, JAPAN  
AROUND 15:10 JST, AUGUST 18, 2010**

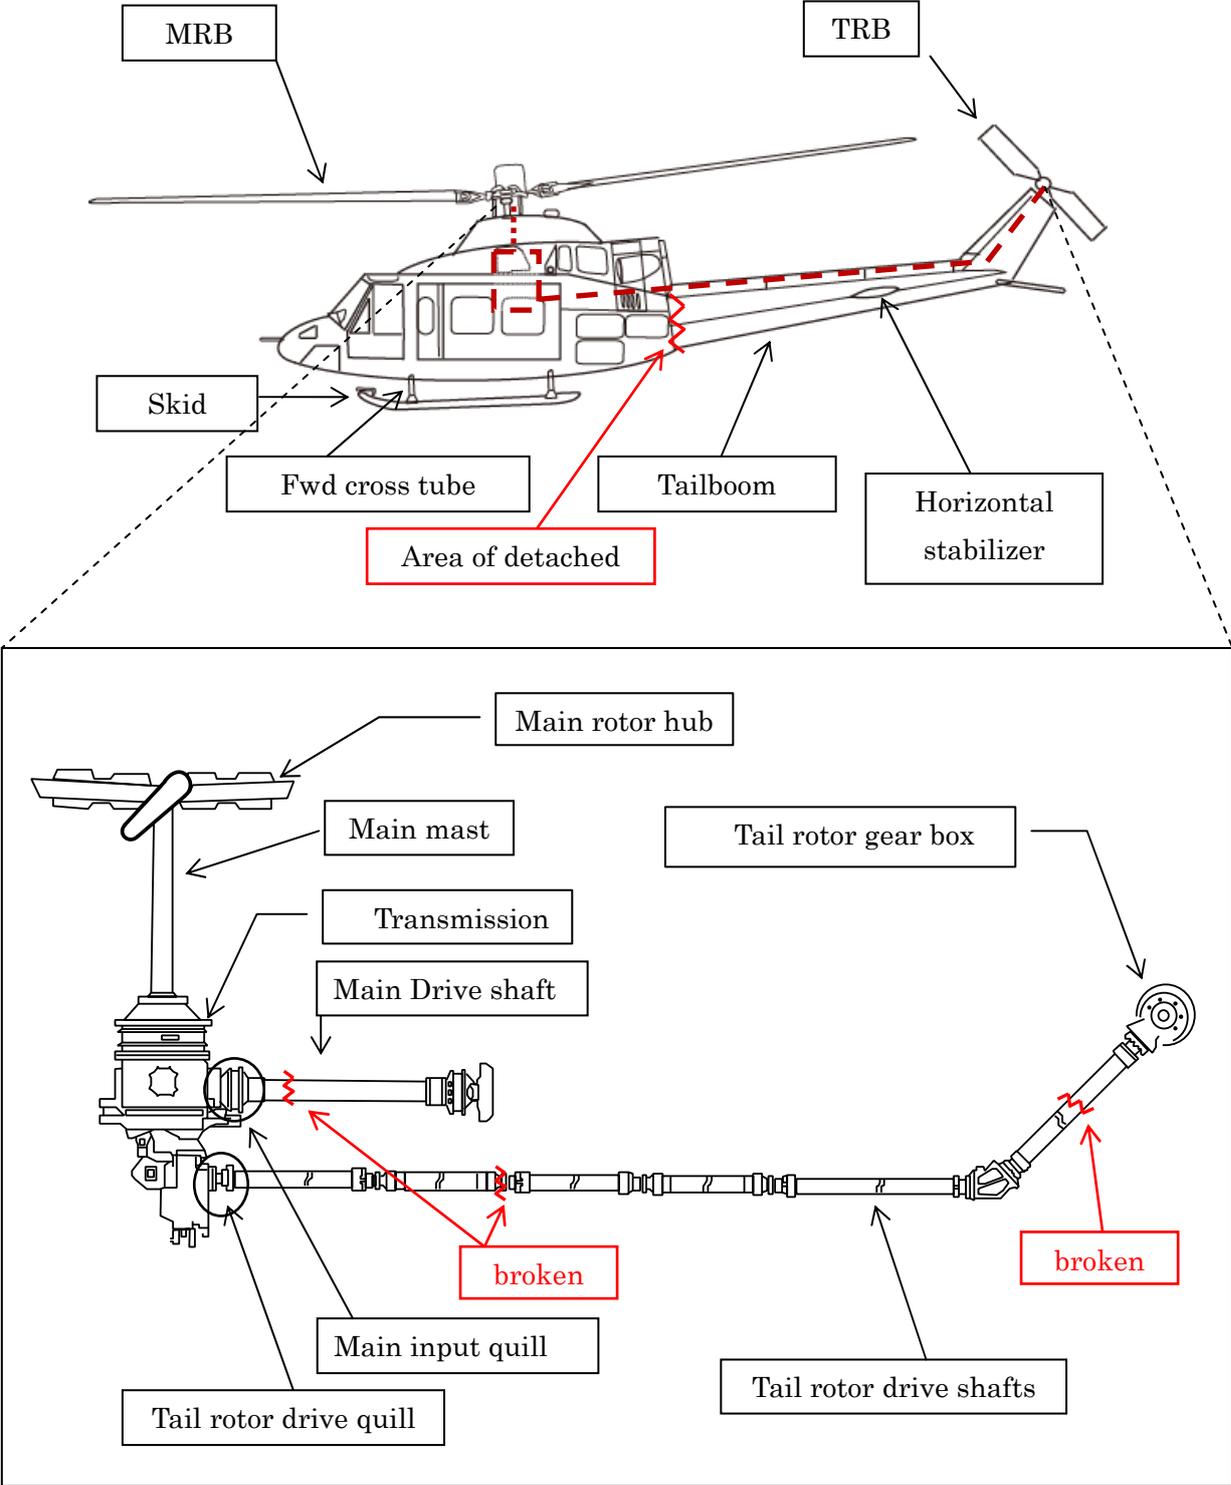
Figure 3 Damaged Area Schematic

The fuselage was severely damaged and none of the original form remained.

Forward and aft cross tubes were fractured from the airframe attaching points. A 35 cm long abrasion were found on the right side of the forward cross tube extending from the skid connecting point to the step. A part of the abrasion formed a groove of about 5 cm long by about 3 cm wide with a depth of 5 mm.

The green MRB<sup>\*9</sup> was damaged in an area about 3 m long on the trailing edge near the central part of the blade. Wrinkles were created at seven places on the leading edge. The leading edge had a cut about 3 cm wide and about 10 cm long at a place 50 cm from the tip. The leading edge of the yellow MRB was damaged in an area about 2 m wide from the tip exhibited broom-like looseness. The red MRB had wrinkles at six places on the leading edge while its trailing edge near the center had about 3 m-long fracture. The blue MRB had about 3 m-long fracture originating from the root.

The main drive shaft was found broken, as if being wrenched off, at the point about 50 cm from the input quill on the power line steel side.

The tail rotor drive system consists of six shafts. The second drive shaft was fractured at its coupling and sixth drive shaft was fractured, just like being wrenched off, near the central portion of the shaft.

The tail boom was found detached from the area where it is connected to the airframe. The vertical stabilizer and part of the right horizontal stabilizer had been broken.

Of the two TRBs, the red blade was broken around the middle section; however, there was no major damage to the white blade.

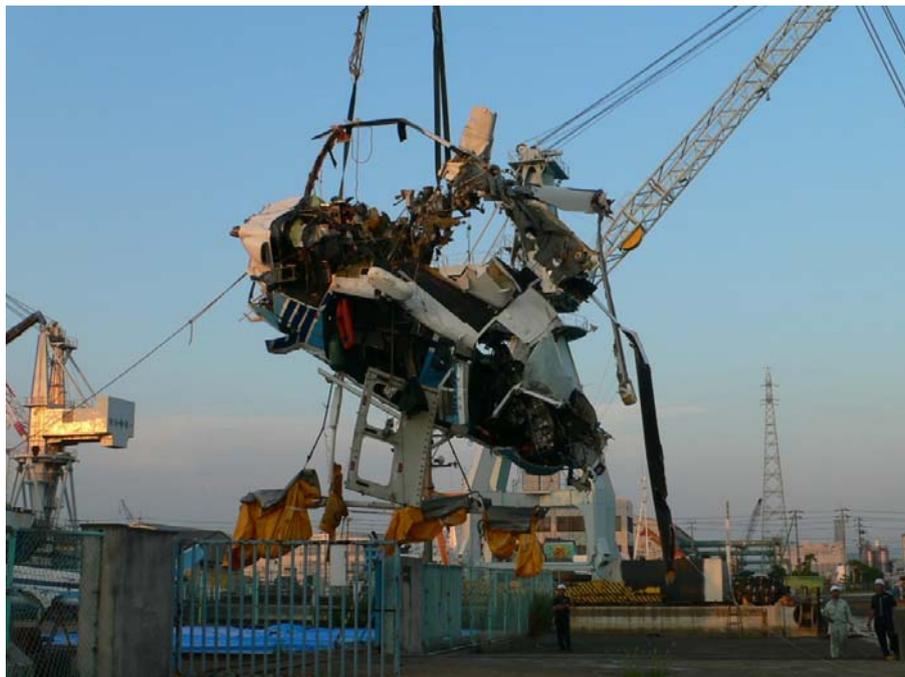
Photo 2 Accident Aircraft

Fuselage and cockpit:	Broken
Main rotor blades (hereinafter referred to as “MRBs”):	All of the four blades were found broken.
Engines:	Both No. 1 and No. 2 engines damaged
Tail boom:	Detached from the joint with the fuselage
Tail rotor blades (hereinafter referred to as “TRBs”):	Of the two blades, the red TRB* <sup>4</sup> was found fractured at a point about halfway.

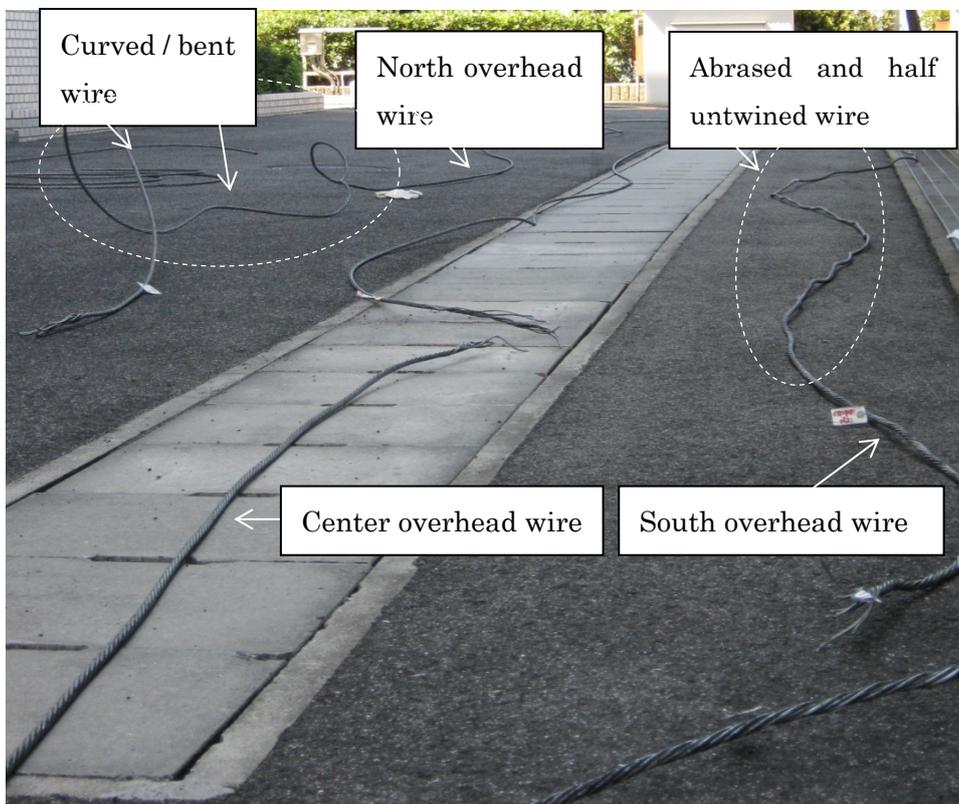
Photo 6 Severed and Deformed Sanagi Lines

Conspicuous bends, curves, traces of abrasion and deformation were found on each overhead wire in sections about 10 m long from the severed points toward Sanagijima Tower.

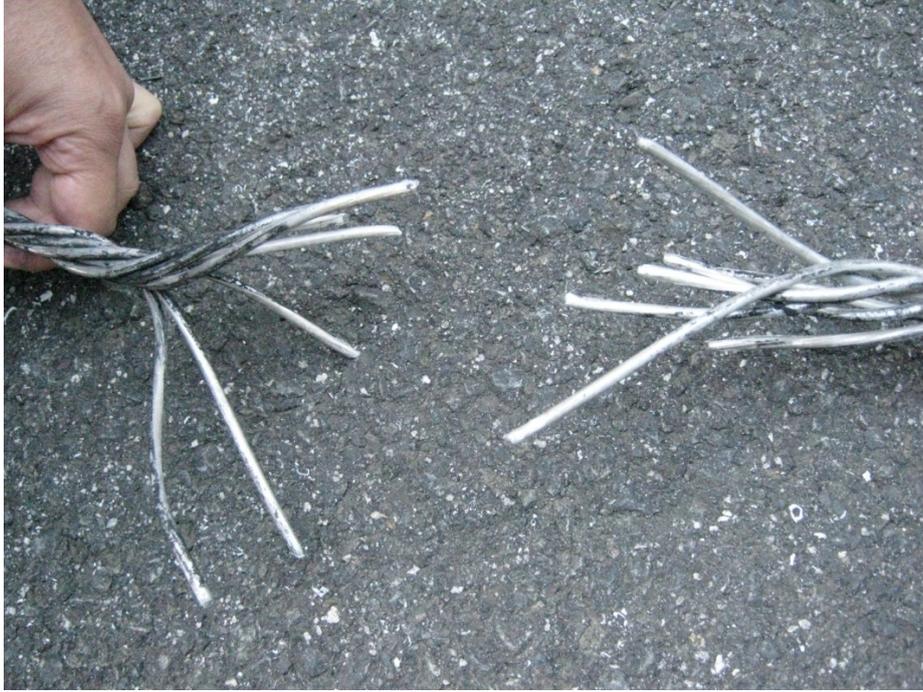
Photo 7 Severed Section of Sanagi Lines

Each overhead wire of the Sanagi Lines is seven-strand steel wire with an aluminum coating with a diameter of about 12.6 mm. The actually measured length\*<sup>8</sup> and the horizontal distance of each of the three overhead wires from the Oshima Tower to the points

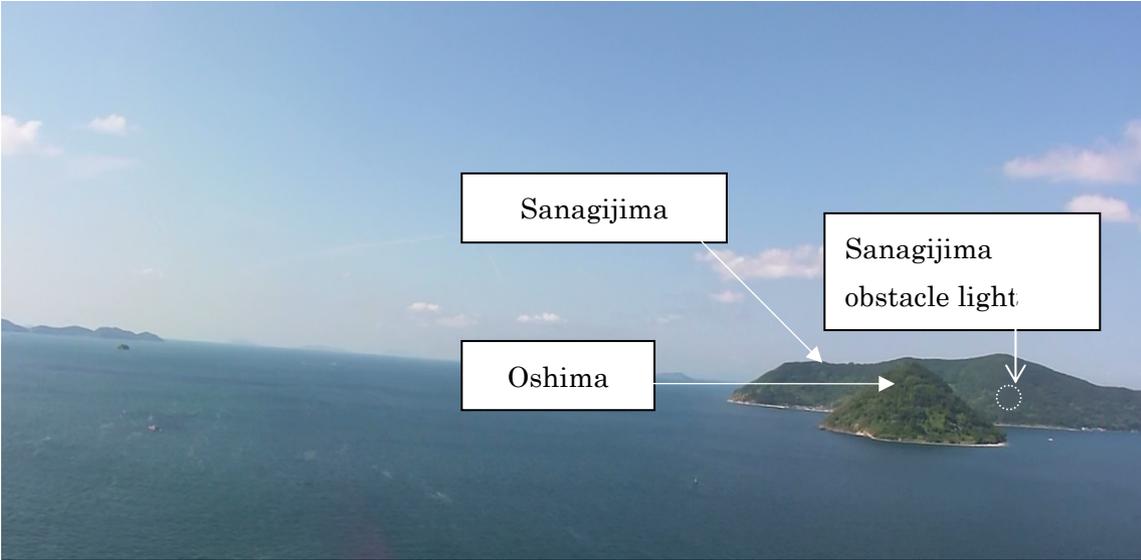
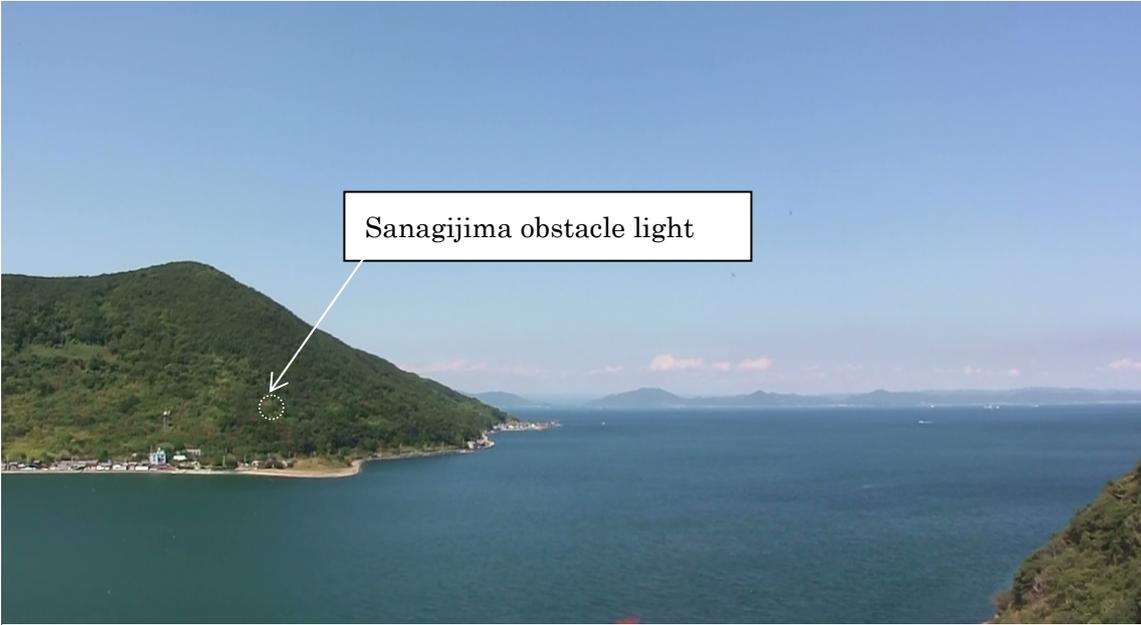
Photo 9 Discerning Sanagijima Obstacle Light

As a result of the visual detection test as described in 2.13 (3), the Sanagijima Obstacle Light could be visually detected in Zone 1, Zone 3, Zone 5 and Zone 7. In addition, as indicated by meteorological observations described in 2.7.2, there was no big difference between the meteorological conditions on the day of testing and those at the time of the accident, in terms of the wind direction, the wind velocity and other factors. Moreover, as described in 3.5, it is highly probable that the obstacle lights on Oshima and Sanagijima were normally functioning at the time of the accident. Based on the findings above, it is probable that the PIC and the Co-pilot could visually confirm Sanagijima Obstacle Light from the same zones as mentioned in the results of the visual detection test.

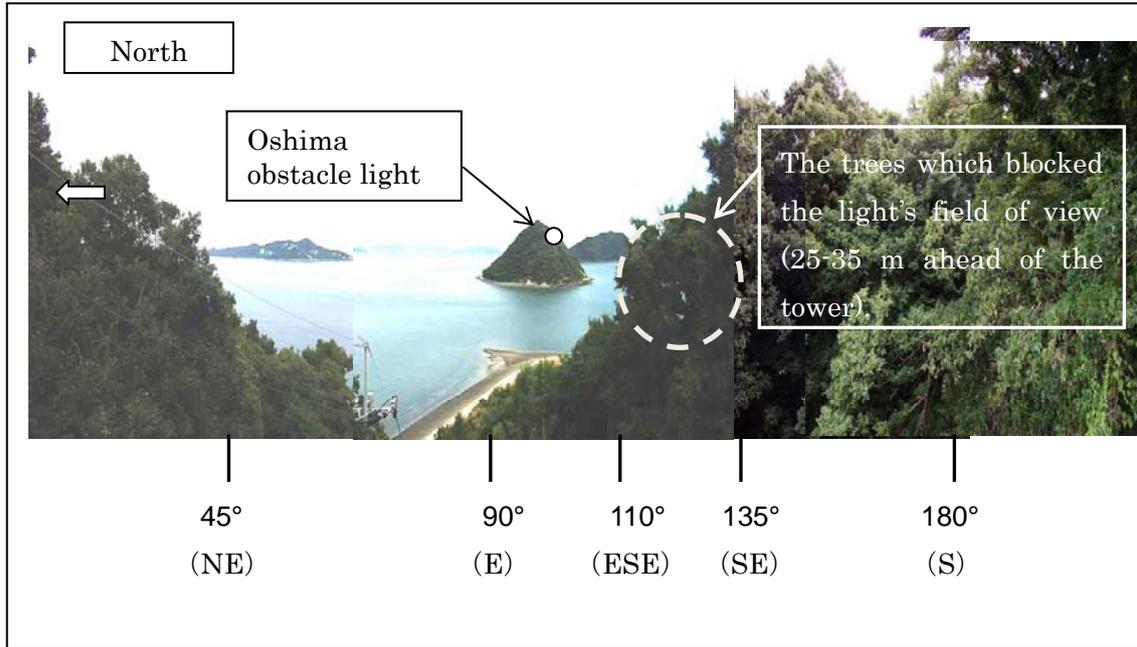
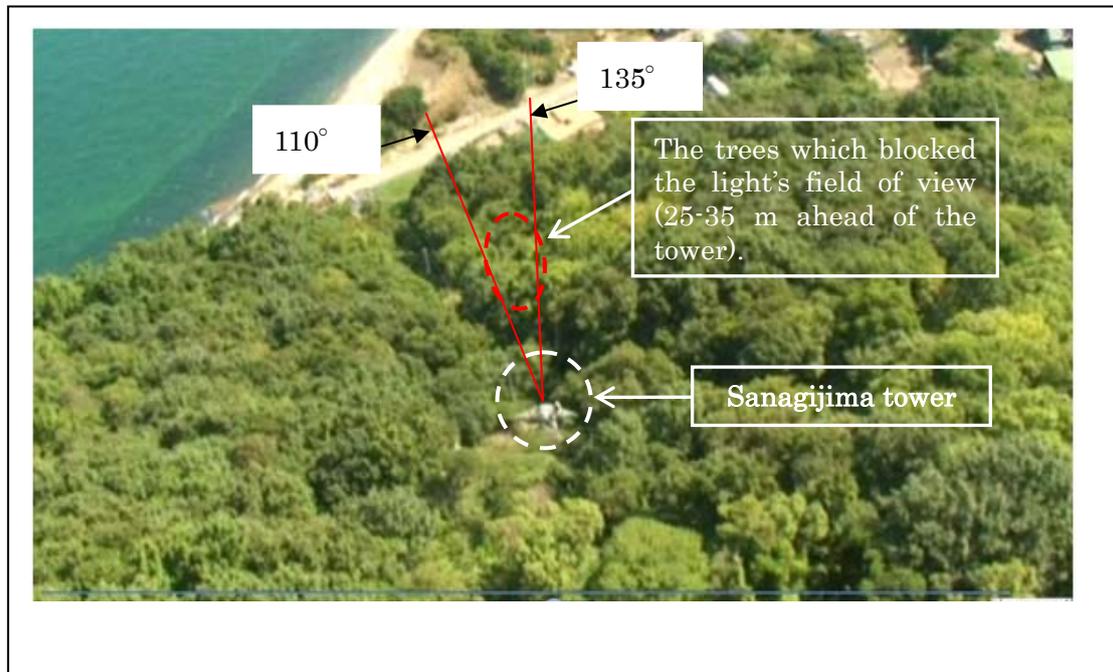
Photo 10 Blocked Field of View at Sanagijima Tower

The Electric Power Company explained that the cause for the field of view problem has been removed because the trees responsible for hampering the field of view of the obstacle lights on Oshima and Sanagijima have been cut down for recurrence prevention in November 2 and 3, 2010. The Electric Power Company intends to take enforced individual management of obstacle lights.
