**AIRCRAFT ACCIDENT
INVESTIGATION REPORT**

November 30, 2017

**AERO ASAHI CORPORATION
KAWASAKI BK117C-2 (ROTORCRAFT)
JA6917
DAMAGE TO THE AIRCRAFT DUE TO HARD LANDING
TEMPORARY HELIPAD
HADANO CITY, KANAGAWA PREFECTURE, JAPAN
AT AROUND 14:04 JST, AUGUST 8, 2016**

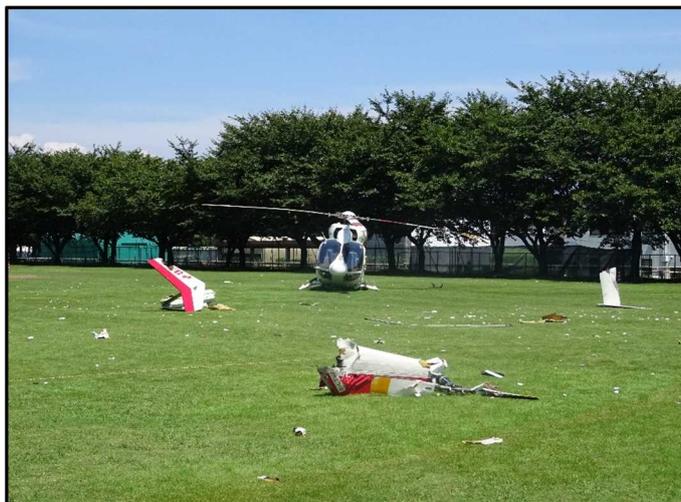
Photo 1 the Accident Rotorcraft

Extent of damage; Destroyed

- (1) Tail Boom; Broken off at the joint with fuselage
- (2) Tail Fin; Broken
- (3) Main Rotor; Damaged
- (4) Tail Rotor; Broken
- (5) Skid; Buckling

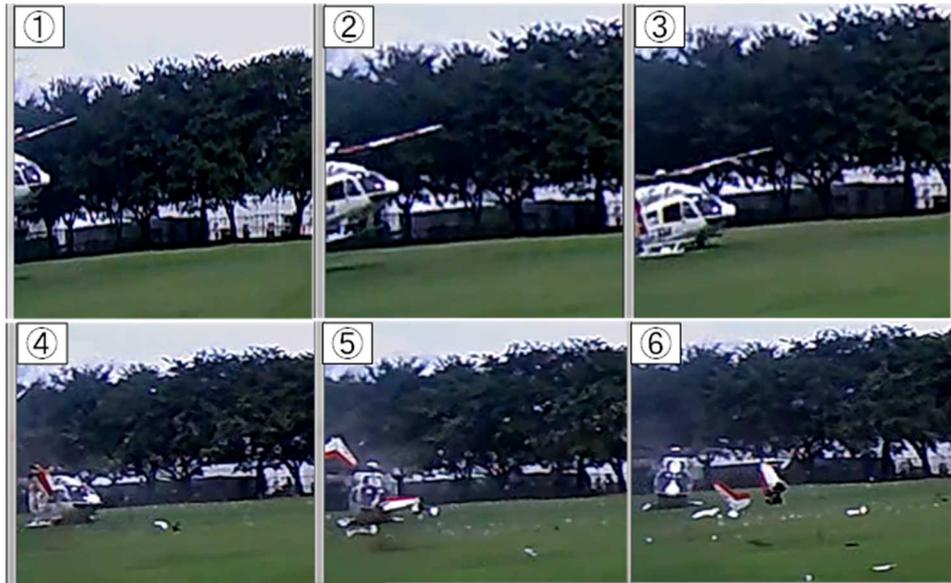
Photo 2 Situation at the time of Hard Landing

Normally, a ground effect due to approaching the ground prior to touchdown, a flare effect due to deceleration and increases in lift by pulling CP up could decrease descent rate to enable the transition to hovering, but because this case lead up to the hard landing without transiting to hover, it is somewhat likely that the rotorcraft fell into VRS where even though increasing the lift in the main rotor, the descent rate still increased.

It is probable that regarding why the rotorcraft resulted in the hard landing, based on these, because the rotorcraft did not use the approach path which is set at the temporary helipad, flew over the steel tower near the temporary helipad of the destination, commenced the approach with a rather large approach angle and decreased the forward airspeed in order to transit to hover, the main rotor of the rotorcraft fell into VRS and even though the pilot pulled up CP, it could not gain the corresponding lift.

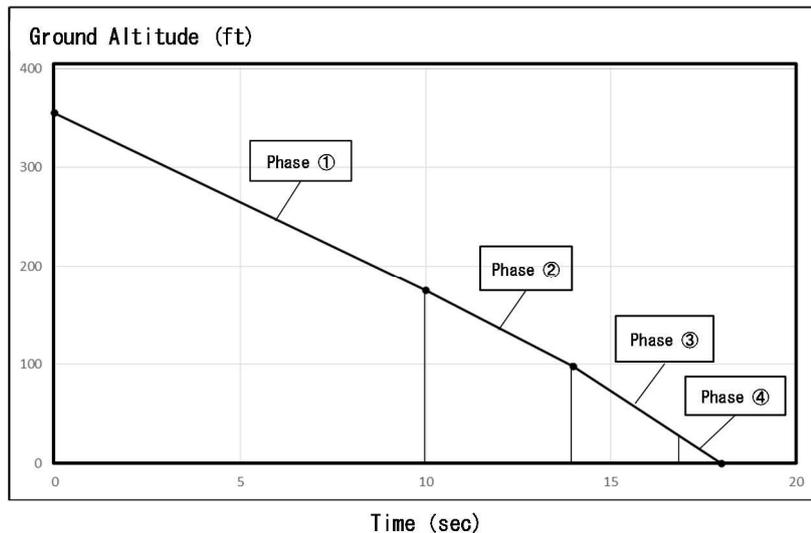
Figure 2 Changes in altitude after commencing the approach

Based on the video records and data of GPS mounted on the rotorcraft, dividing the approach angle of the rotorcraft from the time to start the approach till the landing into four phases named ① to ④, the table 1 shows Average Ground Speed, Average Descent Rate, Ground Altitude and Approach Angle for each phase and Figure 2 shows the change in altitude as a graph. Also, phases from ① to ③ are based on GPS data, and phase ④ is based on the video records.

Regarding the increase of descent rate of the rotorcraft from phase ① to phase ③, because the pilot was piloting as watching the landing target point

and he did not see a vertical speed indicator, it is somewhat likely that he did not notice an increase in the descent rate.

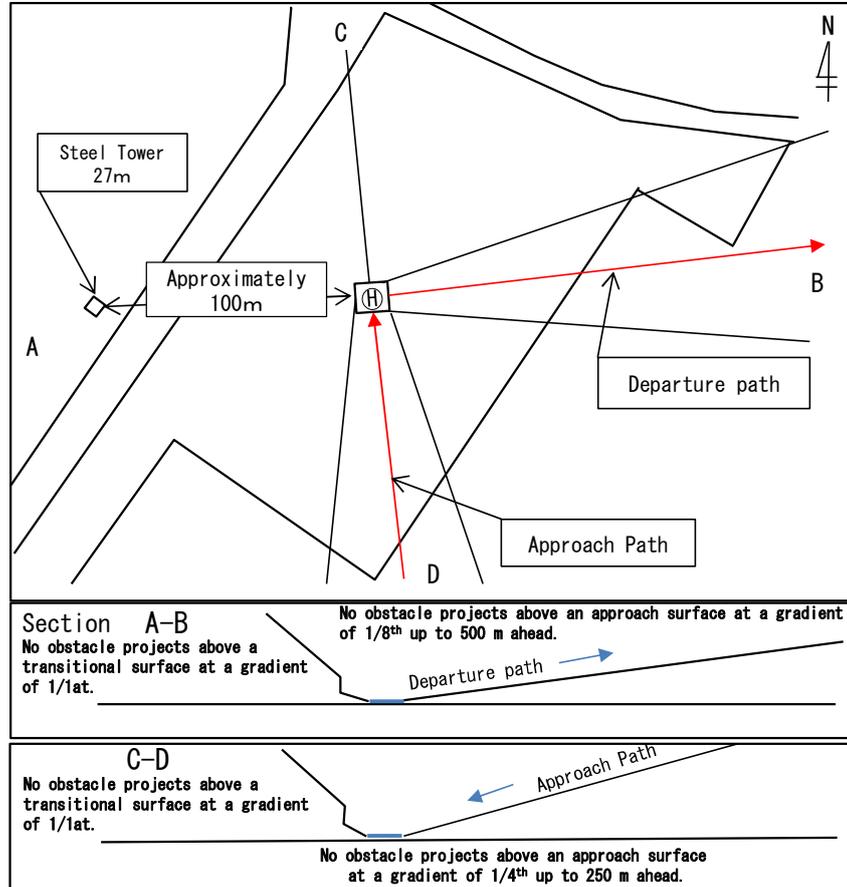
Figure 5 Approach/Departure path at the Temporary Helipad

The temporary helipad is previously set place as a most appropriate temporary helipad for an emergency medical care by the company, and was confirmed that the helipad complied with the standards based on the Operation manual guidelines of the company, however, there was no approach area or approach surface set at the west side of the temporary

helipad for the landing direction where the rotorcraft approached at the time of accident. (Figure 5)

There was a 27 m high steel tower located at about 100 m from the temporary helipad below the approaching path of the rotorcraft. (Figure 5)
