**AIRCRAFT ACCIDENT  
INVESTIGATION REPORT**

**JAPAN AIRLINES CO., LTD.**

**J A 7 0 1 J**

DAMAGE DUE TO TAILSTRIKE DURING GO-AROUND  
JAPAN AIRLINES CO., LTD.  
BOEING 777-200, JA701J  
ON RUNWAY 34L OF TOKYO INTERNATIONAL AIRPORT, JAPAN  
AT ABOUT 16:08 JST, MARCH 31, 2012

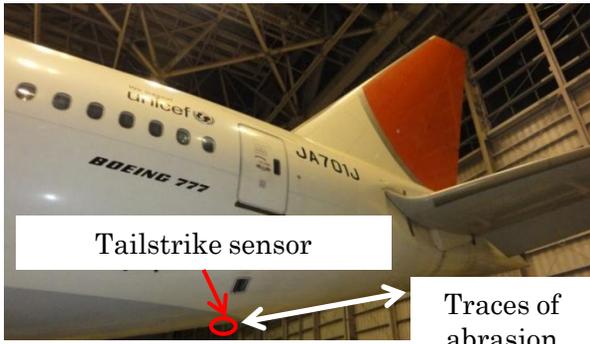
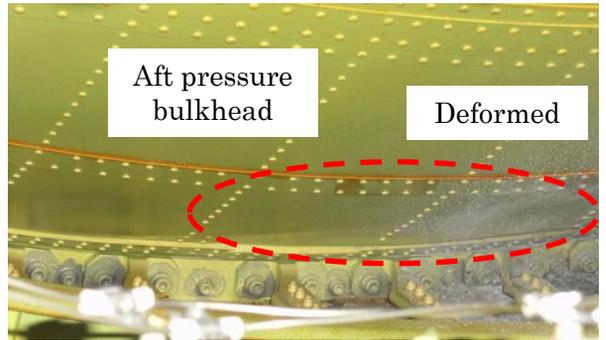
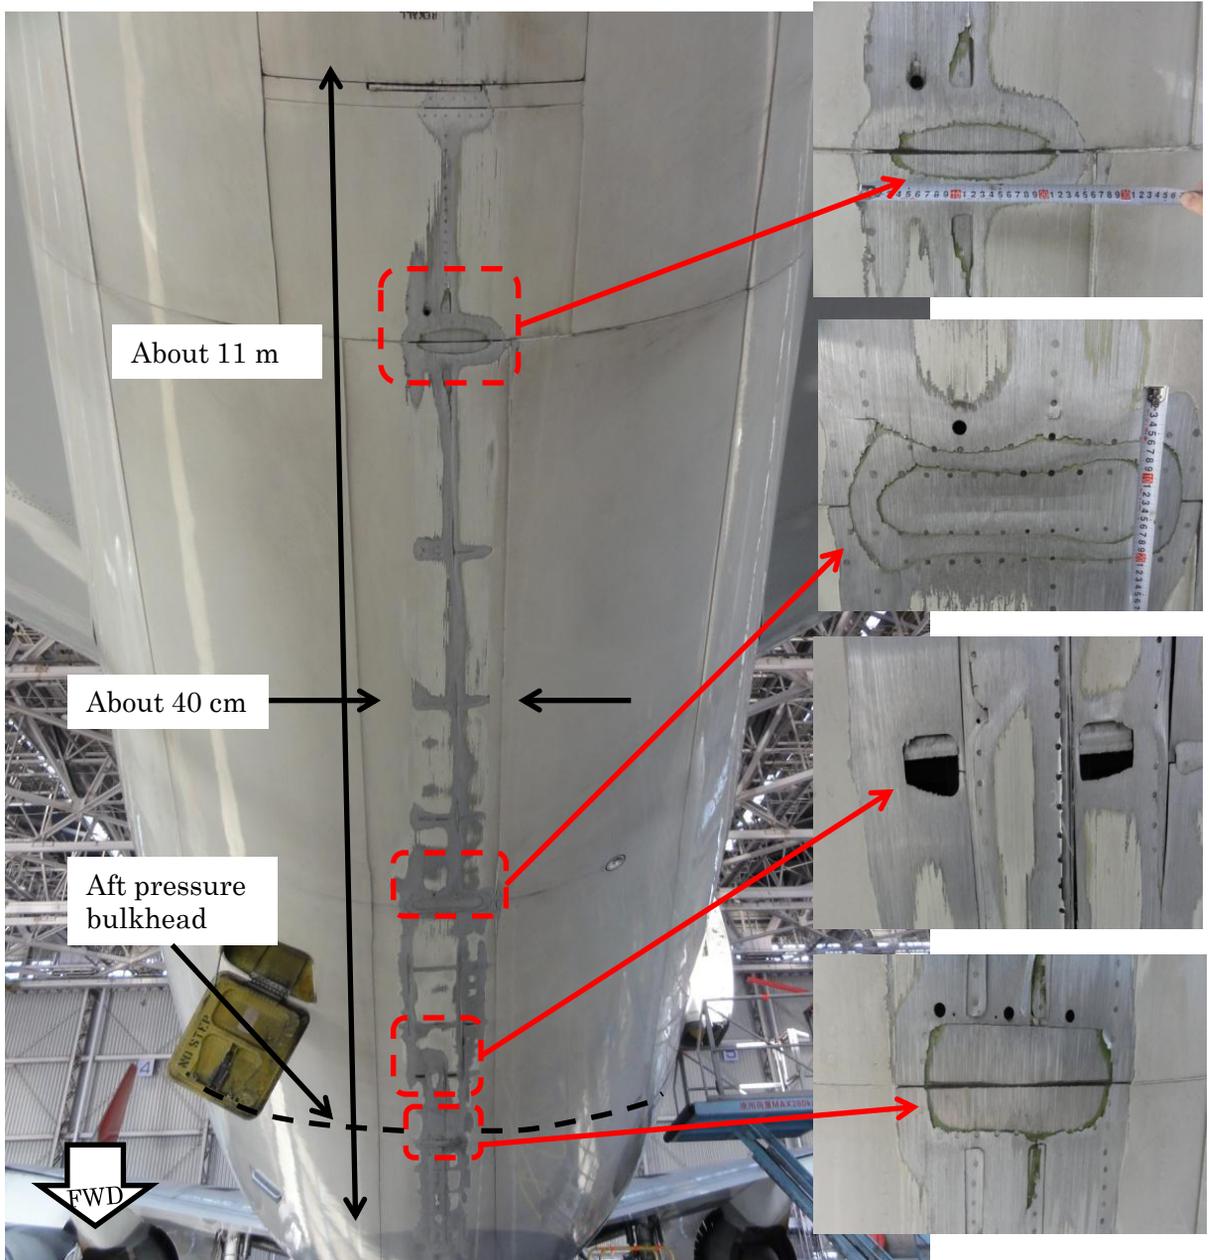
# Photo: Damage to the Fuselage

On the external skin for the lower part of the aft fuselage, there was an abrasion of about 11 m in length and about 40 cm in width, with holes and cracks. The frame within this area was exposed and damaged. Tail strike sensors had been stripped off. And the lower part of the aft pressure bulkhead was slightly deformed.
