**AIRCRAFT SERIOUS INCIDENT  
INVESTIGATION REPORT**

**SKYNET ASIA AIRWAYS CO., LTD.**

**BOEING 737-400, JA737D**

**FEBRUARY 24, 2005**

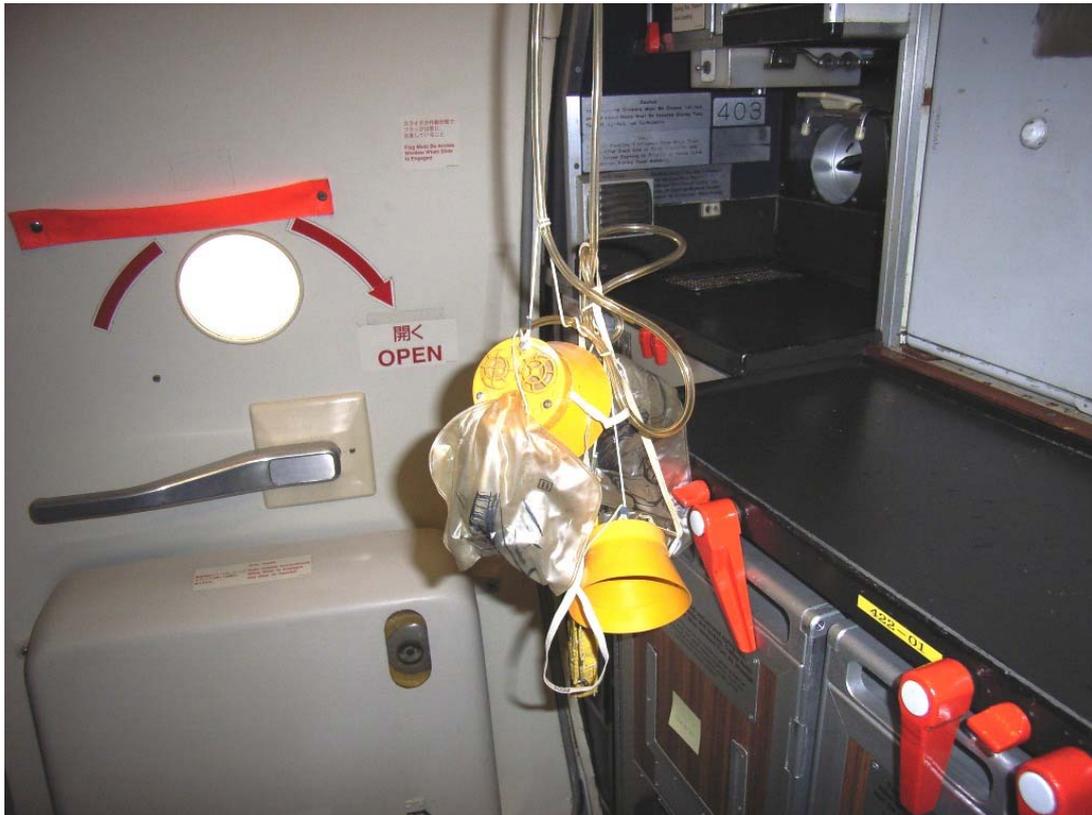
3.11 As 2.1.2 (3), the C Area Attendant stated that, during the emergency descent, she tried to put on an oxygen mask that had deployed right in front of her but because the cord of the mask was entangled with the cord of another mask, she was prevented from wearing it. Not being able to quickly put on an oxygen mask in an immediate emergency could have the risk of hypoxia.

Photo 1 Intertwined two Oxygen Masks

- (1) The cabin oxygen masks including those for the cabin crew were rechecked for automatic deployment function and stowage, on all aircraft that the company operates.
- (2) The Cabin Crew Manager issued a company notice to all cabin crewmembers on the correct method for distinguishing hypoxia and hyperventilation. The contents of the notice were added to the EMERGENCY HANDBOOK.
- (3) The Flight Operations Manager notified all cockpit crewmembers of the serious incident and the company reviewed the relevant procedures for necessary amendments.

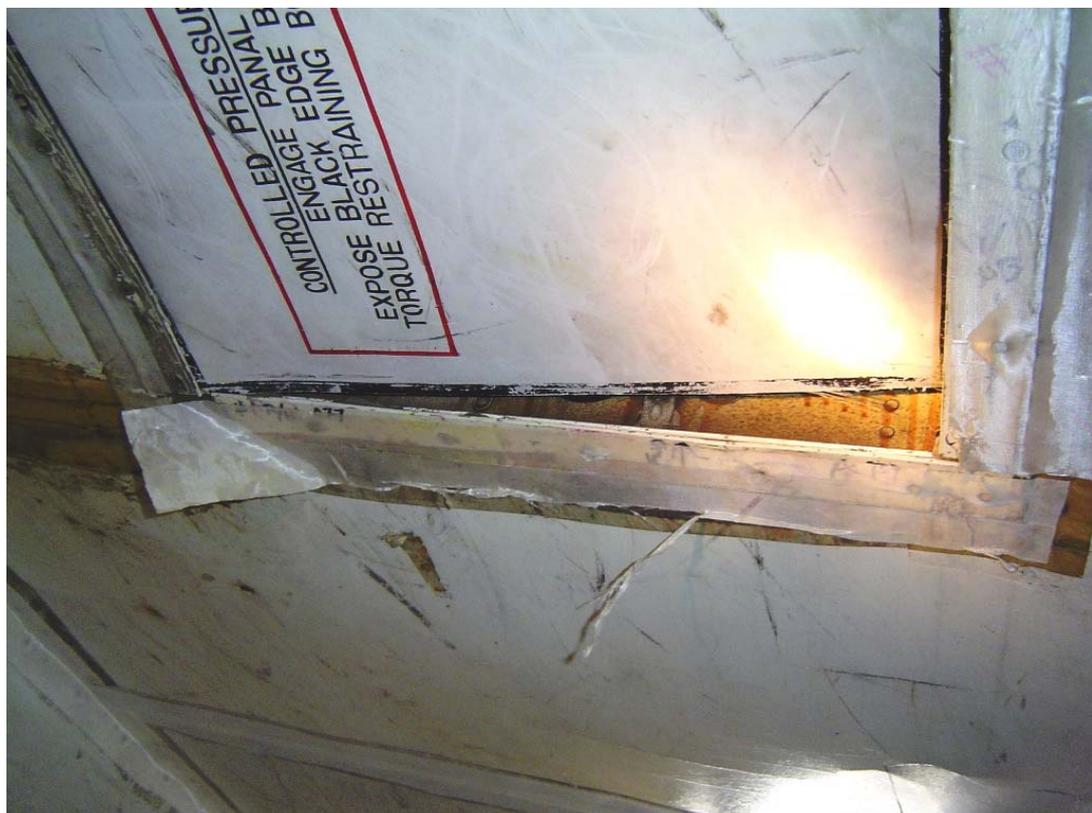
Of the two blowout panels located in the ceiling of the aft cargo compartment (see Section 2.11.2), the forward panel was found to be slightly open.

- (4) As discussed in 2.3, after the aircraft arrived at Miyazaki Airport, the forward one of the two blowout panels located in the ceiling of the aft cargo compartment was found to be slightly open.

Photo 2 Unclosed Forward Blowout Panel

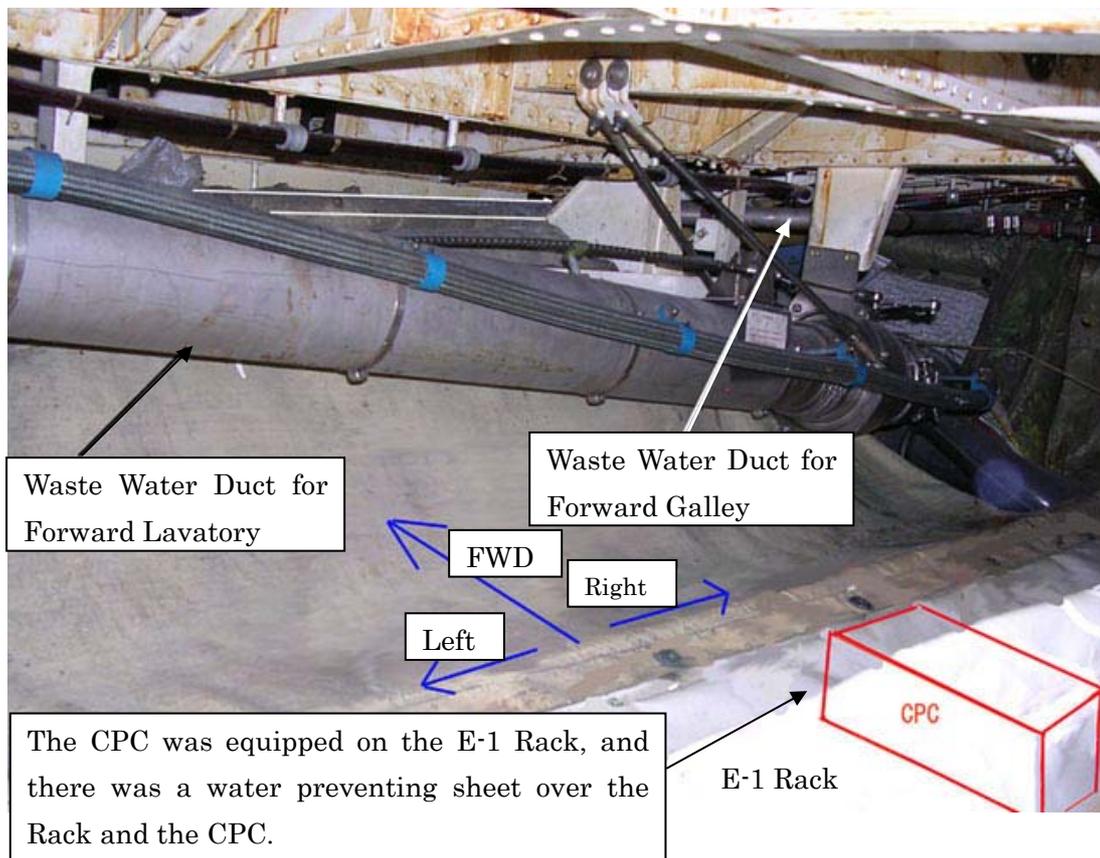
Photo 4 The circumference of the upper part of CPC

The waterproof sheet provided between the pipes and the top of the E-1 rack on which the CPC was installed in such a way that it would have prevented water from leaking into the CPC even if the piping had been leaky.

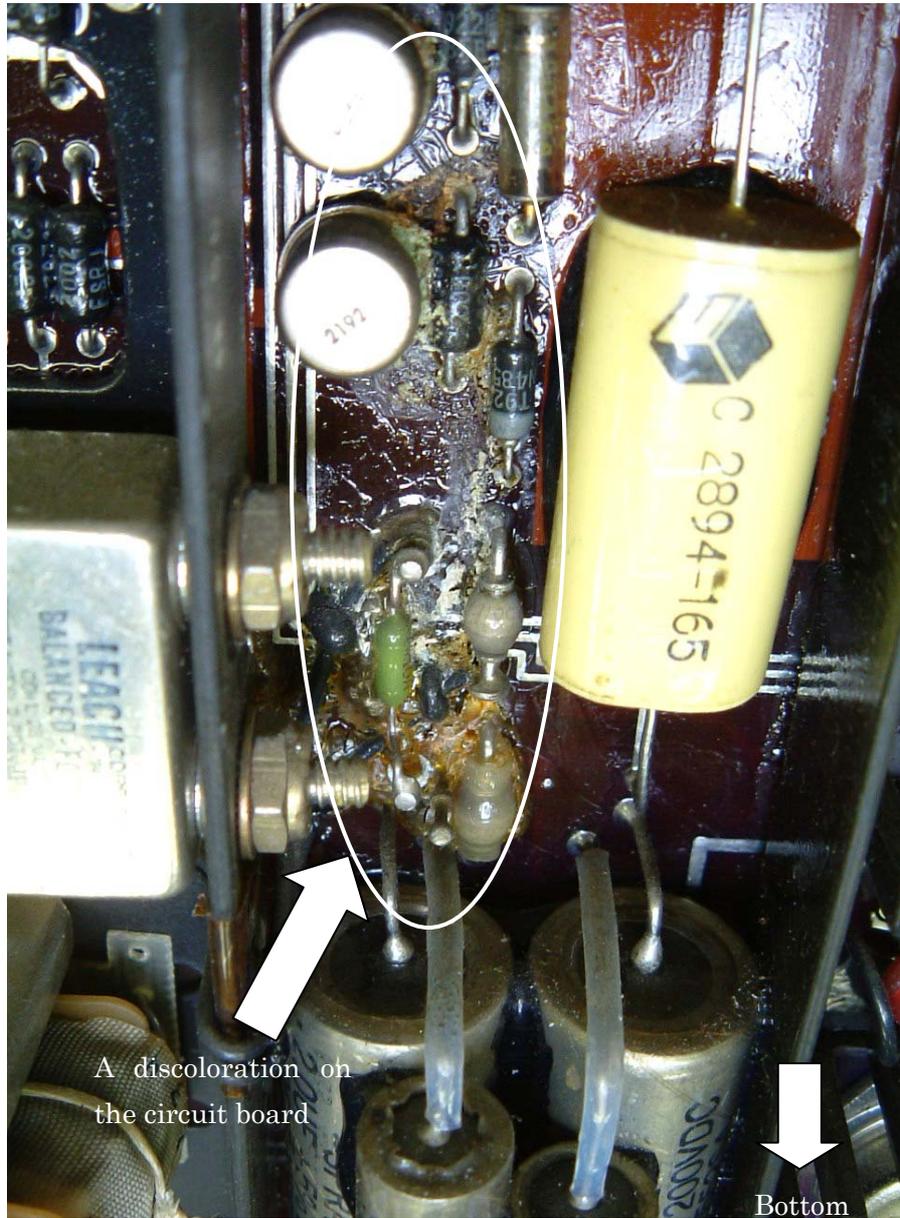
In the discolored portion of the CPC circuit board mentioned in Section 2.10.3 above, there existed a contamination that would have leaked onto it from outside and dried there. The deposit consisted primarily of the following components: nickel, tin, potassium, calcium, sulfur, chlorine, sodium, magnesium, copper, zinc, carbon, and oxygen.

- (2) From what is mentioned in (1) above, it is considered possible that the contamination on the circuit board was drops of wastewater that leaked from the forward lavatory piping and dripped onto the CPC, then fell onto the circuit board through a CPC air vent and contaminated this vent. However, because there was no evidence of water leakage from the piping in the aircraft or in other aircraft of the same type that the company operates, and because a waterproof sheet was installed between the piping and the CPC as revealed by the inspection discussed in 2.10.5, it is considered likely that the contamination was not formed after the company started using the aircraft.

- (3) For the reasons enumerated below, it is considered possible that wastewater, which was part of the small amount of wastewater that had dripped onto the CPC case, made its way onto the circuit board and dried there during the time that the aircraft was operated by the previous operator and the CPC was transferred to another aircraft that had a similar forward lavatory layout; subsequently, the dried wastewater gradually corroded the circuit board.

While it was not possible to establish the cause of the sudden excessive opening of the cabin pressurization outflow valve, it is considered possible that the contamination deposit on a circuit board of the cabin pressurization system deteriorated the board over time to the extent that it caused the electrical circuitry to malfunction.

Photo 5 Contamination of Circuit Board
