**AIRCRAFT SERIOUS INCIDENT
INVESTIGATION REPORT**

**JAPAN AIRLINES CO., LTD.
J A 8 2 9 9**

BOEING 767-300, JA8299

ATTEMPTED LANDING ON RUNWAY

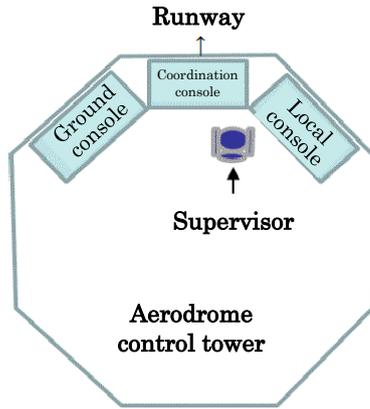
Figure 1 Seated position (image)

After this, the Supervisor placed a chair near the middle with the local console and the coordination console, and sat facing toward the runway at the front. (See Figure 1)

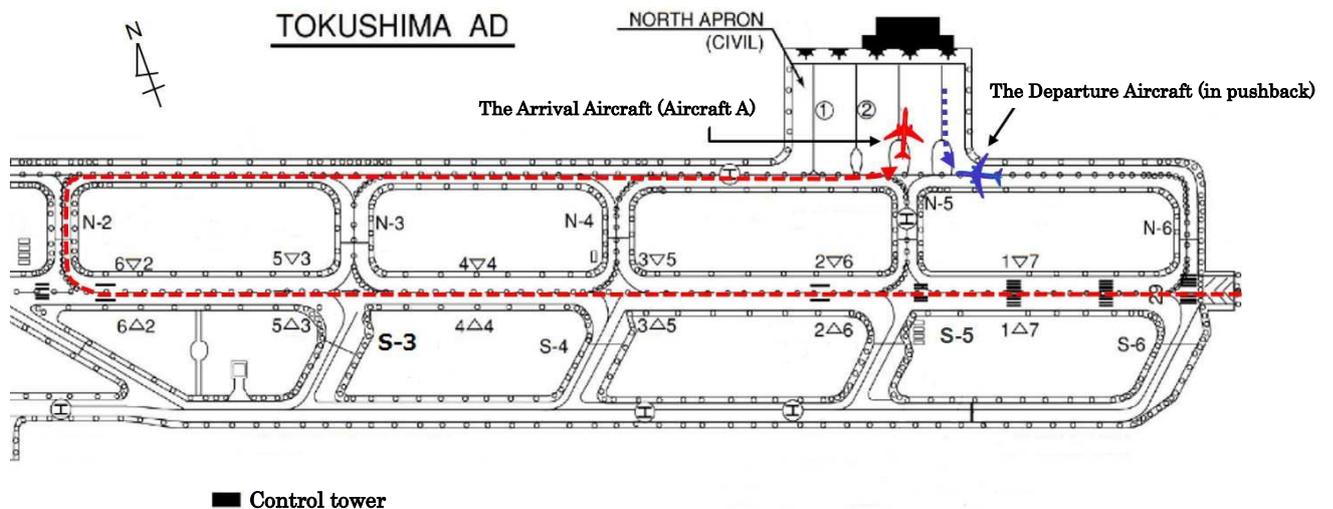
Figure 2 Image of positional relationship between the Departure Aircraft from Runway 11 and the Arrival Aircraft to Runway 29

Visibility was poor to the east, the direction of approach of Aircraft A, and the Supervisor first saw Aircraft A when it was around 3 nm from the runway. From this point on, the Supervisor focused attention on the two aircraft while imagining a sequence whereby the Arrival Aircraft would enter Spot No.3 while the Departure Aircraft was pushed back and holding on the taxiway, after which the Departure Aircraft would taxi and take off. (See Figure 2)

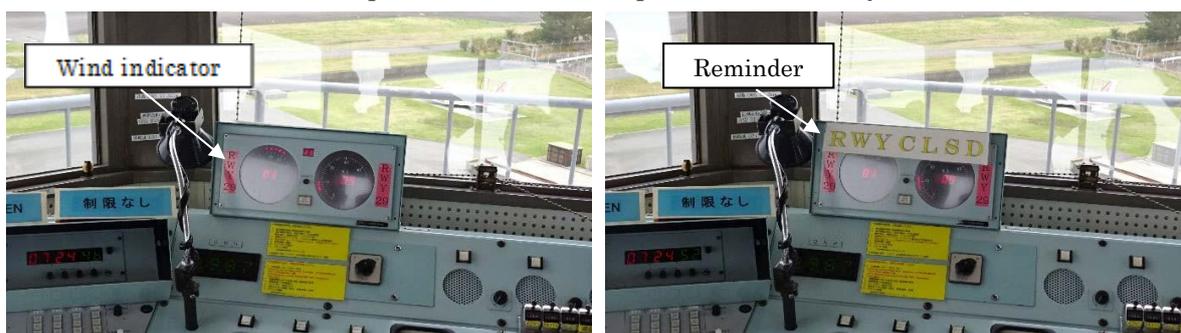
Photo 3 Situation of the reminder in use

In the control tower of Aerodrome, the method of hanging a sign marked “RWY CLSD” (meaning that the runway was closed) over part of the display on the wind indicator installed on the Tower and the Ground control consoles was adopted, as a reminder to raise attention in situations when the runway could not be cleared for take-offs and landings due to runway closed or other reasons. If the reminder is used, the sign can be expected to be noticed when checking the wind direction and velocity, which are provided at the same time, thereby preventing the issuance of the clearance of take-offs and landings on the runway when it closed or otherwise cannot be used, even if the Tower mistakenly intends to issue the clearance for take-offs and landings. Although the use of this reminder has not been stipulated, it had been practiced routinely since around 2007.

It is somewhat likely that the fact that the Supervisor did not to use the reminder contributed to his failure to notice the presence of the Work Vehicle, either before or after giving landing clearance to Aircraft A. It is probable that he did not use the reminder because, as described in 2.1.3, he judged that he could cope with the situation by memory alone since it was a day when the air traffic volume was light, but it is probable that the reminder would have been effective precisely in this kind of occurrence when there was only one person in the control tower.

5) It is probable that the fact that the Supervisor did not use the reminder contributed to his failure to notice the presence of the Work Vehicle at the point of issuing landing clearance to Aircraft A. (3.6.5)

As well as enforcing the use of the reminder by having air traffic controllers understand the importance of the reminder based on runway incursion incidents occurred at other airports, stipulating and circulating rules on the use of the reminder, and carrying out spot inspections, it also increased the size of the reminder and improved their visibility.
- (3) Elimination of unsafe elements involving work in the aerodrome
 - 1) Restrictions on work in the aerodrome

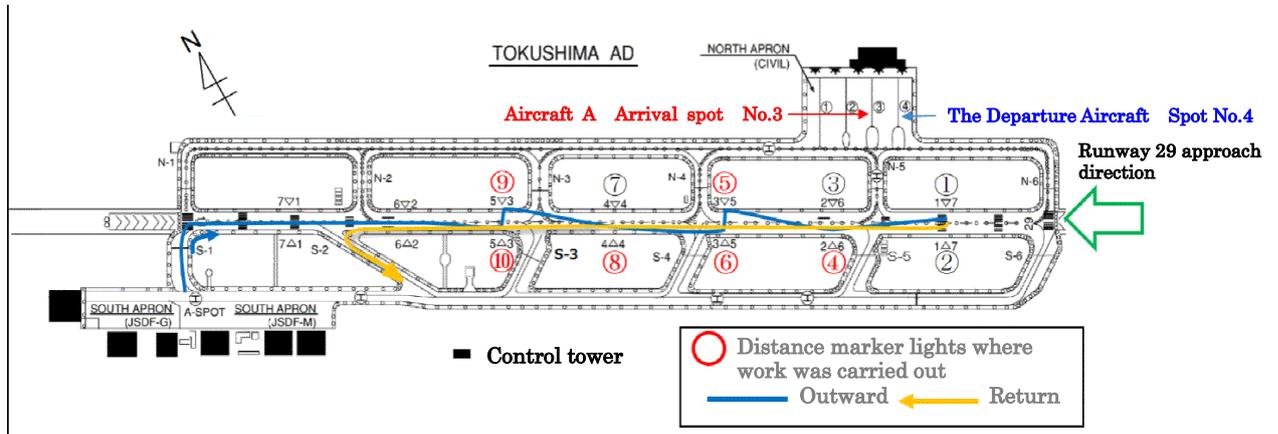
Figure 3 Work locations and route travelled by the Work Vehicle

Of the 14 runway distance marker lights located along the side of the Aerodrome runway, the locations of bulb replacement work by the Worker when the serious incident occurred were positions of ⑩, ⑨, ⑧, ⑥, ⑤ and ④, shown in red in Figure 3. The time needed to change the bulbs was about one to two minutes in each location, and during the work, the Worker stopped the

vehicle at the edge of the runway near the runway distance marker lights. Also, after finishing the work at ④, he moved the vehicle to a point between ① and ② to confirm that their lights were working, inspected them by sight from inside with the vehicle running, and then he turned in order to leave the runway and drove along the runway. Until he noticed Aircraft A, he was moving at a speed of 40-50 km/h, including when moving between work locations. (According to the Airfield Regulations, the speed limit for vehicles on the runway was 60 km/h, except in emergencies and other similar cases.)

As described in 2.11.3, it is highly probable that, the Worker undertook the work of replacing bulbs in the runway distance marker lights without reporting to the Tower that he was moving among the work locations and that he had added the two bulb replacement work locations ⑤ and ⑧, which were not originally scheduled.

It is highly probable that the Worker, after receiving permission to enter the runway, undertook the work of replacing bulbs in the runway distance marker lights without reporting to the Tower that he had added bulb replacement work in locations that were not originally scheduled. (3.5.1)
