**AIRCRAFT ACCIDENT
INVESTIGATION REPORT**

AIR NIPPON CO., LTD.

J A 8 3 8 4

AIR NIPPON CO., LTD.
AIRBUS INDUSTRY A320-200, JA8384
DAMAGE DUE TO TAILSTRIKE
ON THE RUNWAY 27 OF SENDAI AIRPORT, JAPAN
AT ABOUT 09:03 JST, FEBRUARY 5, 2012

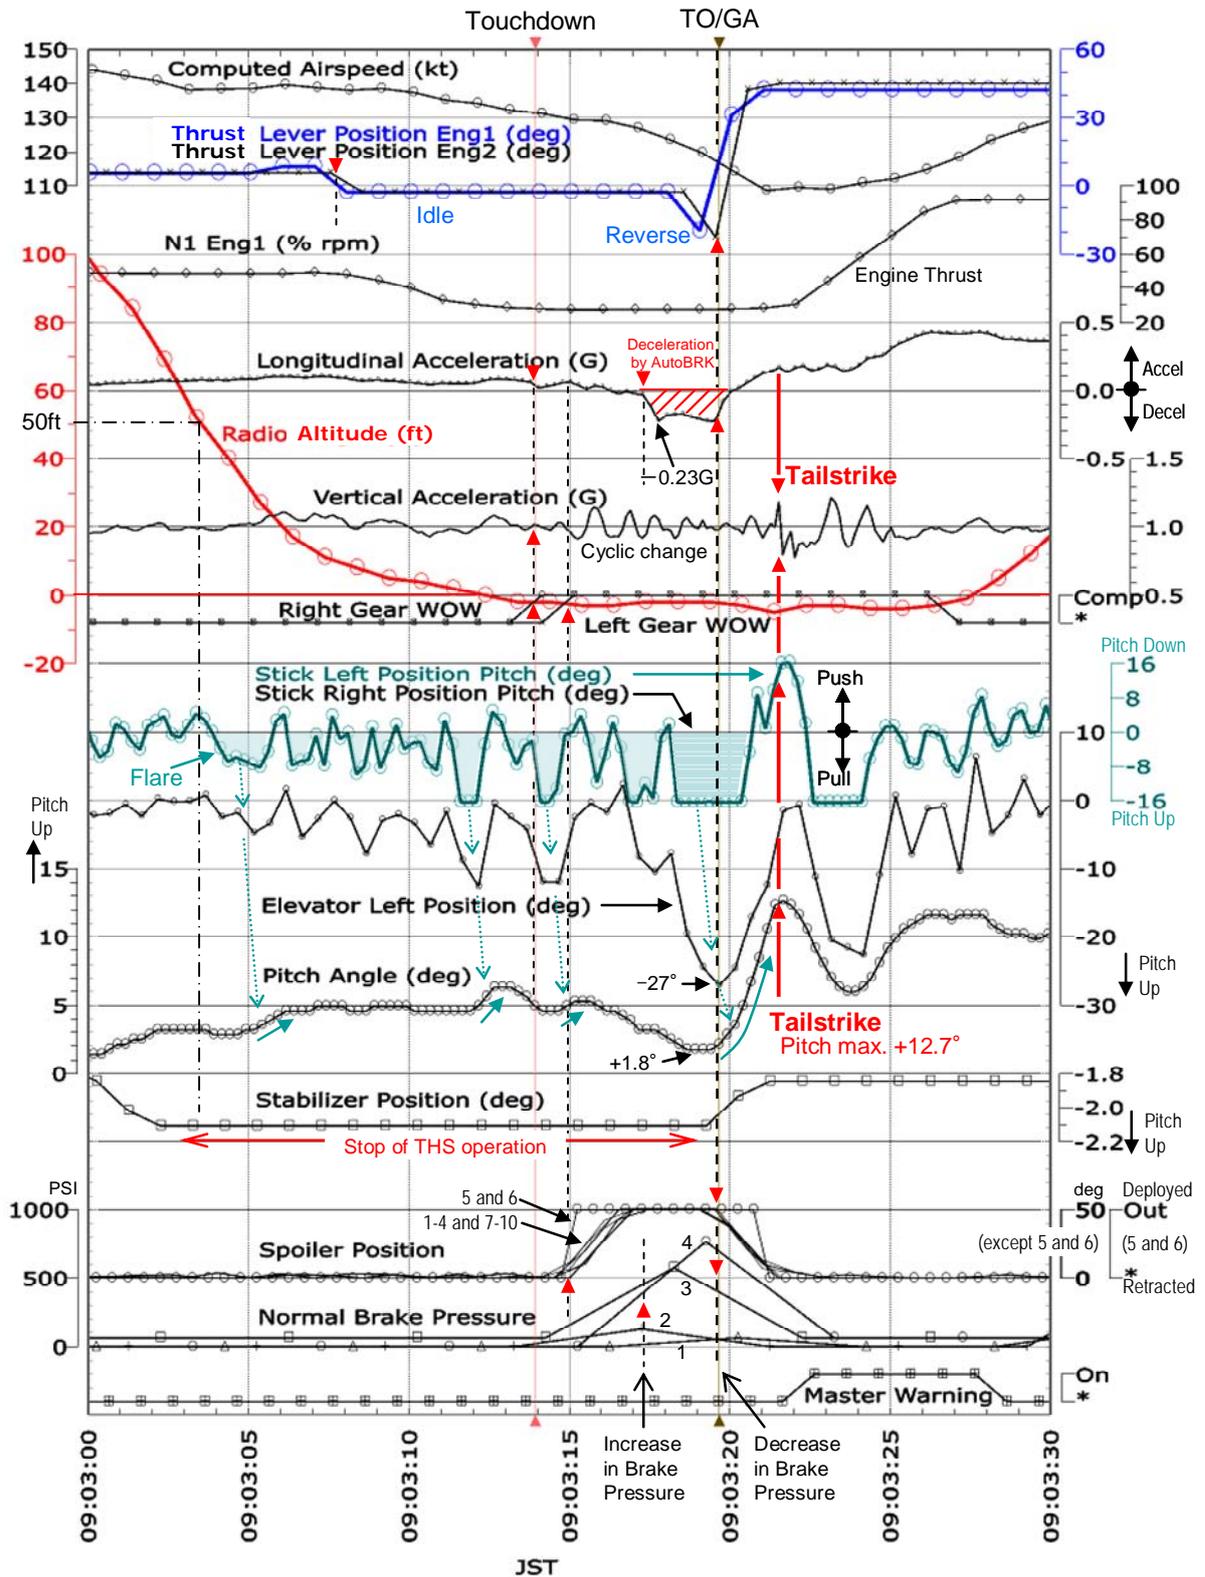
Figure C : DFDR Records

- 9:02:47 The auto thrust (A/T) was disengaged.
- 9:03:00 The automatic voice called out (hereinafter referred to as “Auto Callout”), “One hundred (100 ft RA).”
- 9:03:02 The movement of the trimmable horizontal stabilizers (THSs) stopped.
- 9:03:04 The Aircraft passed the Runway 27 threshold at about 50 ft RA, at an airspeed of 138 kt, and at a pitch angle of 3.2 degrees, followed by the “Fifty (50 ft RA)” Auto Callout.
- Around 9:03:05-08 Three Auto Callouts were annunciated: “Thirty (30 ft RA),” “Twenty (20 ft),” and “Retard (returning the thrust lever to the IDLE position).”
- 9:03:08 The thrust levers were moved to the IDLE position.
- Around 9:03:08-10 The second and third “Retard” Auto Callouts were annunciated.

At that time, the pitch angle of the Aircraft sharply increased from +1.8 degrees to +12.7 degrees in 2.25 seconds. This means that the nose was raised at an average rate of about 4.4 degrees per second (momentarily up to about 8.4 degrees per second), sharper than the rate of about three degrees per second recommended at takeoff as described in FOBN in 2.9.6 (2) and AOR in 2.9.8. (meaning that the nose was raised very sharply). Based on the statements of the cockpit crew included in 2.1.2, however, it is highly probable that neither the captain nor the first officer recognized during the go-around operation that the nose of the Aircraft went up substantially.

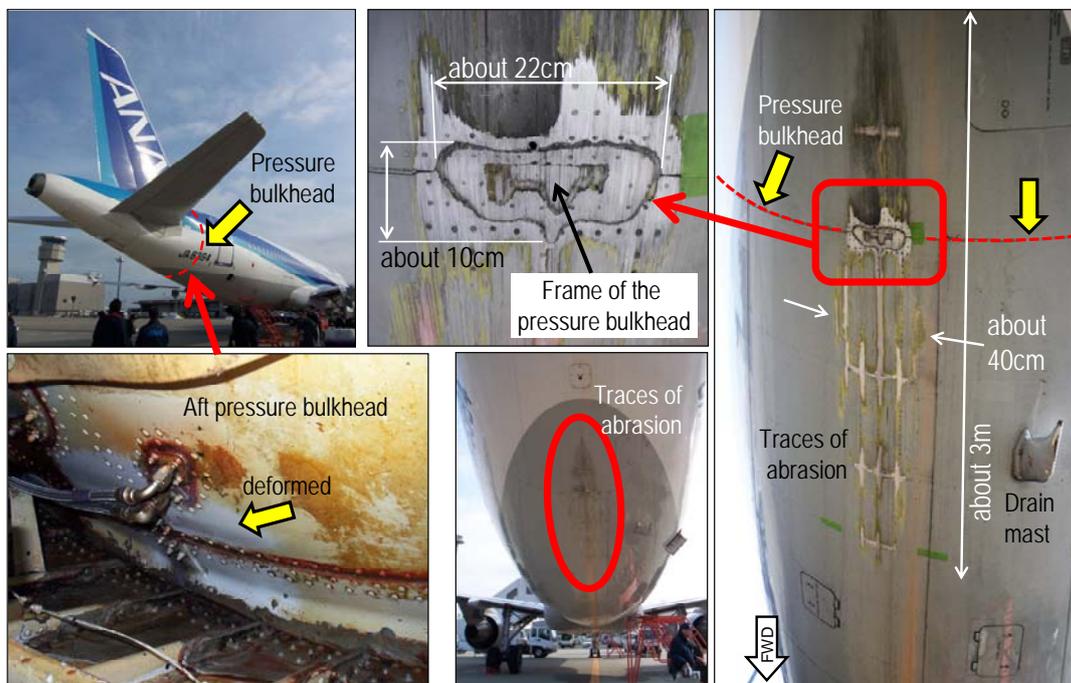
Photo B : Damage to the Fuselage

On the external plates for the lower part of the rear fuselage was an abrasion of about three meters in length and about 40 centimeters in width, and two of the drain masts were damaged. The lower portion of the rear pressure bulkhead was slightly deformed, and the frame of the bulkhead close to the portion was also damaged.

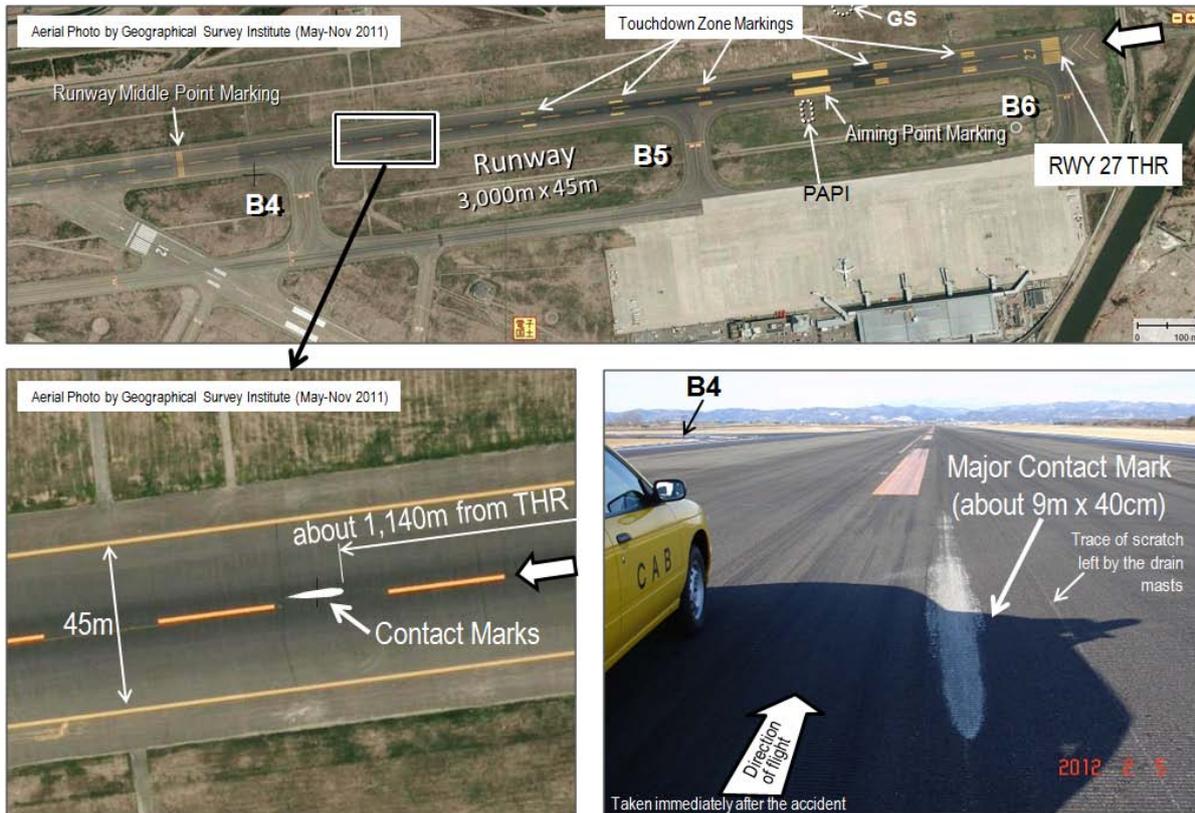
Photo C : Condition of the Runway

nine meters in length and about 40 cm in width, and metal fragments were left in the grooves (which are dug to drain water and improve the effects of braking) on the runway. In parallel with this mark, fine contact marks were also left on the right-hand side of the direction of flight. The conditions of these marks on the runway almost corresponded with the locations of those of abrasion on the lower part of the rear fuselage and damaged drain masts.

There was no damage to the runway, lights and markings.

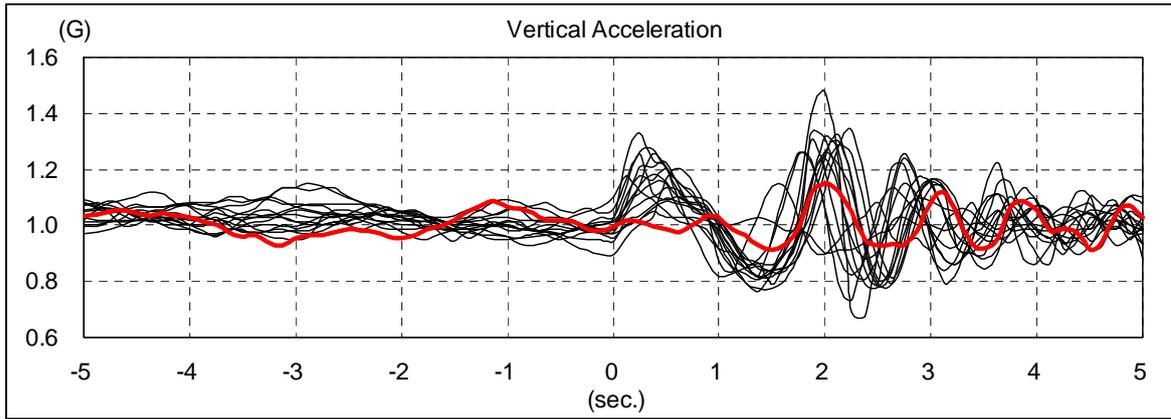
Figure E : Vertical Acceleration at Touchdown

In most of the previous landings, the vertical acceleration increased sharply to the positive side when the main landing gears touched down (average increase: +0.19 G), but when the accident occurred, the change in vertical acceleration remained within the range of 0.98 G to 1.04 G (increase: +0.06 G) when the right main landing gear touched down, followed by the left one.

- Vertical accelerations for previous 15 touchdowns retained in DFDR
- The time when any landing gears touched down is zero.
- All waveforms are smoothed.
- The thick red line shows the G's of this event.
