**AIRCRAFT SERIOUS INCIDENT
INVESTIGATION REPORT**

Japan Transport Safety Board

- 1. JAL EXPRESS CO., LTD
DOUGLAS DC-9-81, JA8499**
- 2. JAPAN AIR COMMUTER CO., LTD
BOMBARDIER DHC-8-402, JA844C**

**ABOUT 1NM ON FINAL APPROACH PATH OVER BUILT-UP
AREA TO RUNWAY 32R, OSAKA INTERNATIONAL AIRPORT
AROUND 09:10, JULY 23, 2009**

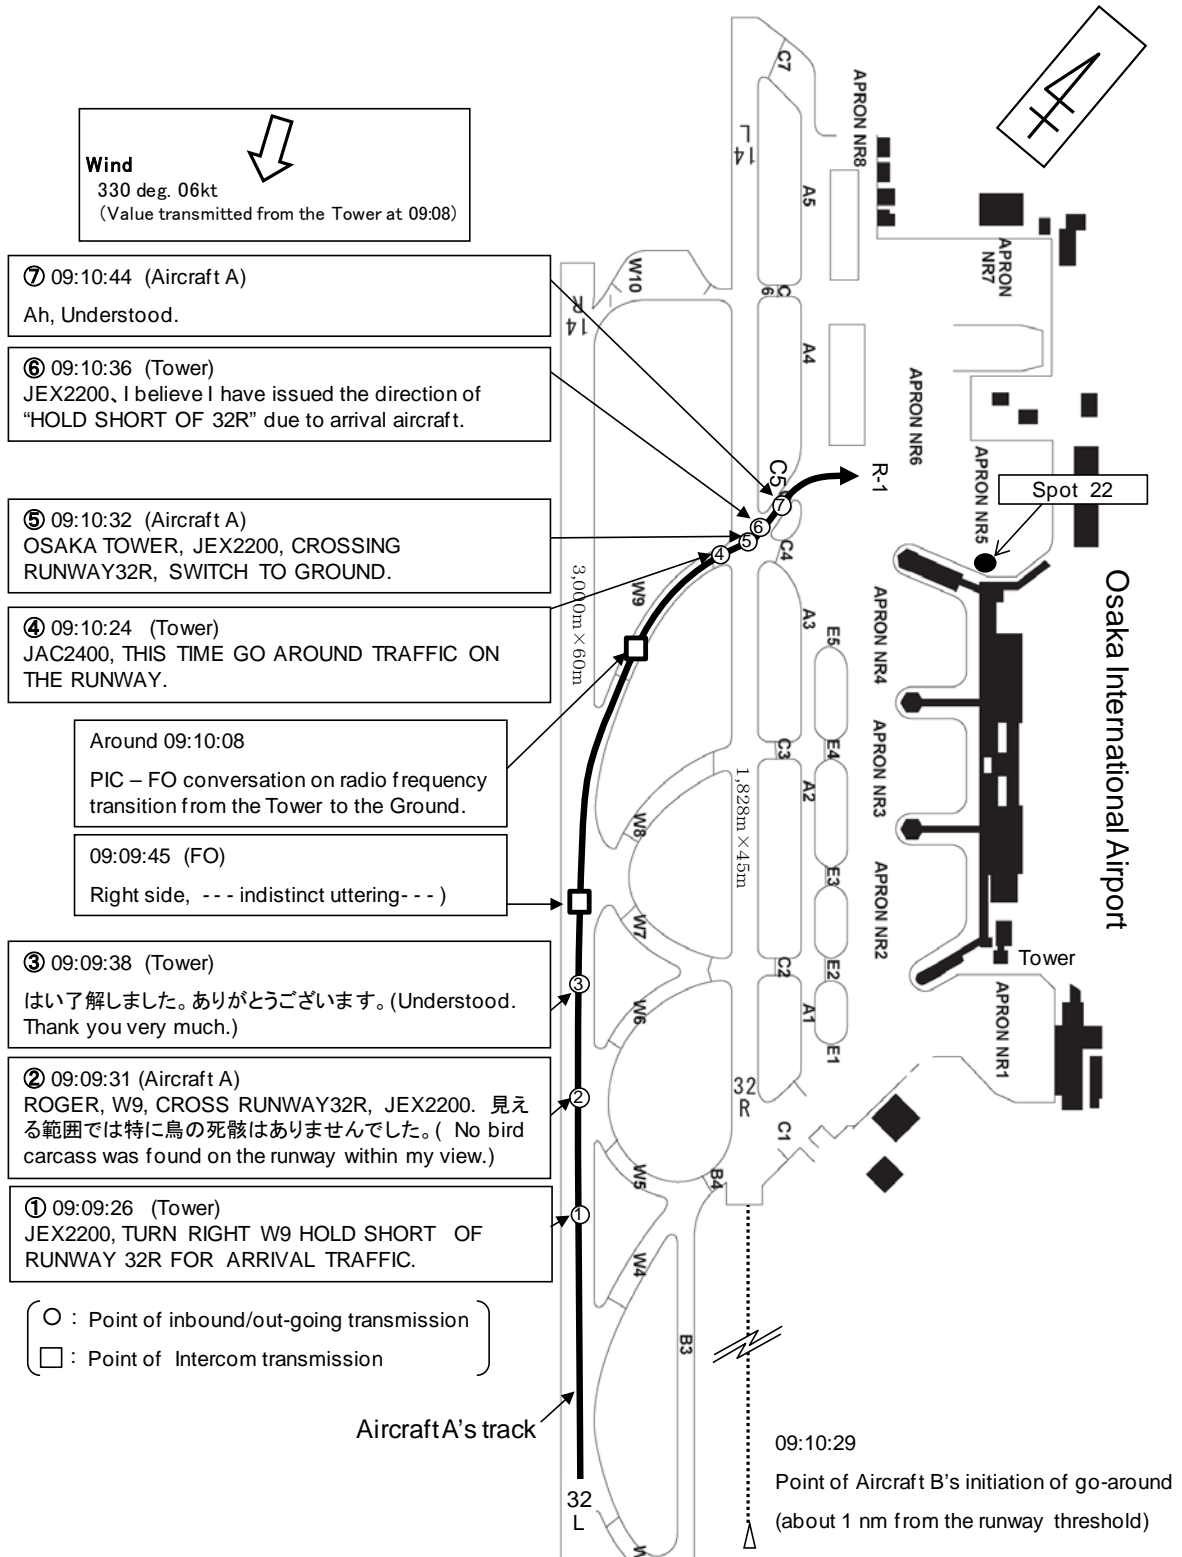
Figure 1 Estimated Ground Track

This serious incident³ occurred around 09:10 July 23, 2009, on a final approach path over built-up area to runway 32R around 1nm from its approach end. (See Figure 1 Estimated Ground Track, Figure 2 Douglas DC-9-81 (Aircraft A), Figure 3 Bombardier DHC-8-402 (Aircraft B), Attachment 1 Radio Communications (CVR Excerpts)

This data demonstrated the distance between the two aircraft at the time of occurrence to be around 1.6 nm; in other words, the Aircraft B was located about 1 nm from the runway threshold of 32R.
