**AIRCRAFT SERIOUS INCIDENT  
INVESTIGATION REPORT**

**ALL NIPPON AIRWAYS CO., LTD.  
JA85AN**

MULTIPLE MALFUNCTIONS IN ONE OR MORE SYSTEMS  
EQUIPPED ON AIRCRAFT IMPEDING  
THE SAFE FLIGHT OF AIRCRAFT  
TOKYO INTERNATIONAL AIRPORT  
AT AROUND 08:22 JST, MAY 27, 2016

ALL NIPPON AIRWAYS CO., LTD.  
BOEING 737-800, JA85AN

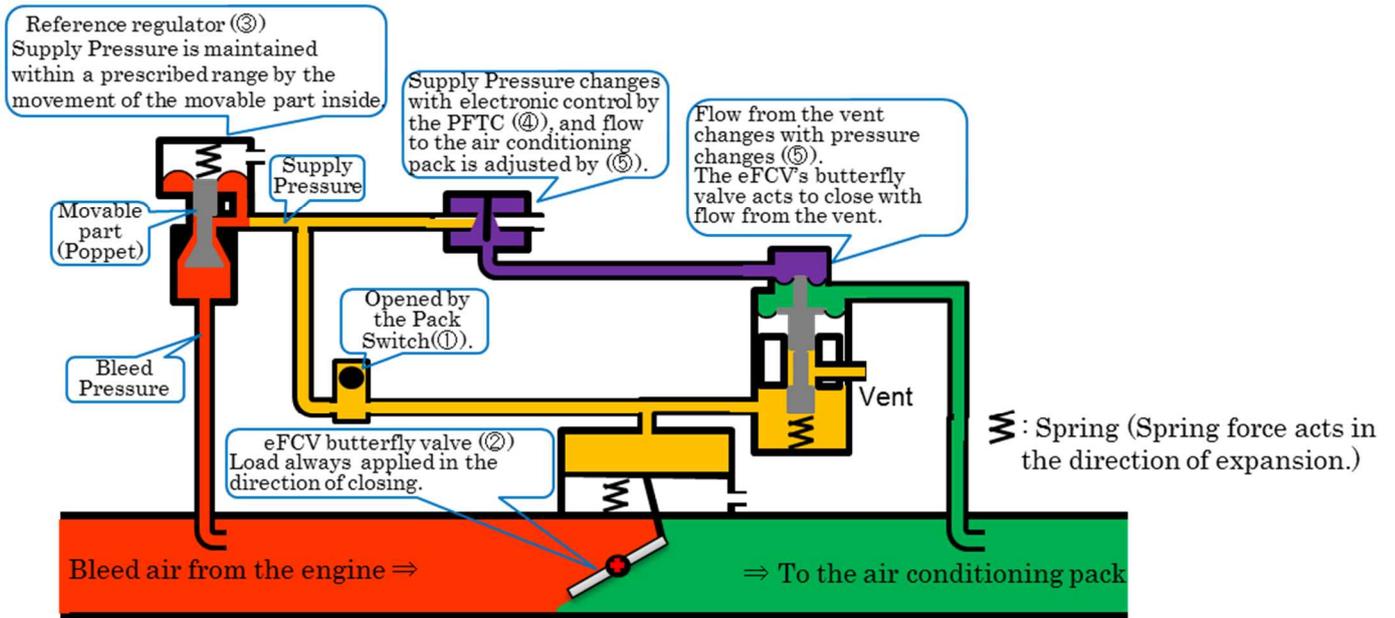
Figure 4 eFCV Outline

- (2) From the eFCV mechanism that was described in 2.9.4 as well as the eFCV investigation that was described in 2.10.2 and 2.10.3 and the case of a similar failure on another aircraft, it is probable that the eFCVs fully closed because the reference regulators were stuck open. If a reference regulator is stuck open, the function of the reference regulator, which adjusts the Supply Pressure to correspond to increases in the Bleed Pressure, is lost and the eFCV's butterfly valve closes as a result of the excessive Supply Pressure.

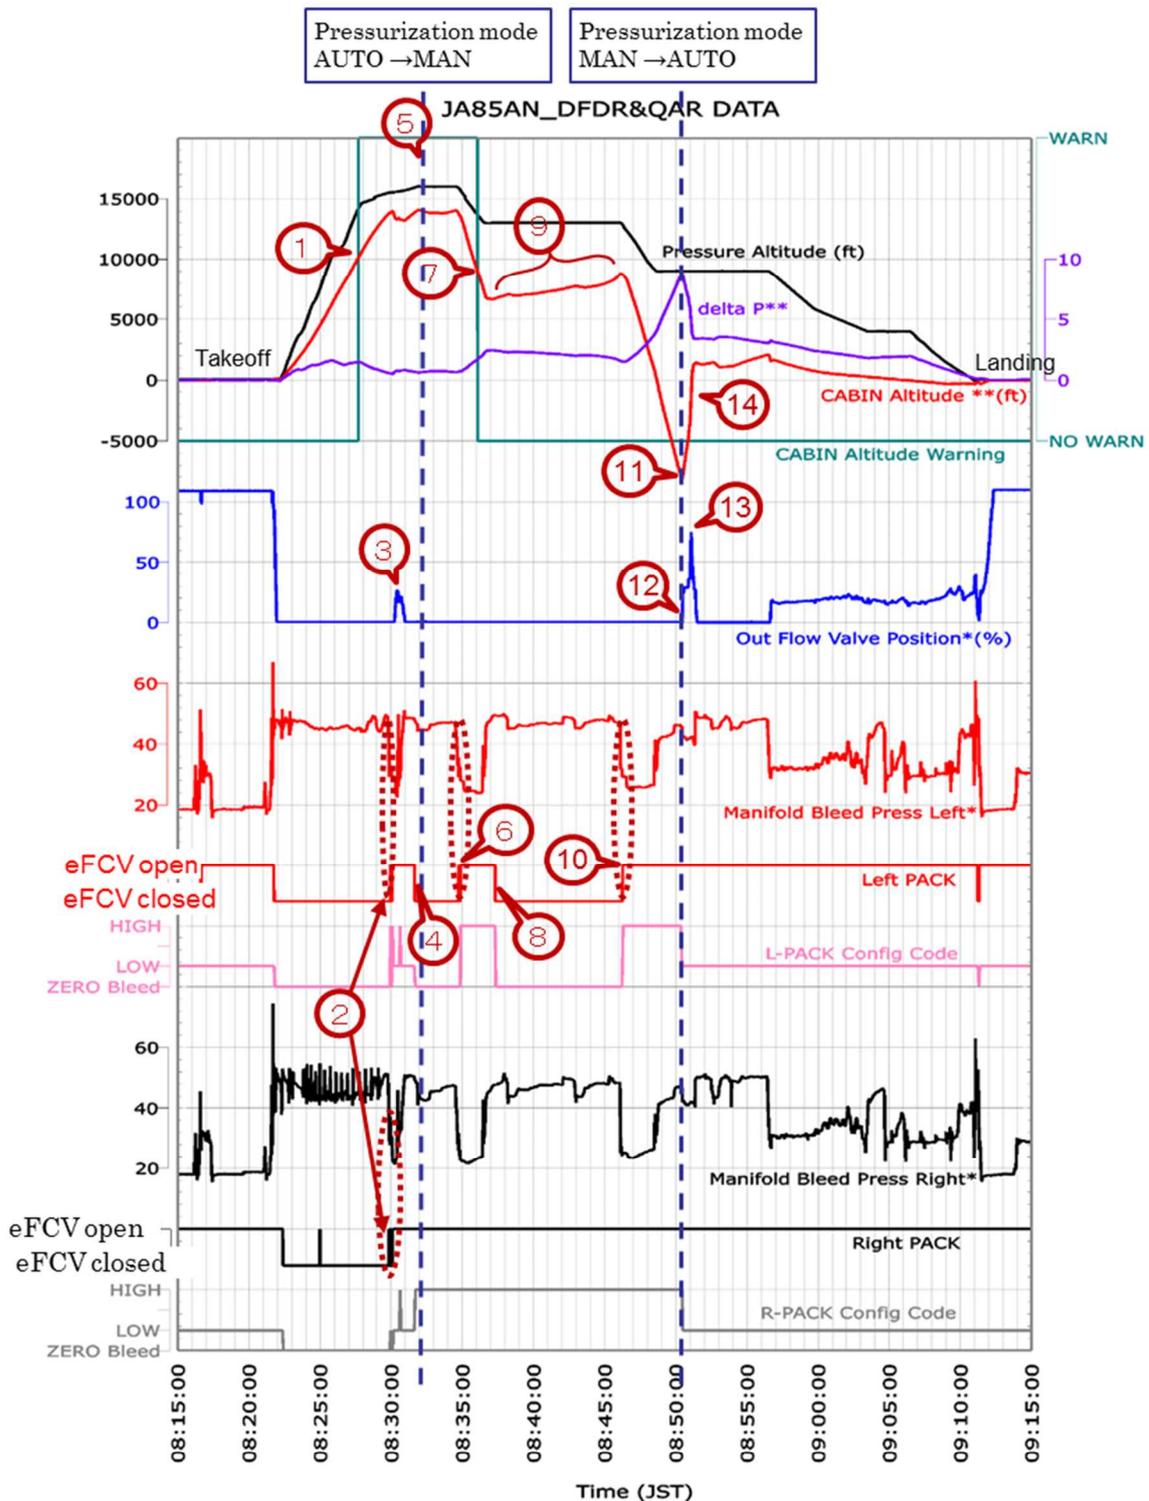
## Attached Figure 2 FDR and QAR Records

- (1) It is highly probable that the cabin altitude warning device activated when the cabin altitude reached approximately 10,000 ft because the left and right air conditioning packs sequentially shut down for the reason described in 3.5 (2) when the engines power increased during takeoff and pressure to the cabin increased under conditions in which it was not being maintained. (See Appendix Figure 2 ①)

- (2) The flight crewmembers canceled ascent when the cabin altitude warning activated, transitioned to level flight at FL160, and slowed to 250 kt. It is probable that, as a result, the left and right air conditioning packs restarted for the reason described in 3.5 (3) because the Bleed Pressure decreased together with the decrease both engine power. (See Appendix Figure 2 ②)

- (3) It is probable that, although both air conditioning packs had restarted and pressurization began, the OFV was temporarily left open to prevent a rapid descent in cabin altitude because, as was mentioned in 2.11.3, a lower limit was set for the automatically controlled rate of descent of cabin altitude. (See Appendix Figure 2 ③)

- (4) It is probable that, after the Aircraft transitioned to level flight at FL160, the left air conditioning pack shut down again because the Bleed Pressure increased together with the engine power. (See Appendix Figure 2 ④)

- (6) It is probable that, as a result of the descent to 13,000 ft, the Bleed Pressure decreased together with the engine power and the left air conditioning pack restarted. (See Appendix Figure 2 ⑥)

It is probable that the amount of air flowing into the cabin increased suddenly with the operation of both air conditioning packs because both PACK switches were operating at HIGH with the OFV fully closed. As a result, during the approximately two minutes that the Aircraft descended to 13,000 ft, pressurization progressed rapidly and there was a rapid descent in cabin altitude at rate of -3,500 fpm on average. During this time, the cabin altitude warning stopped, as the cabin altitude reached approximately 9,000 ft. (See Appendix Figure 2 ⑦)

- (7) It is probable that, when the Aircraft transitioned to level flight at 13,000 ft, the left air conditioning pack shut down again because the Bleed Pressure increased in the same manner described in (4) above. (See Appendix Figure 2 ⑧)

- (8) The FDR record showed that, during the Aircraft's approximately ten minutes of level flight at 13,000 ft, the right air conditioning pack was working and operating at High Flow, but the cabin altitude was gradually rising and pressurization was not being maintained. Given that, as was described in 2.11.2, pressurization is ordinarily maintained with High Flow operation by one air conditioning pack, It is somewhat likely that, although the right eFCV was partially open but regulating incorrectly due to the reference regulator issues described earlier in the report. It is not likely that it was full closed as the limit switch was not faulty any other point during the event or during the subsequent component evaluations and because the cabin altitude was climbing slowly during this time and not rapidly as would be the case if there was no cabin air inflow. (See Appendix Figure 2 ⑨)

- (9) It is probable that, as a result of the descent to 9,000 ft, the Bleed Pressure decreased together with the engine power and the left air conditioning pack restarted again. (See Appendix Figure 2 ⑩)

Similar to the situation described in (6) above, the operation of both air conditioning packs while the outflow valve was fully closed in manual mode resulted in a state of rapid pressurization. Moreover, it is probable that both air conditioning packs continued operating, even after the Aircraft transitioned to level flight at 9,000 ft, because the Bleed Pressure did not rise high enough to result in the left air conditioning pack's shutting down in the manner described in (7) above, and thus the situation became one in which the most rapid pressurization on the flight was occurring. Consequently, for a period of approximately four minutes that lasted from after the Aircraft descended to 9,000 ft and transitioned to level flight until the pressurization mode was switched to AUTO and the OFV opened, pressurization continued rapidly and the cabin altitude rate of descent was below -4,000 fpm on average and for a moment fell below -8,000 ft ( $\Delta P=8.967$  psid) . (See Appendix Figure 2 ⑪)
