**AIRCRAFT SERIOUS INCIDENT  
INVESTIGATION REPORT**

**ALL NIPPON AIRWAYS CO., LTD.**

**J A 8 6 7 4**

Operator: ALL NIPPON AIRWAYS CO., LTD.  
Type: BOEING 767-300  
Registration number: JA8674  
Type of serious incident: ENGINE INTERIOR DAMAGE  
Time and date of outbreak: AT 09:19 , JULY 8, 2011  
Occurrence Point: AT AN ALTITUDE OF APPROX. 8,500M  
ABOUT 79KM TO THE NORTHWEST  
OF TOKYO INTERNATIONAL AIRPORT

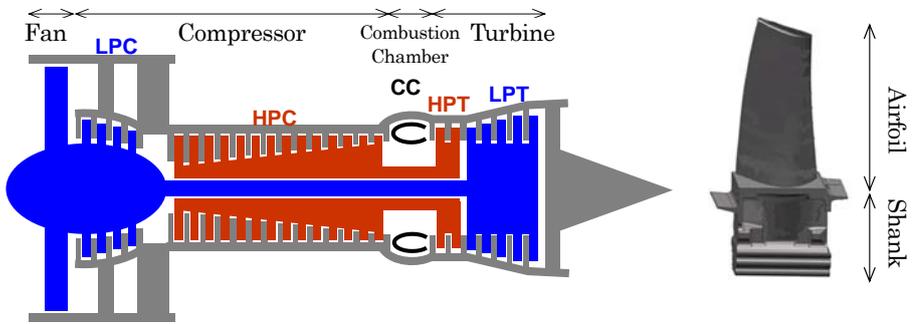
<p><b>2.2 Injuries to Persons</b></p>	<p>None</p>
<p><b>2.3 Damage</b></p>	<p>(1) Extent of Damage: Minor damage (major damage to inside of the engine)</p> <p>(2) Damage to inside of the Engine</p> <p>The High Pressure Turbine (hereinafter referred to as “HPT”) is composed of two stages. Out of 74 second stage HPT blades, the blade 69 (hereinafter referred to as “the Blade”) was separated at a distance of 1.3 inches (1 inch = about 25.4mm) from the bottom in the shank and lost.</p> <p>Other blades exhibited damage on the blade tips.</p> <p>The Low Pressure Turbine (hereinafter referred to as “LPT”) is composed of five stages. The LPT blades exhibited damage along the full axial length of the LPT module.</p> <div style="text-align: center;">

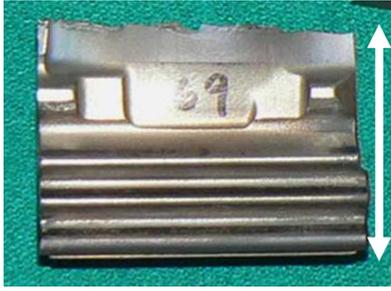
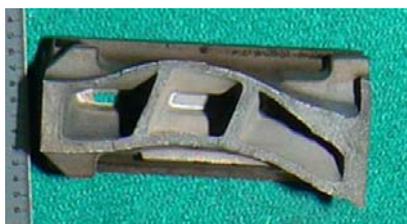
<p>Blade 69 (side view)</p> </div> <div style="text-align: center;">

<p>Blade 69 (top view)</p> </div> </div>

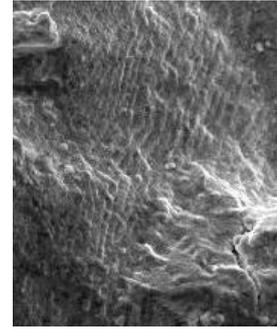
Fracture surface

Traces of fatigue propagation were observed on the fracture surface of the Blade.

The shank wall thickness was thinner than the minimum design value of 0.055 inches.

High-temperature corrosion was observed on the internal surface of the fracture part, but it was limited within the outermost aluminide coating and did not penetrate into the base material. The component material analysis of the Blade showed no abnormality.
