**AIRCRAFT SERIOUS INCIDENT
INVESTIGATION REPORT**

NAKANIHON AIR SERVICE CO., LTD.
AÉROSPATIALE AS332L (ROTORCRAFT)
JA9660

DROPPING OF OBJECTS
DURING EXTERNAL CARGO SLING OPERATION
TAKAHAMA TOWN, OI GUN, FUKUI PREFECTURE, JAPAN
BETWEEN 10:35 AND 10:40 JST, OCTOBER 8, 2015

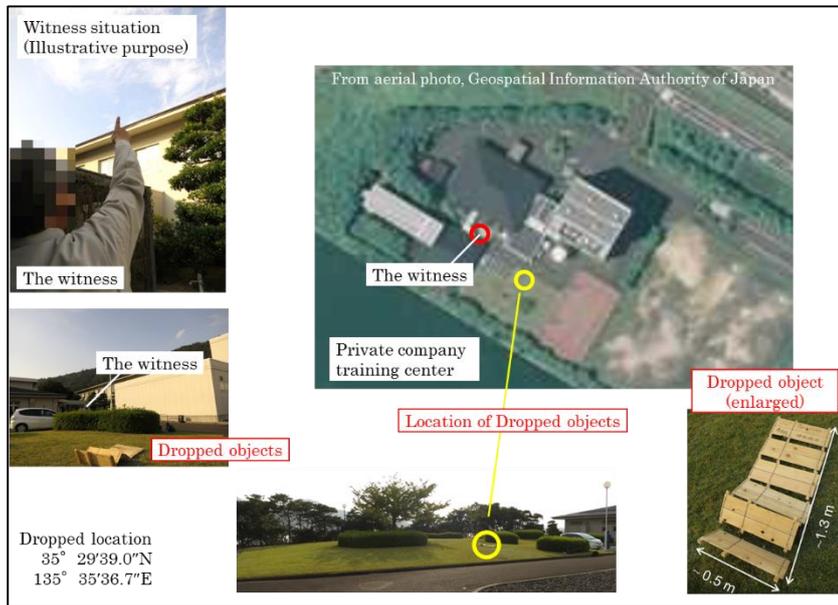
Fig. 2 Dropped site

The serious incident occurred at the time between 10:35 and 10:40, at the point with an altitude of about 1,500 ft, about 1.4 km east of the temporarily helipad (35°29'55"N, 135°35'35"E).

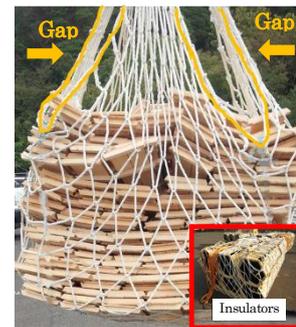
Fig. 3 Situation of packing (Replicate)

3.5 Analysis of Findings	<p>(1) Preparation of loads transport (Packing)</p> <p>It is probable that appropriate actions was not taken for the gap of Mokko for slinging loads. Because it was difficult to notice the gap due to overlapped parts of Mokko in packing, preventing the confirmation of existence of the gap, the task for blocking the gap was not enough, and the final confirmation for packing by the person in charge of packing was performed partly by reports from ground workers;</p> <p>(2) History of drop of wooden frames</p> <p>The fallen wooden frames became a shape which tended to contain air by being folded into two in packing, which was more vulnerable to effects of air current accompanied with flight. Therefore, it is highly probable that a pair of wooden frames in the top of slinging loads came out from the gap of Mokko due to the effects of air current and dropped on the ground. (See Fig 3)</p> <p>(3) Flight route and dropped site</p> <p>Regarding no damages against people and objects on the ground by this dropping loads, it is probable that because the flight route which does not affect the safety of people and objects on the ground is set and the captain also flied while paying attention to the configuration of transportation loads and the weather. However, the loads, which were relatively light-weight with large surface area, were drifted to the south side from the flight route due to the north wind which blew when the loads were dropping, and dropped onto the grass area inside the training center of private company instead of the ground directly below the route; therefore, it is probable that it might cause damages depending on wind conditions.</p> <p>It is important to not only ensure the measures for preventing the drop</p>

<p>In this serious incident, it is highly probable that the wooden frames were transported under the conditions where the Mokko had the gap, causing the pair of wooden frames to come through the gap due to effects of air current accompanied with the flight and dropped on the ground.</p> <p>Regarding the transportation under the conditions the Mokko had the gap, it is probable that it was because the confirmation of the gap in packing and the task for closing the gap were not enough, and the final confirmation for packing by the person in charge of packing was performed partly by reports from ground workers.</p>
--

<p>5.1 Safety Actions Taken by the Company</p>	<p>The company established the following recurrence preventive measures in response to this serious incident.</p> <ol style="list-style-type: none"> (1) Drop prevention measures are always taken for slinging loads for which the Mokko is used, such as a cover Mokko, a cover net, or binding the gap of Mokko according to the shape of loads. (2) The color of ropes for binding the gap of the Mokko are changed different from Mokko and is attached to Mokko when it is distributed to the field. (3) The cover Mokko, the cover net, or the binding conditions of Mokko gap are confirmed visually and “by using hands”. (4) The configuration and the contents of confirmation of secure the binding of loads is ensured visually and by using hands are added to a safety educational material, and (1) - (3) are made known to participants of education including ground workers and a person in charge of packing as notes for packing procedures.
