AA2010-3

**AIRCRAFT ACCIDENT
INVESTIGATION REPORT**

AERO ASAHI CORPORATION

**AERO ASAHI CORPORATION
AEROSPATIALE AS332L (ROTARCRAFT), JA9690
AT ABOUT 500 M ELEVATION, IN THE MOUNTAIN,
IMAZU-CHO, TAKASHIMA CITY, SHIGA PREFECTURE, JAPAN
AT ABOUT 8:28 JST, AUGUST 3, 2009**

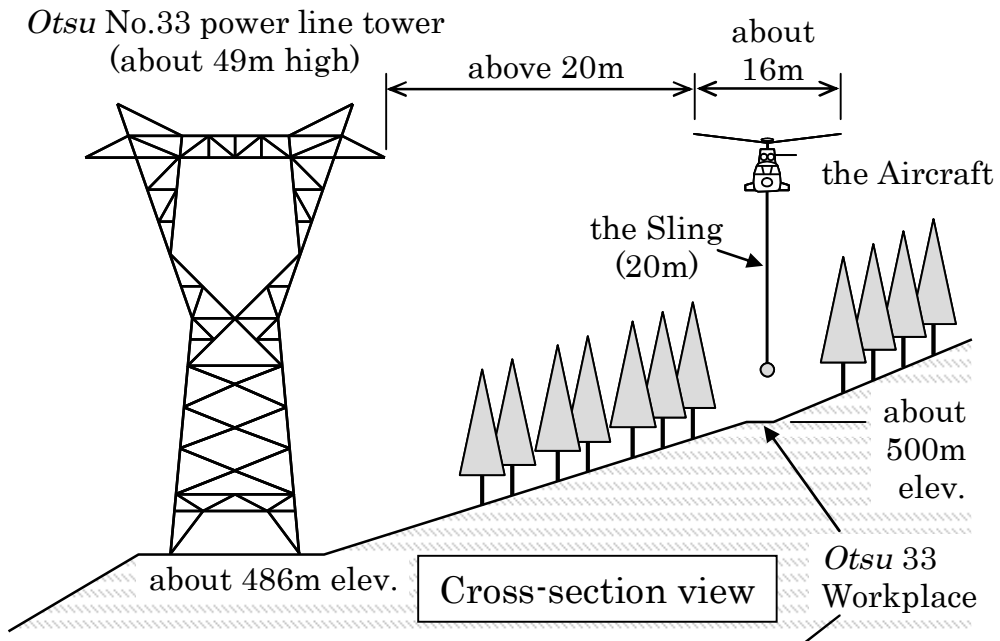
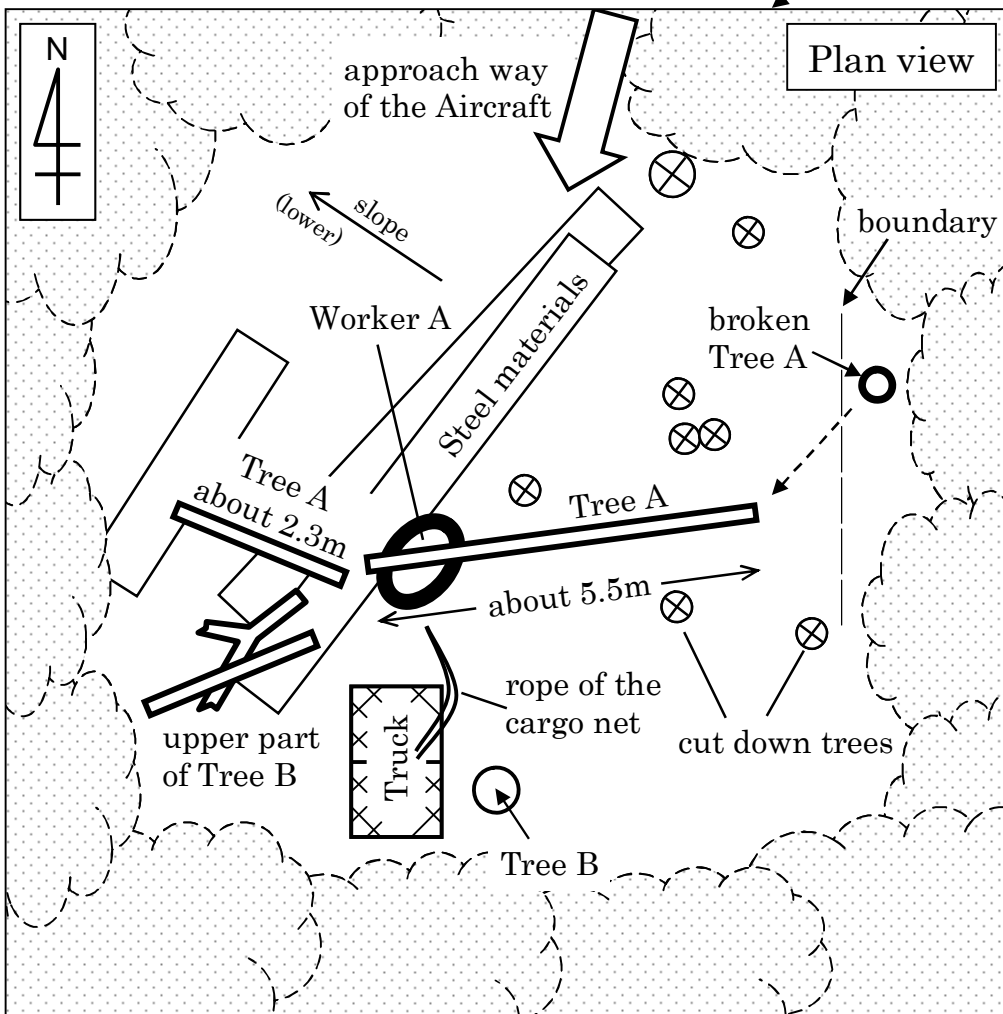
Figure 2 Accident Site Layout

The accident site was a workplace for material transport by helicopters set up in the mountain at about 500m elevation of Imazu-Cho, Takashima City, Shiga Prefecture, and was a slope of high in the east and low in the west with the maximum slope angle about 20 degrees and with a flat part. Trees within about 11m square had been cut down and *Otsu* No.33 power line tower of 49m high was on the ground about 40m in the west from the accident site (about 486m elevation).

Tree A was about 9m high on the ground and was outside of cut down area in the mountainside. It broke down at about 1m high from the ground (about 20cm in diameter) and the broken tree fell down to the valley side. It broke at about 5.5m from the broken point again and the broken parts fell on the steel materials. Tree A had no leaves, and though there remained bark at around the broken part, the inside rotted and became a cave.

Not only Tree A but a broken part of the tree near the truck (hereinafter refer to as "Tree B") fell on the steel materials and the inside rotted.
(See Figure1 Estimated Flight Route, Figure2 Accident Site Layout, Photo2 *Otsu* 33 Workplace and Photo3 Accident Site)

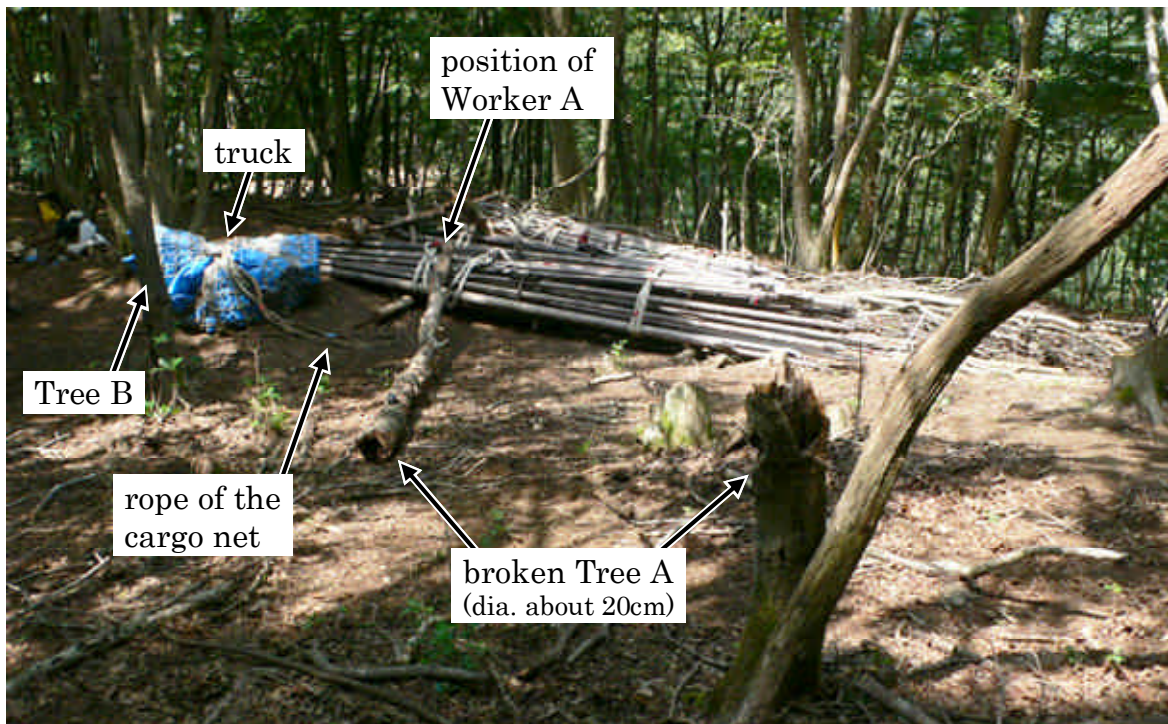
Photo 3 Accident Site

Judging from the description in 2.1 and 2.6, it is considered highly probable that Tree A, the inside of which rotted and became a cave, about 9m high on the ground and had been outside of cut down area on the mountainside of *Otsu 33 Workplace*, broke down at about 1m high from the ground because it had been swayed by the downwash of the Aircraft. It is considered highly probable that the broken Tree A fell down involving Tree B which also had been rotten inside and hit Worker A from his back. It is considered highly probable that Worker A could not notice the falling tree and could not avoid it because it occurred in the noise of the Aircraft and its downwash and also Tree A fell down from out of his view.

It is considered highly probable that this accident occurred that the tree which had been standing around the workplace with its inside rotten was broken by the downwash of the Aircraft and hit, and injured the Worker A on the ground during the Aircraft was gradually descending to sling up materials at *Otsu 33* Workplace.

To select a workplace, it is necessary to decide the cutting area properly not only by considering various factors above but also by paying sufficient attention to the condition of trees around which might be broken with the downwash of a helicopter.
