**AIRCRAFT ACCIDENT  
INVESTIGATION REPORT**

**KOREA PILOT SCHOOL  
N 1 7 6 C D**

AIRCRAFT DAMAGE CAUSED BY FORCED LANDING  
KOREA PILOT SCHOOL  
OPERATED BY PRIVATELY CONTRACTED PILOT  
CIRRUS SR20, N176 CD (THE UNITED STATES)  
NISHIKATA, IBUSUKI CITY, KAGOSHIMA PREFECTURE, JAPAN  
At ABOUT 14:30 JST, OCTOBER 12, 2014

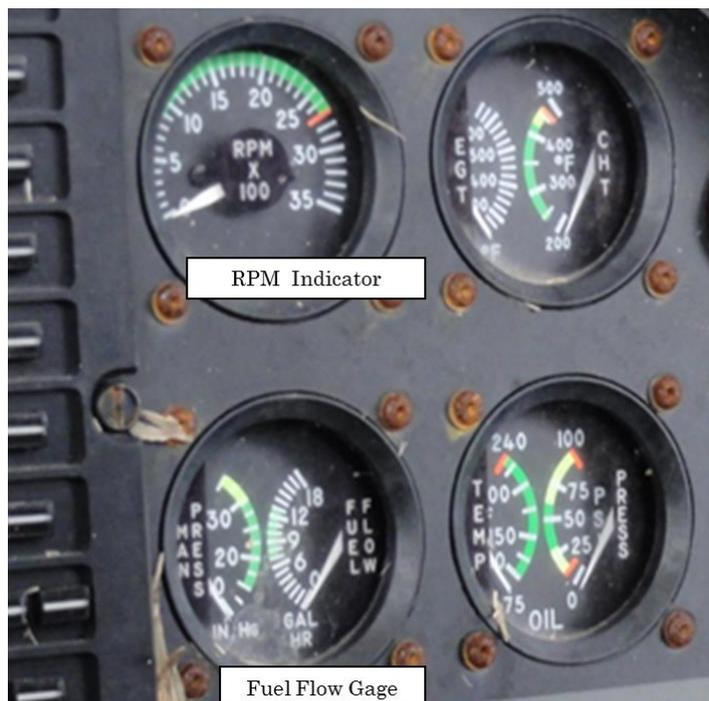
Photo A The Fuel Flow Gage and RPM Indicator

Pilot judging the rear ferry tank fuel was low, then switched to the front ferry tank which he was planning to use next, but the surging did not stop, and about 15 to 20 seconds later, the engine sound stopped and the indication of the fuel flow gage was showing zero.

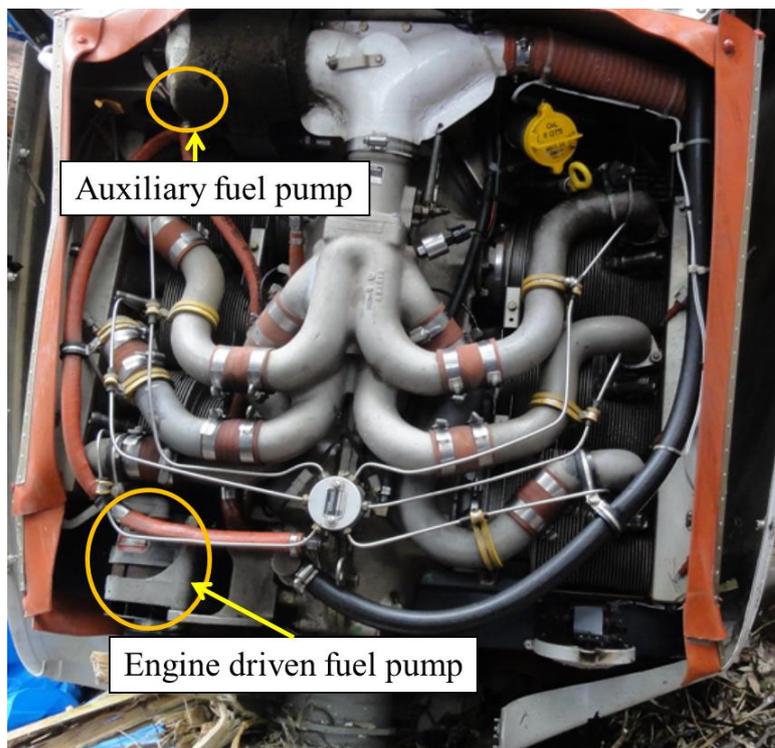
Photo B: The Status of the Engine

a) As regards the exterior of the engine body, the engine mount and the engine cover had deformed, and partially broken, but there was no other damage.

b) There was no damage as regards the ignition, lubricating oil, intake, exhaust and engine control systems.

c) When the auxiliary fuel pump switch was put on the PRIME position, the pump started operating and the indication of fuel flow gage rose, and fuel spouting from the fuel injection nozzle. However in the BOOST position, the operating sound of the pump was weak, the fuel flow gage showed zero, and there was no spouting of the fuel from the fuel injection nozzle (Fuel was put in the right wing tank only, which was in a higher position than the engine. The operation confirming was conducted in a situation where the fuel could flow out into the engine due to gravity.).

d) The engine driven fuel pump showed no irregularities with the exterior, the connecting section with the engine and drive shaft. The drive shaft was able to rotate.

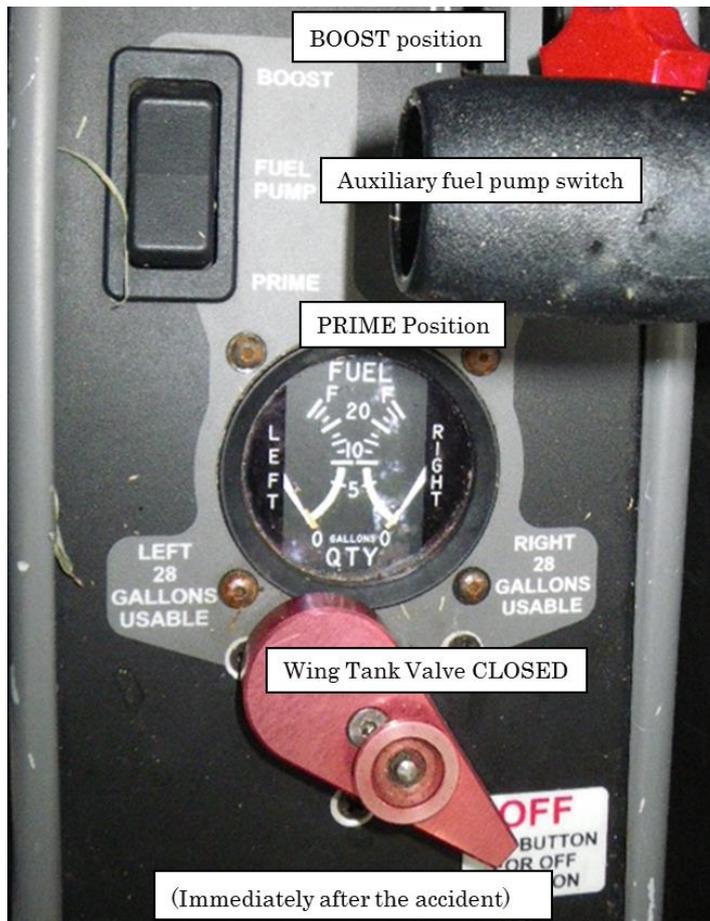
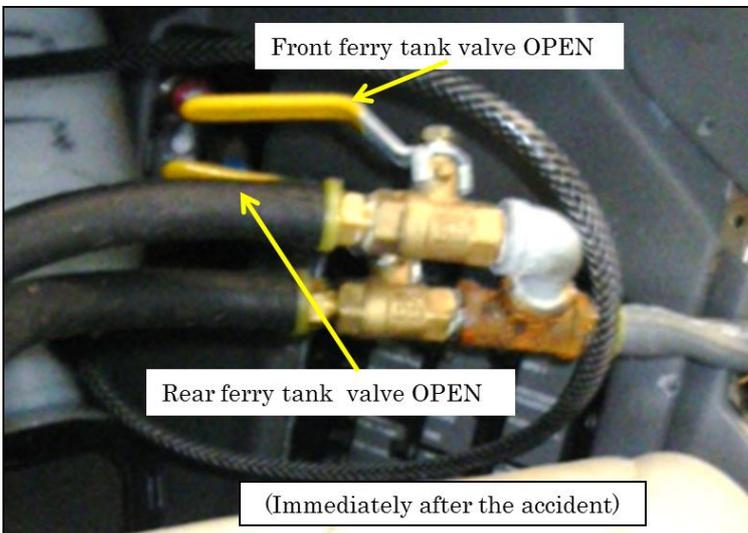
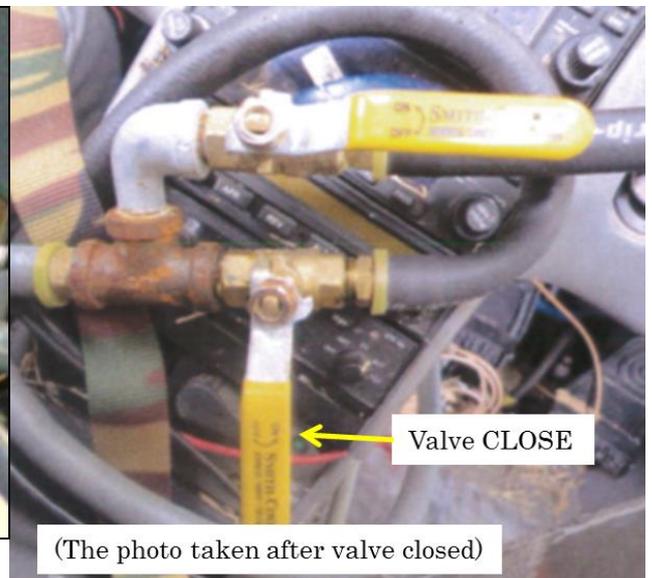
Photo C : The Status of the Fuel Selector Valve of each ferry tank

The fuel selector valve of the wing tanks was set in the OFF position (hereinafter referred to as "CLOSE"); however, the fuel selector valves and the vapor return valve for the front and rear ferry tanks were all set in the ON position (hereinafter referred to as OPEN").

The remaining fuel of each ferry tank was as below: Right wing tank: 20 gal, left wing and front ferry tanks: 10 gal respectively, rear ferry tank: zero gal

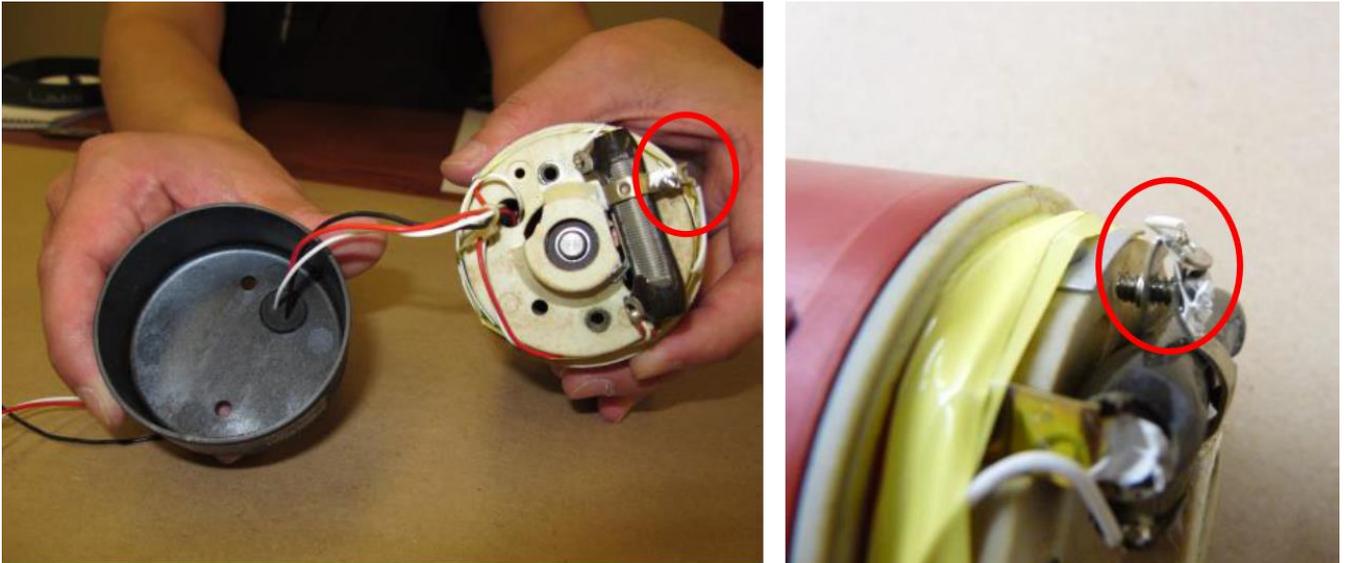
Photo E: Variable resistor unit mounting part that had loosened

- b. The results of the function test based on the normal acceptance test procedures were as follows:
- a) In the High Boost (PRIME) position, the relationship between the fuel pressure and fuel flow volume were within the special value (PASS). However, in the Low Boost (BOOST) position, the results were FAIL, even after two measurements.
  - b) As a result of the check after removing the cover of the electronic circuit section, the screw of the p-clamp (a P-shaped metal) attached to the variable resistor was loose, and then the contact part was wobbly. When the position of the p-clamp was moved slightly, the resistance reading would vary between 24 - 42  $\Omega$ .

- c) When the p-clamp was set at 21.9  $\Omega$  on variable resistor unit and a Low Boost function test was conducted, the results were within the special value.
- c. Conclusion

The resistance value fluctuated with the looseness of the screw of the p-clamp; therefore, the operation of the auxiliary fuel pump at BOOST position became irregular.

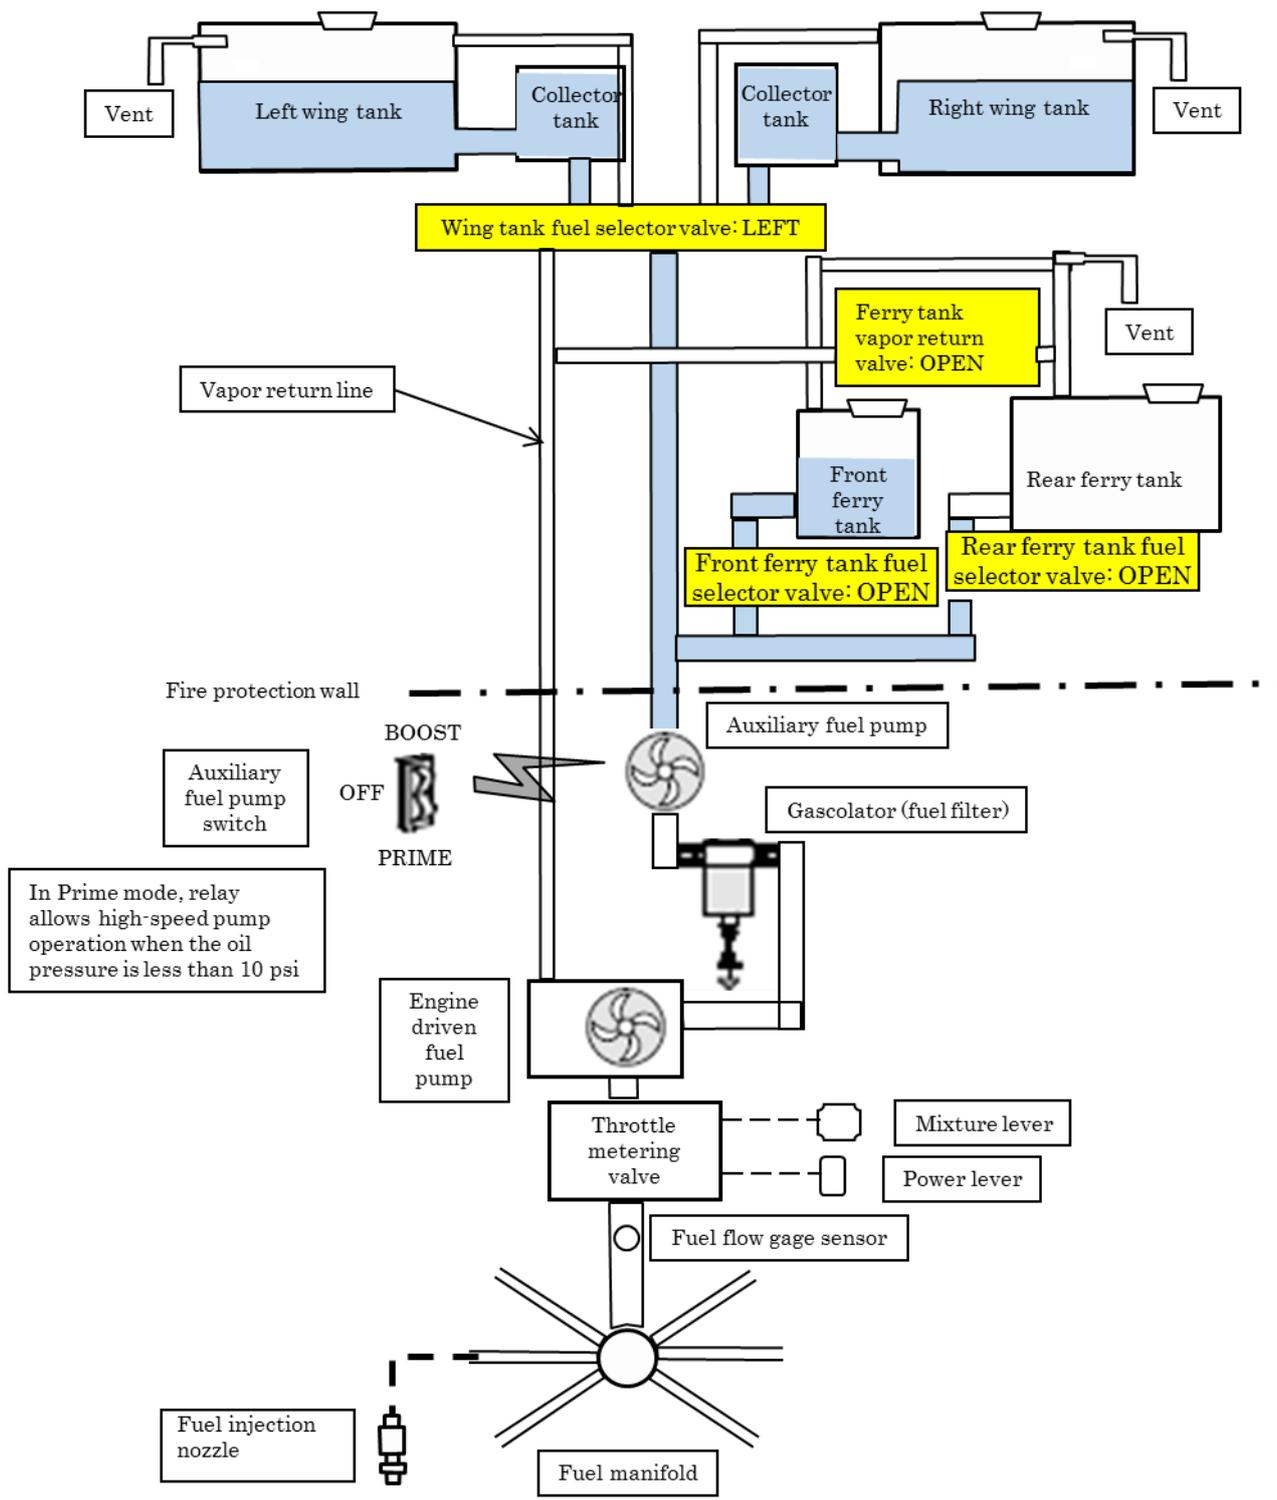
Diagram 2 The Fuel System at the Time of the Failure of Airstart

It is somewhat likely that this initially caused the air from the empty rear ferry tank entering into the fuel line, eventually as shown in Diagram 2, due to gravity, the fuel in the front ferry tank which is positioned higher than the engine flowed into the fuel supply line of the rear ferry tank which had become empty. However, it is somewhat likely that due to previously contained air inside the fuel line caused a difficulty of the fuel supply.

Moreover, as described in 2.10, since it is somewhat likely that the auxiliary fuel pump was not fully functioning with it being in an ON (BOOST) position at the time of the airstart, it is somewhat likely that the contained air inside the fuel line could not be removed swiftly.

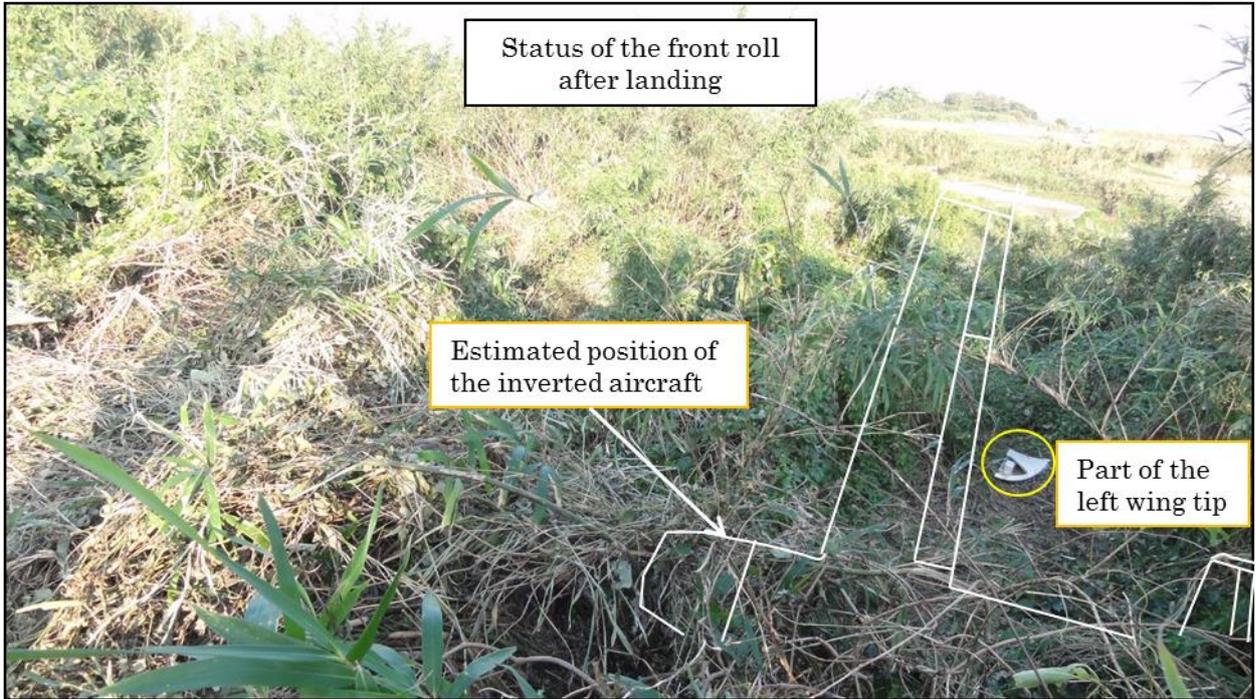
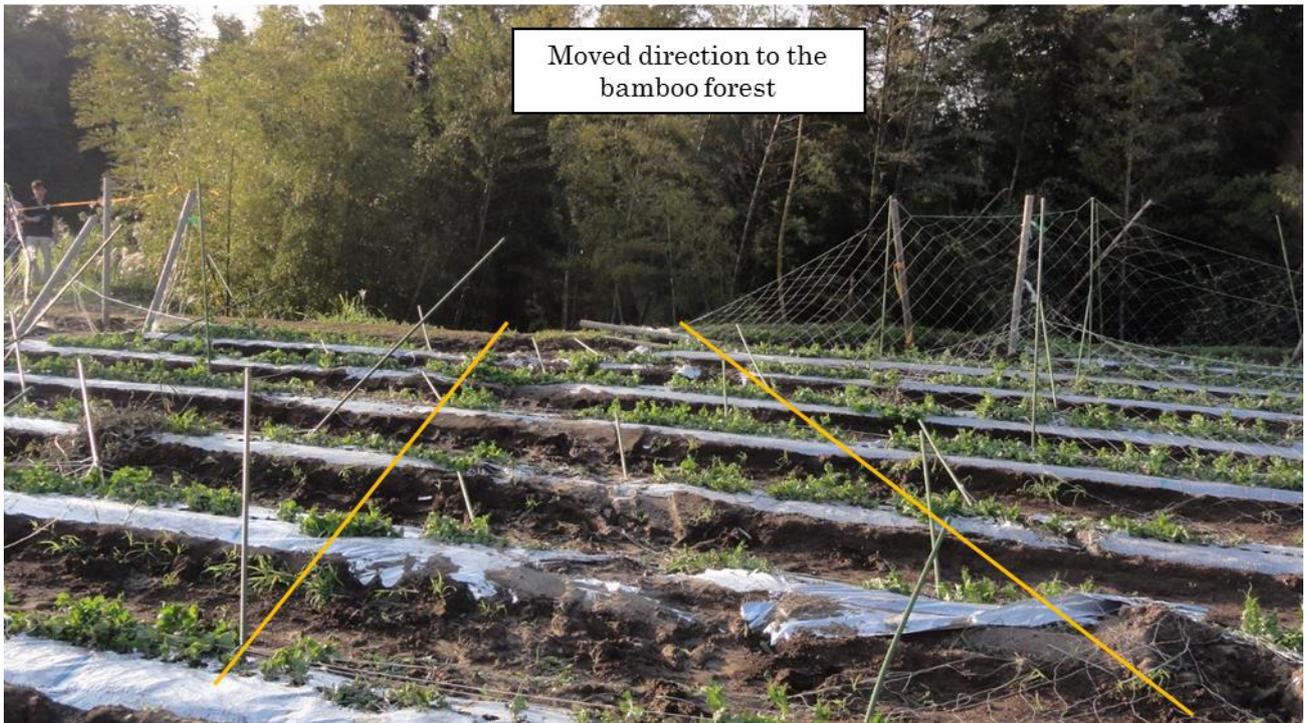
# Photo 1 Forced Landing Site

Damage of crops and bamboo forests falling down

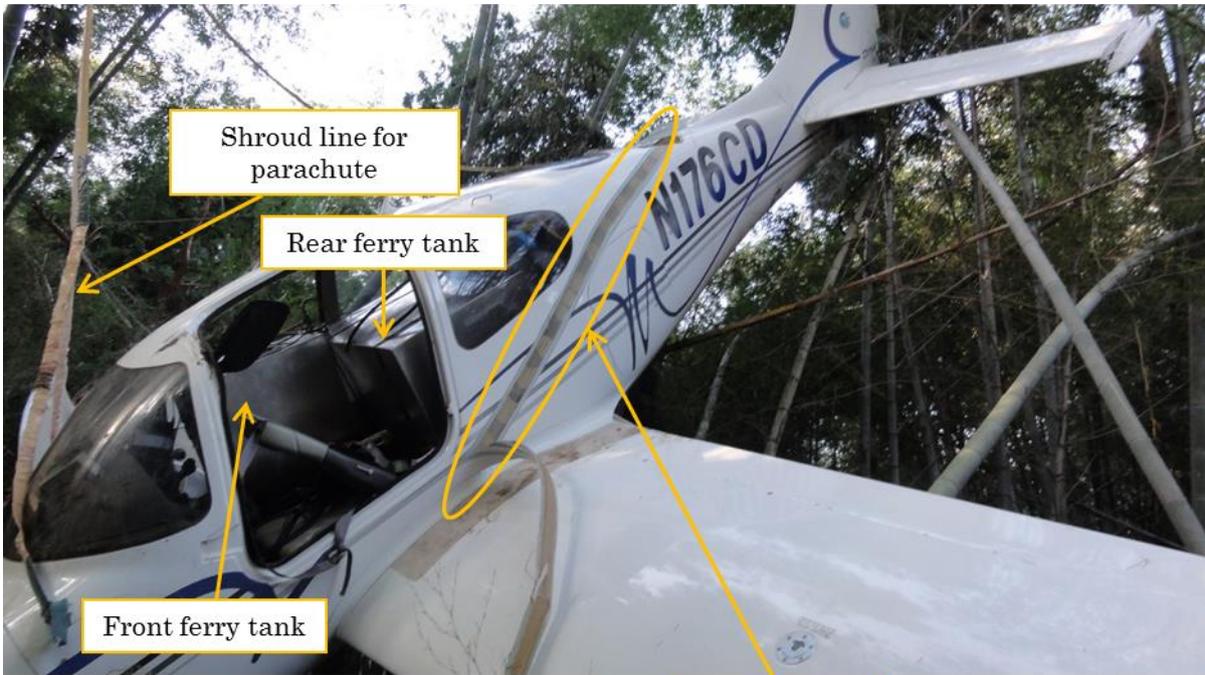
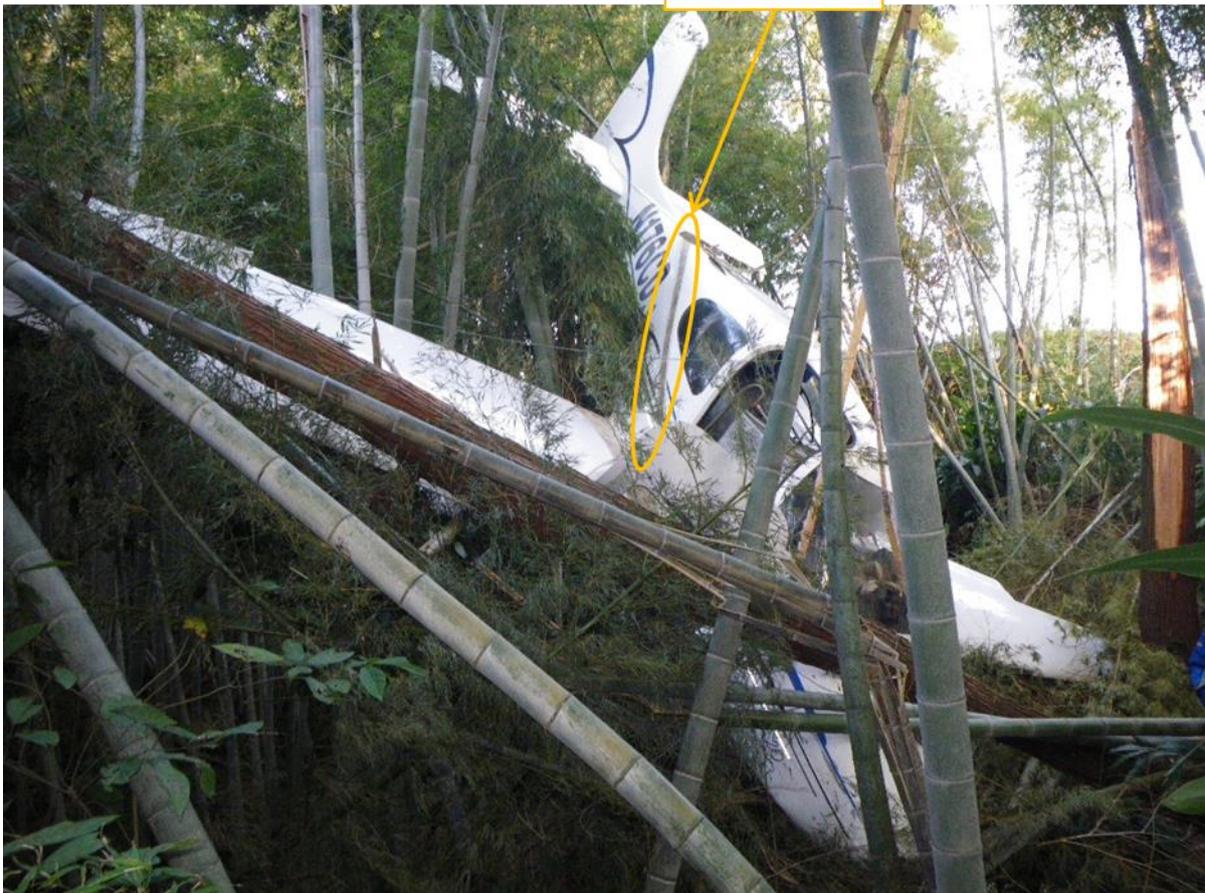
Photo 2 : Accident Aircraft

- a. Engine: engine cover damaged, engine mount deformed, and partially destroyed
- b. Propeller: blades deformed
- c. Wing : left wing destroyed, left and right ailerons damaged
- d. Fuselage: disengagement of left and right doors, detachment of left and right outer skins due to the emergency parachute deployment
- e. Empennage : right horizontal tail damaged, vertical tail damaged

It is probable that the damage of each section of the Aircraft described in 2.3.2 was due to the deployment of the emergency parachute system or the impact with the ground following the forced landing. As the gliding was carried out normally until the deployment of the emergency parachute, it is highly probable that although the engine of the Aircraft had halted its control system had no abnormalities.

Fuselage  
outer board  
detachment
