AIRCRAFT ACCIDENT INVESTIGATION REPORT

FEDERAL EXPRESS CORPORATION

N 5 2 6 F E

**CRASH DURING LANDING
FEDERAL EXPRESS CORPORATION
MCDONNELL DOUGLAS MD-11F, N526FE
NARITA INTERNATIONAL AIRPORT
MARCH 23, 2009**

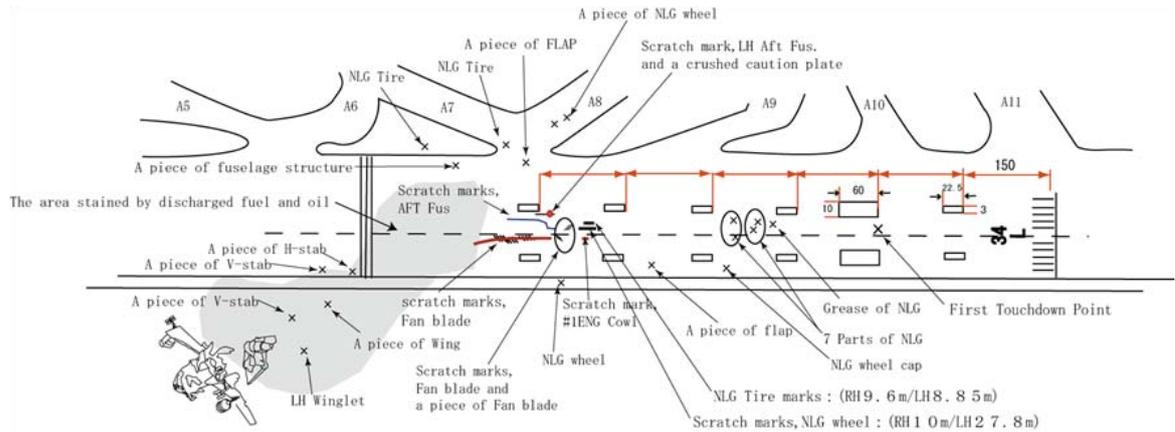
Figure 1 Overview of the Airplane's Wreckage

- n. Fuel and oil discharged from the airplane spread over the runway with a length of 210 m and a width of about 50 m, and in the grass area with a length of 230 m and a width of 30-60 m.

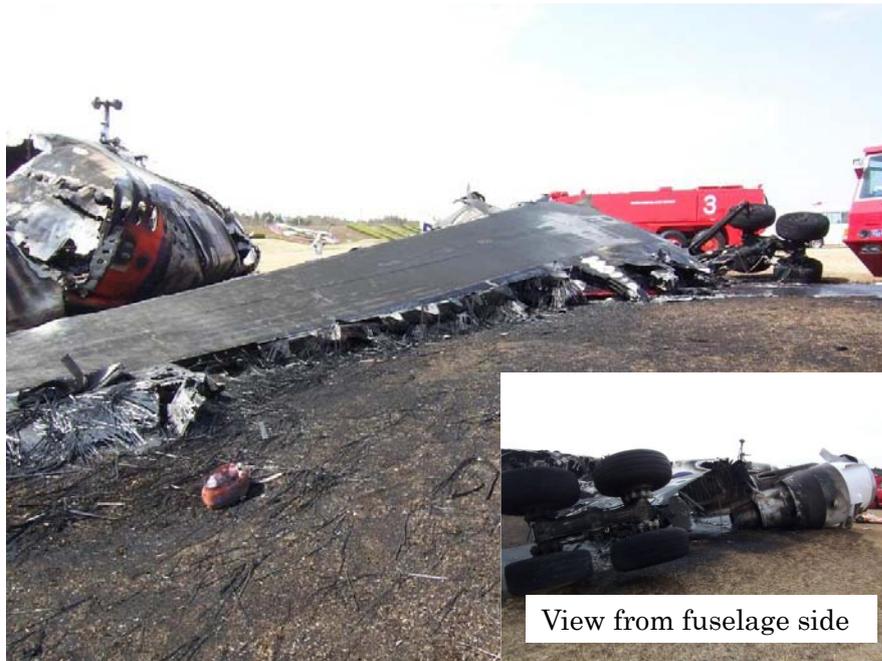
Photo 5 Fractured Left Wing

The No. 1 engine and the left MLG remained attached to the left wing structure lay on its lower surface on the grass area to the east of the fuselage.

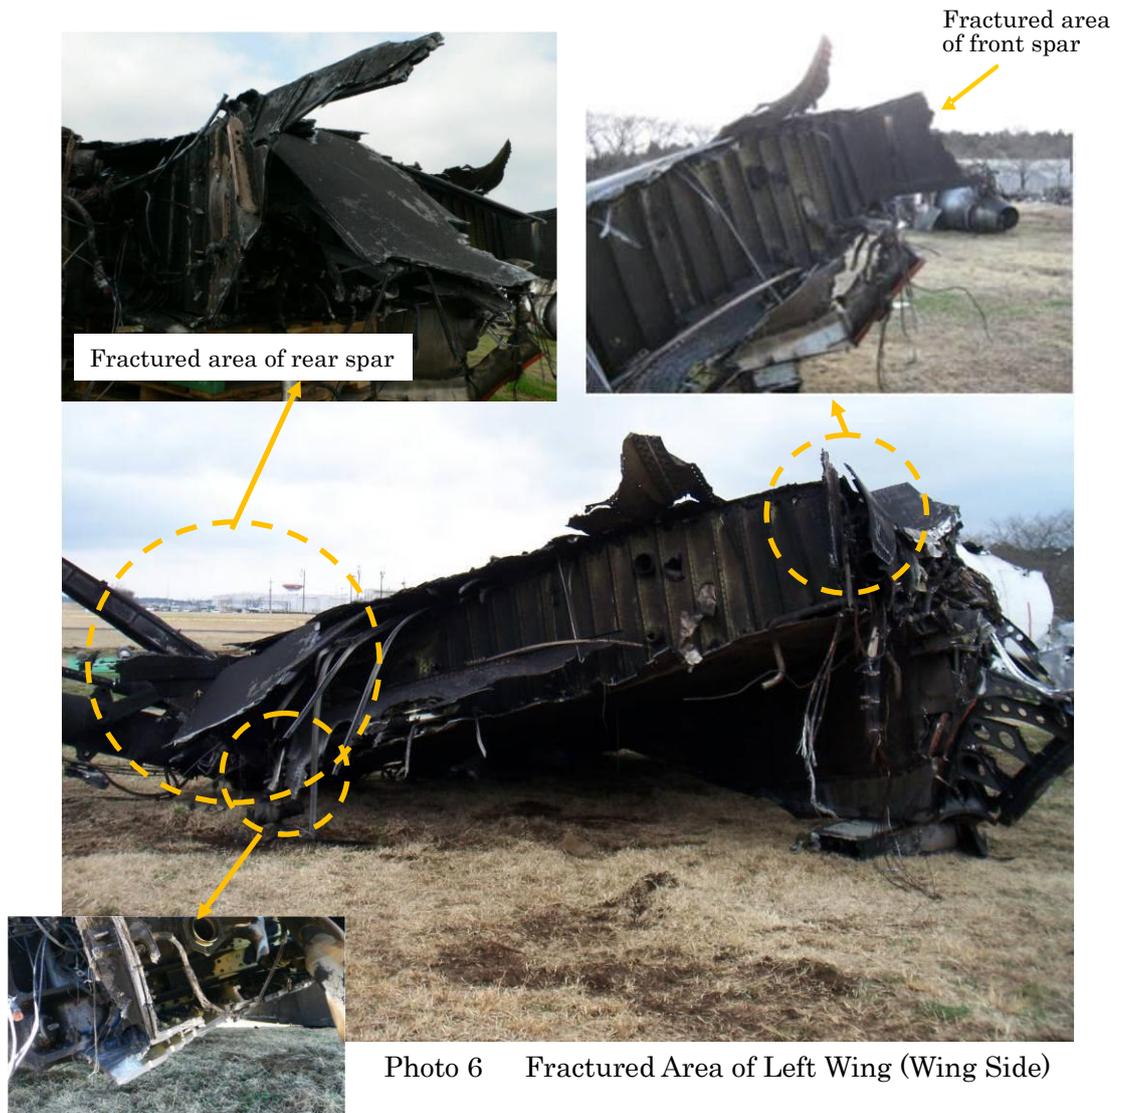
Photo 6 Fractured Area of Left Wing (Wing Side)

The fractured lower wing skin was applied with tension stress, forming openings between the skin and the stringer, with rivet heads broken. The skin near the rear spar was bent downward. (Photo 6)

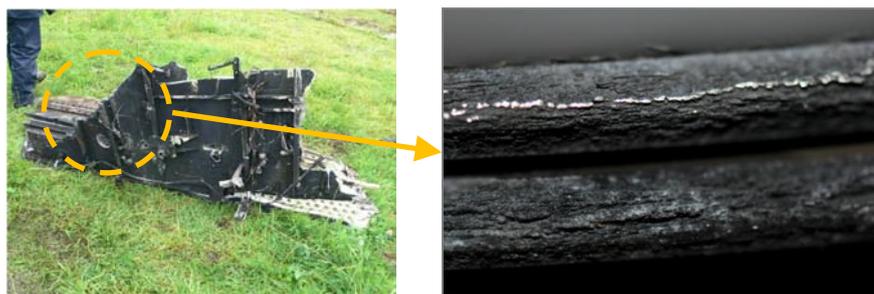
Photo 7 The fracture face of the left wing rear spar (fuselage side)

Fractured rear spar (except for the areas exposed to fire) was examined by JAXA. The fracture surface showed no indications of repetitive loads such as scratching. The examination showed that the spar fractured quickly under the excessive stress. (Photo 7)

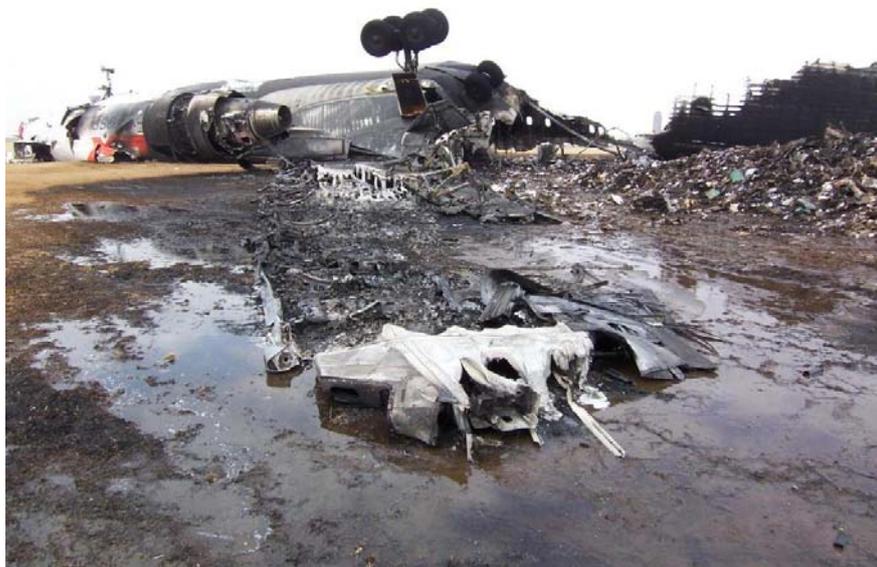
Photo 8 Right Wing

The right wing lay inverted attached to the fuselage. The fire consumed the most part of the wing. The remaining parts from the fire were melted or sooted.

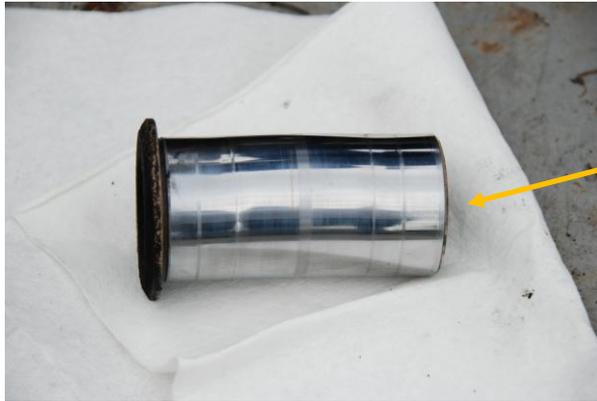
Photo 10 Forward Trunnion Bolt (Fuse Pin)

attached to the MLG. The forward trunnion bolt (fuse pin) was slightly deformed, however, it did not fail. About the two bolts which were attached to the side brace fitting (pillow block) and the trapezoid panel, the inboard bolt was broken leaving part of it in the panel, while the outboard bolt was removed from the pillow block out of the broken bolt hole, remained in the pillow block with the landing gear. A

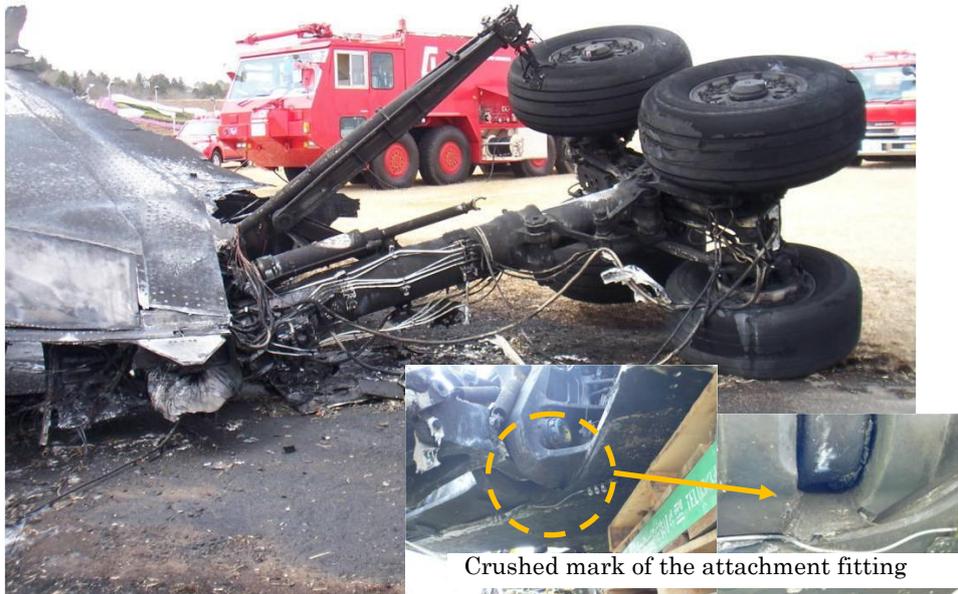
Photo 11 Left MLG

lug, which is connected to the lower end of the landing gear, was torn apart. The sooted left MLG strut was fully extended with no apparent damage. The surface of the four wheels and tires were all burned and sooted. There were slight traces of scratch on the two outer wheels. No. 5 and No. 6 tires were deflated without any indications of burst. The torque link was undamaged. The MLG attachment fitting had no damage, but in the lower part of fitting, there was dent caused by the strut. (See Photos 9, 10 and 11, Figure 3)

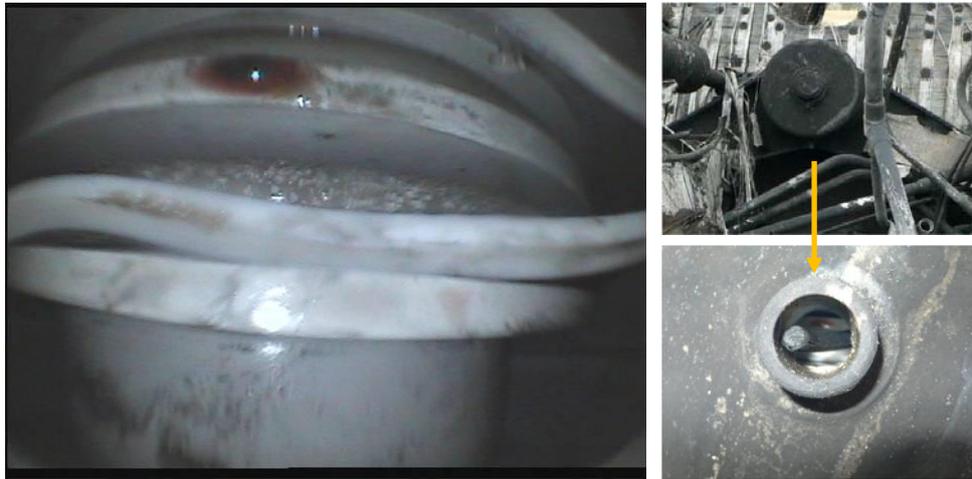
Photo 12 The Inside of the Blow-out Hole of Center MLG

The center MLG remained attached to the inverted fuselage, but as the fire consumed the fuselage interior, it somewhat drooped into the body. Borescope image (See Photo 12) through the strut blow-out hole shows the smashed crush tube*⁴, indicative of a strut bottoming. (See Figure 4)

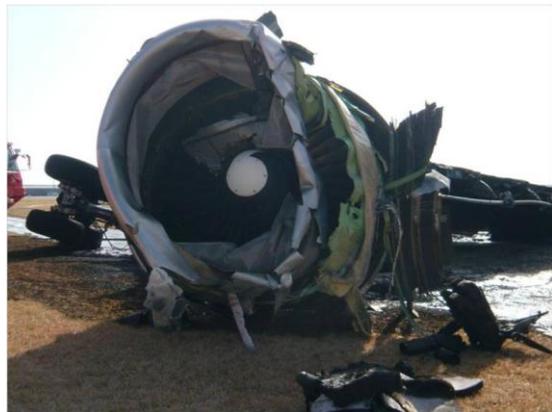
Photo 13 No.1 Engine

The lower side of the No.1 engine inlet cowl was grinded to inside of the fan cowl. The tip of the fan blades suffered gradual bending damages, while the left upper section of the fan cowl was

crushed, smeared with the paint of the fuselage. The thrust reverser actuator was in the retracted position. There was no indication of in-flight engine fire.

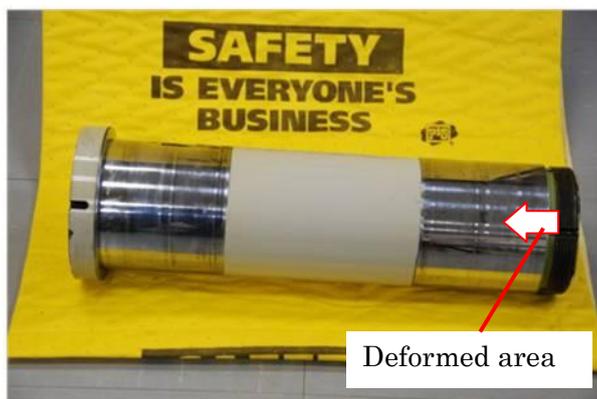
Photo 17 Track Beam Bolt

The left MLG had no exterior damage except for the fire damage or that caused by the movement from the accident site to the storage site. The longitudinal straightness of the outer diameter of the track beam bolt (parts number: ARG7373-1), which transfers the loads on the landing wheels to the struts, was measured with a thickness gauge at JAXA, and a gap of 0.03-0.04 mm was observed. The residual deformation generated the gap, and the gap was made as a result of the plastic deformation occurred to the bolt when it was exposed to a load.

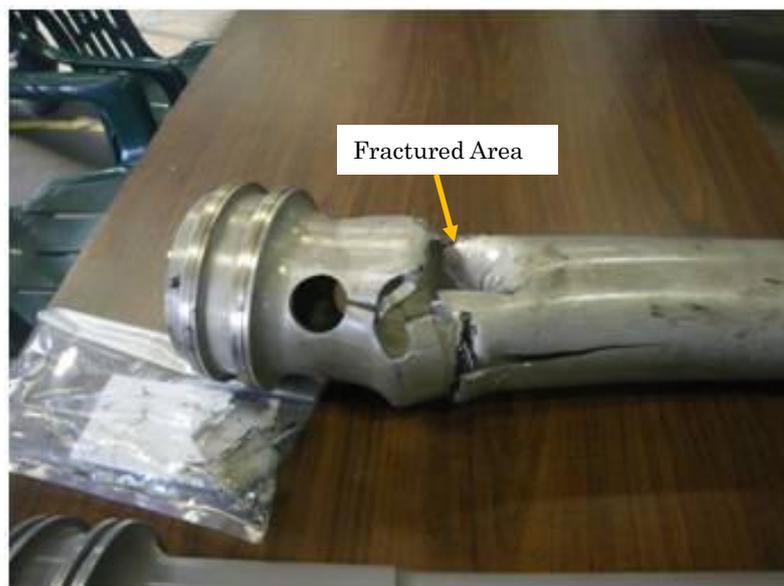
Photo 18 NLG Orifice Support Tube

Visual examination of the gear found no major damage except for damage caused by the movement from the accident site. The examination of the NLG components found that the orifice support tube was fractured through holes due to axial compression load.

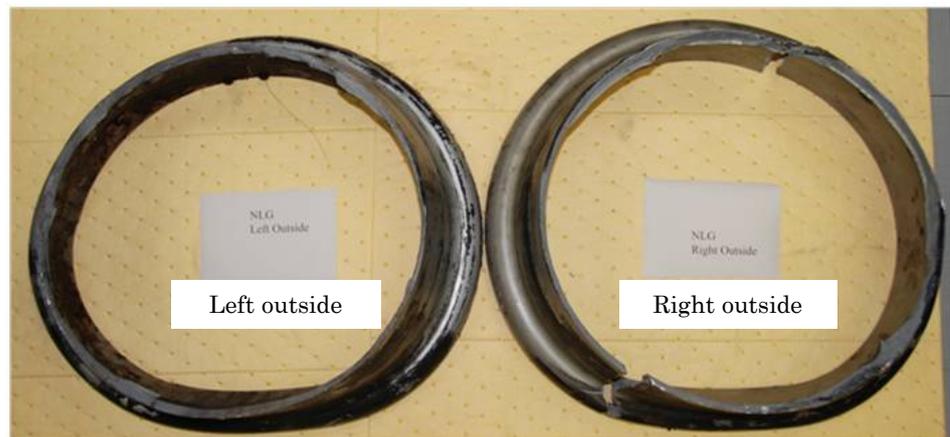
Photo 19 Fractured Pieces of NLG Wheels (Rim)

- (1) The rims were fractured with an upward load,
- (2) The wheel halves, which form the wheel hub, were extended outward and deformed to opening direction, and
- (3) The threads of the tie bolts and the nuts were fractured.

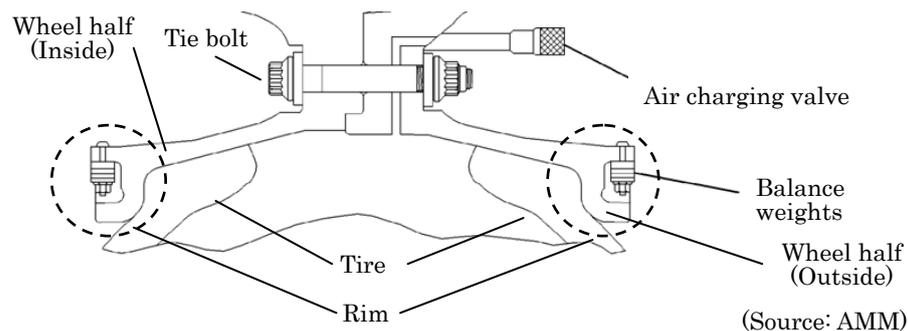
Figure 5 Cross-sectional schematic of NLG Wheel Hub

- (1) Large upward load applied upon touchdown of NLG caused the tire to expand sideways,
- (2) The rims were fractured with the bending load, while the wheel halves were forced to expand sideways stretching the tie bolts, and
- (3) The fracture of bolts' and nuts' threads made the nuts loose.

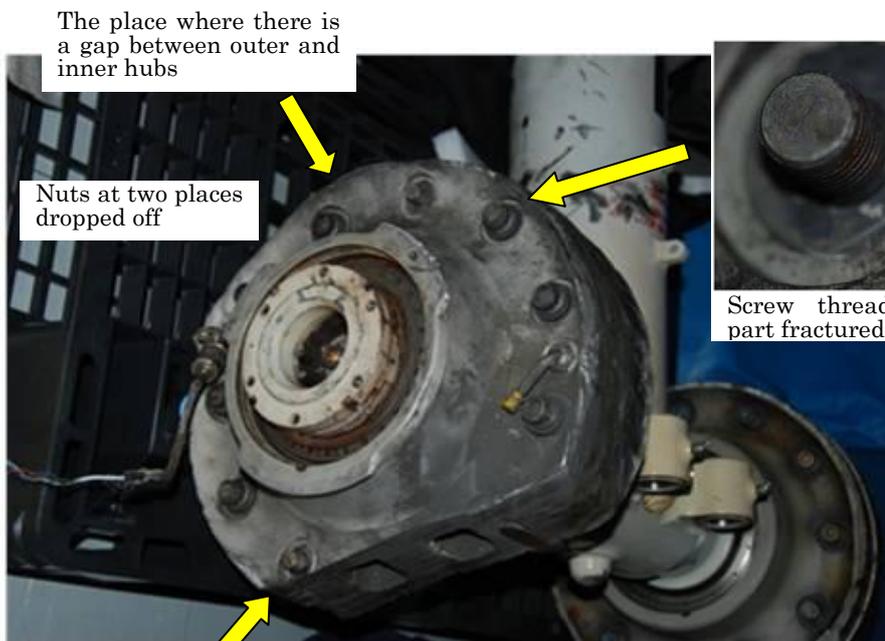
The place where there is a gap between outer and inner hubs

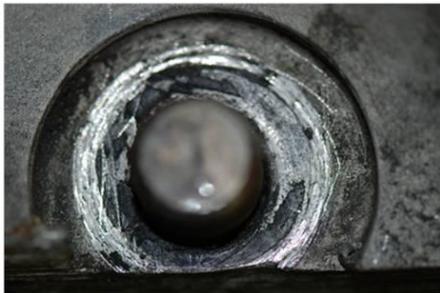
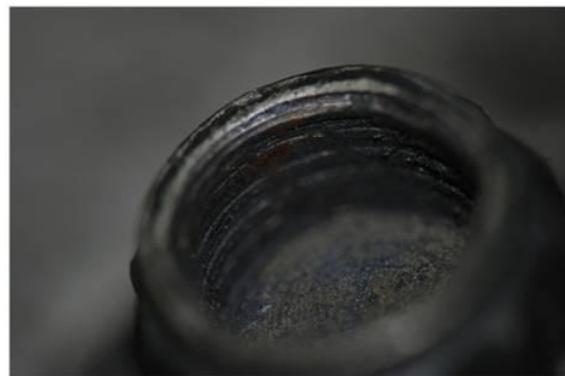
Scratch mark with washer (Nuts displaced by scraping with the ground.)

The inside of loosened nut (screw threads shaved, about to come off with tensile load)

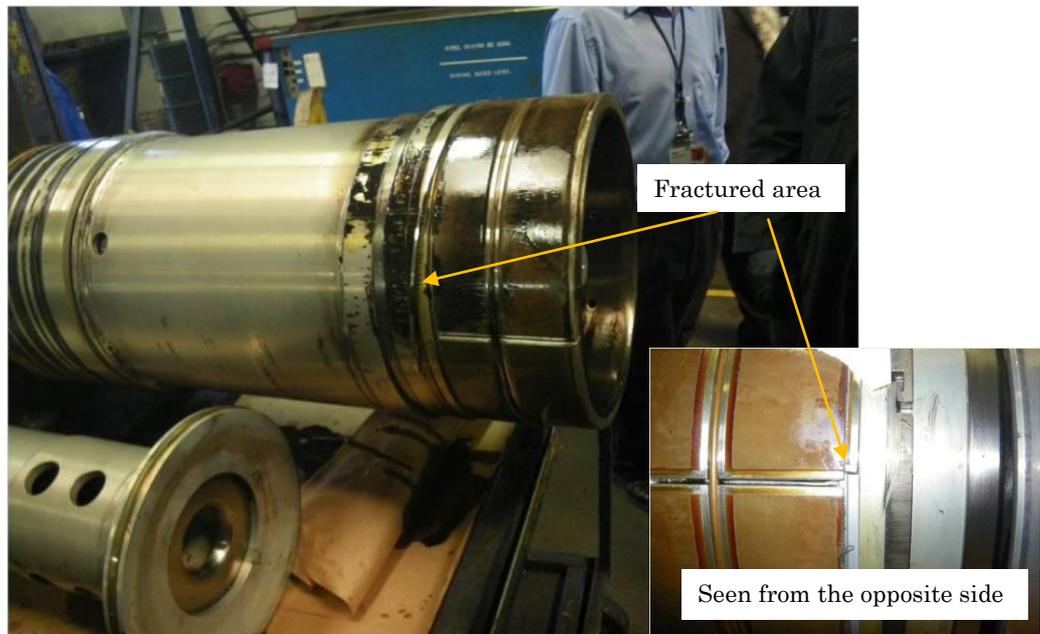
Photo 21 Left MLG Upper Bearing

Visual examination of the left MLG strut found no visible damage. The examination of the MLG components found no major damage with exception that the lower lip of the upper bearing (the inner part that supports the upper end of the piston) completely separated from the bearing halves at the place where it is connected to the other components.
