**AIRCRAFT SERIOUS INCIDENT
INVESTIGATION REPORT**

**HAWAIIAN AIRLINES, INC.
N 5 8 8 H A
ALL NIPPON AIRWAYS CO., LTD.
J A 8 3 5 6**

June 27, 2014

HAWAIIAN AIRLINES, INC.
BOEING 767-300, N588HA
ALL NIPPON AIRWAYS CO., LTD.
BOEING 767-300, JA8356
RUNWAY INCURSION
ON RUNWAY 06R AT KANSAI INTERNATIONAL AIRPORT
AT ABOUT 21:36 JST, OCTOBER 12, 2011

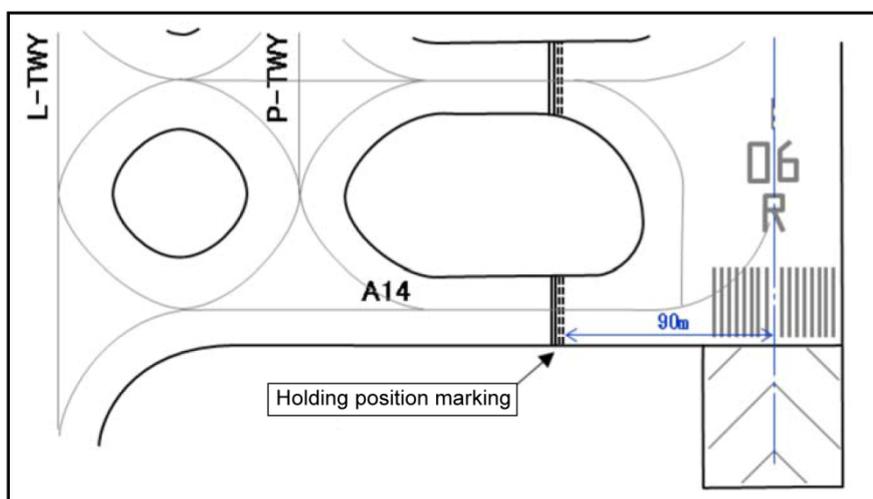
Taxiway A14 is located between the parallel Taxiway L and Runway A and runs across the parallel Taxiway P. Taxiway A14 leads to the entry to Runway 06R; therefore, it is primarily used for departing aircraft when they enter Runway 06R for takeoff. A holding position marking is installed at 90 m from the centerline of the Runway A to indicate where aircraft shall stop before entering the runway.

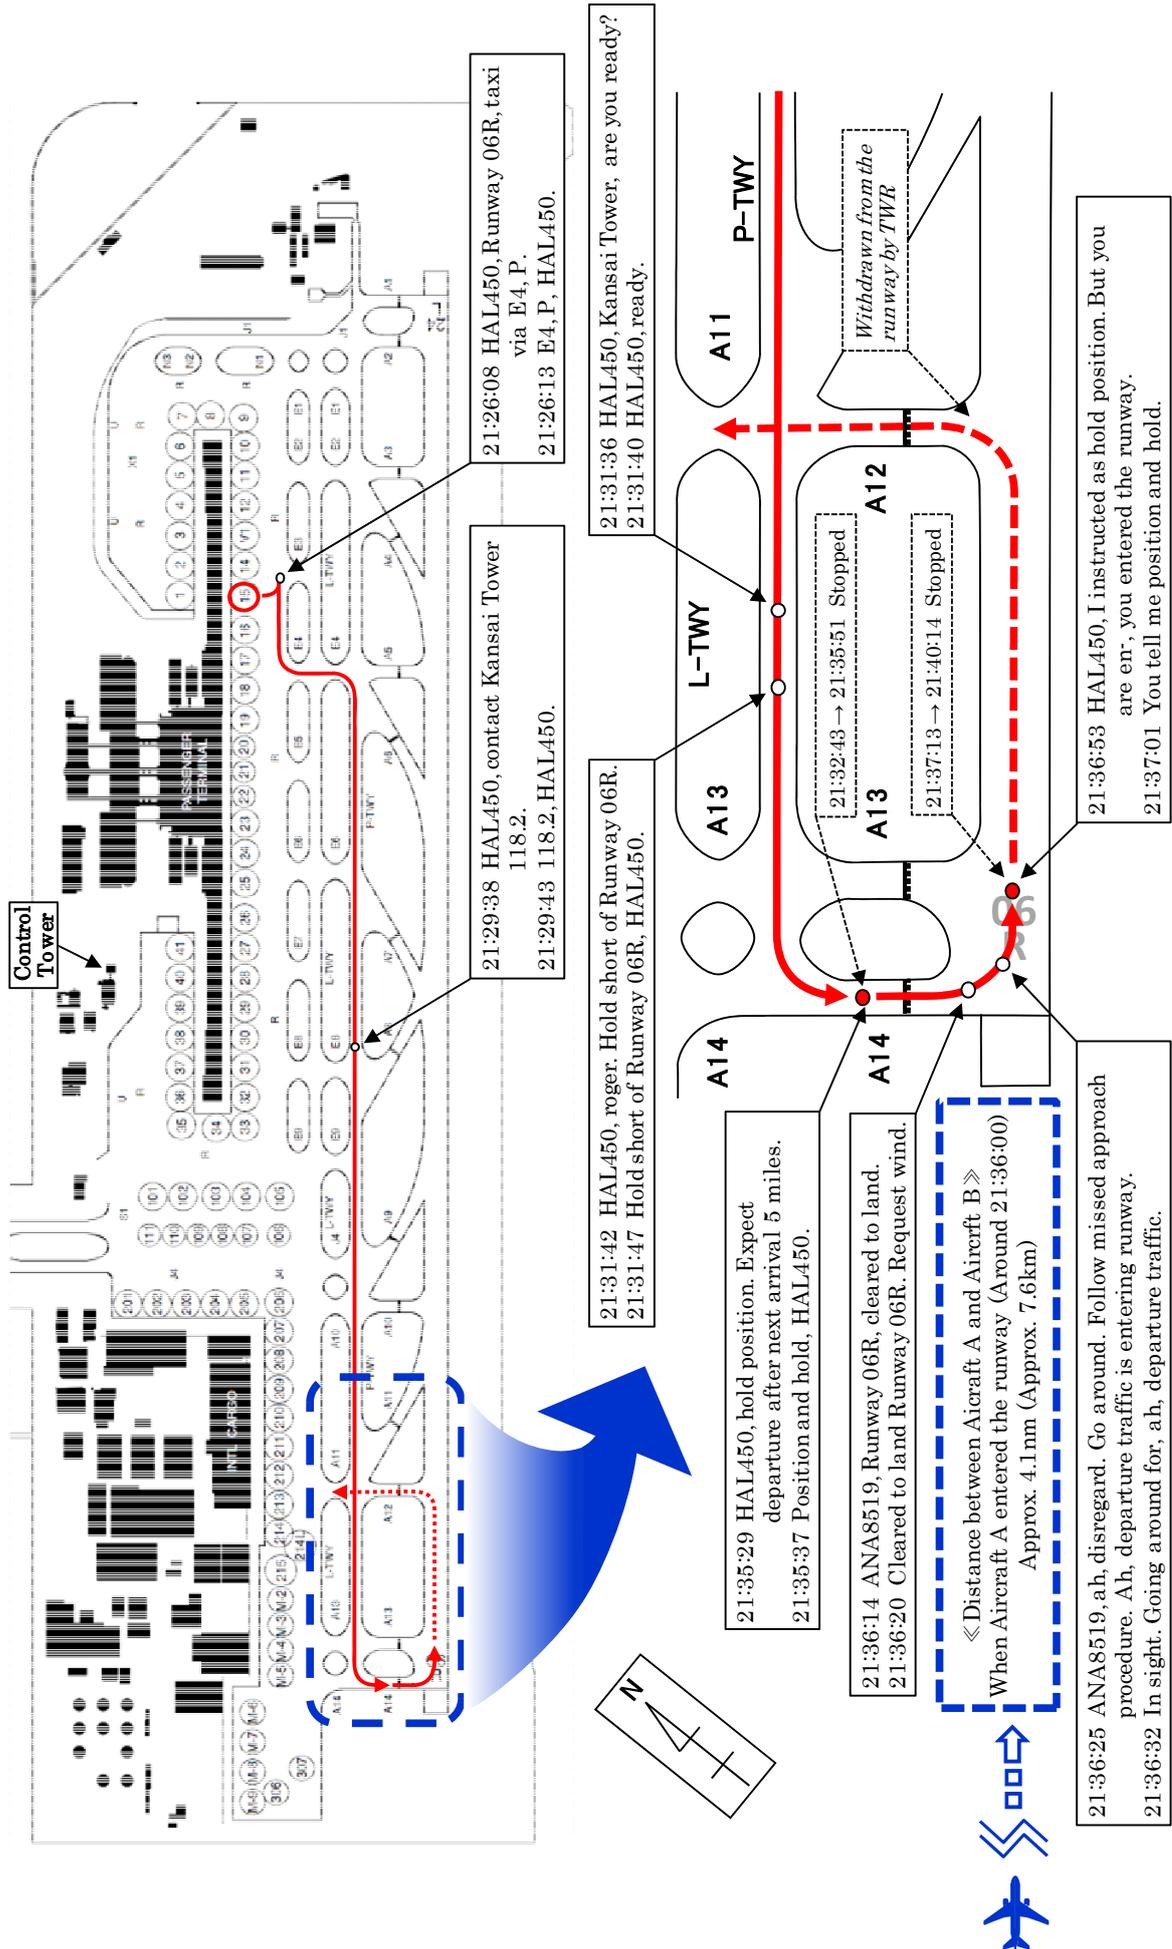
Figure 1: Estimated Taxing Route of Aircraft A

21:32:43	The Aircraft A entered Taxiway A14 and stopped short of Runway 06R.
21:34:11	The Tower cleared All Nippon Airways Flight 1720 (hereafter referred to as “the Aircraft C”), which was preceding the Aircraft B, to land on Runway 06R, and instructed it to take Taxiway A7 for leaving the runway, if possible, after landing. The Aircraft C read them back.

21:35:37	The Aircraft A read back saying “Position and hold.”
21:35:52	The Aircraft A on Taxiway A14 resumed taxiing, and then entered Runway 06R beyond the holding position marking.

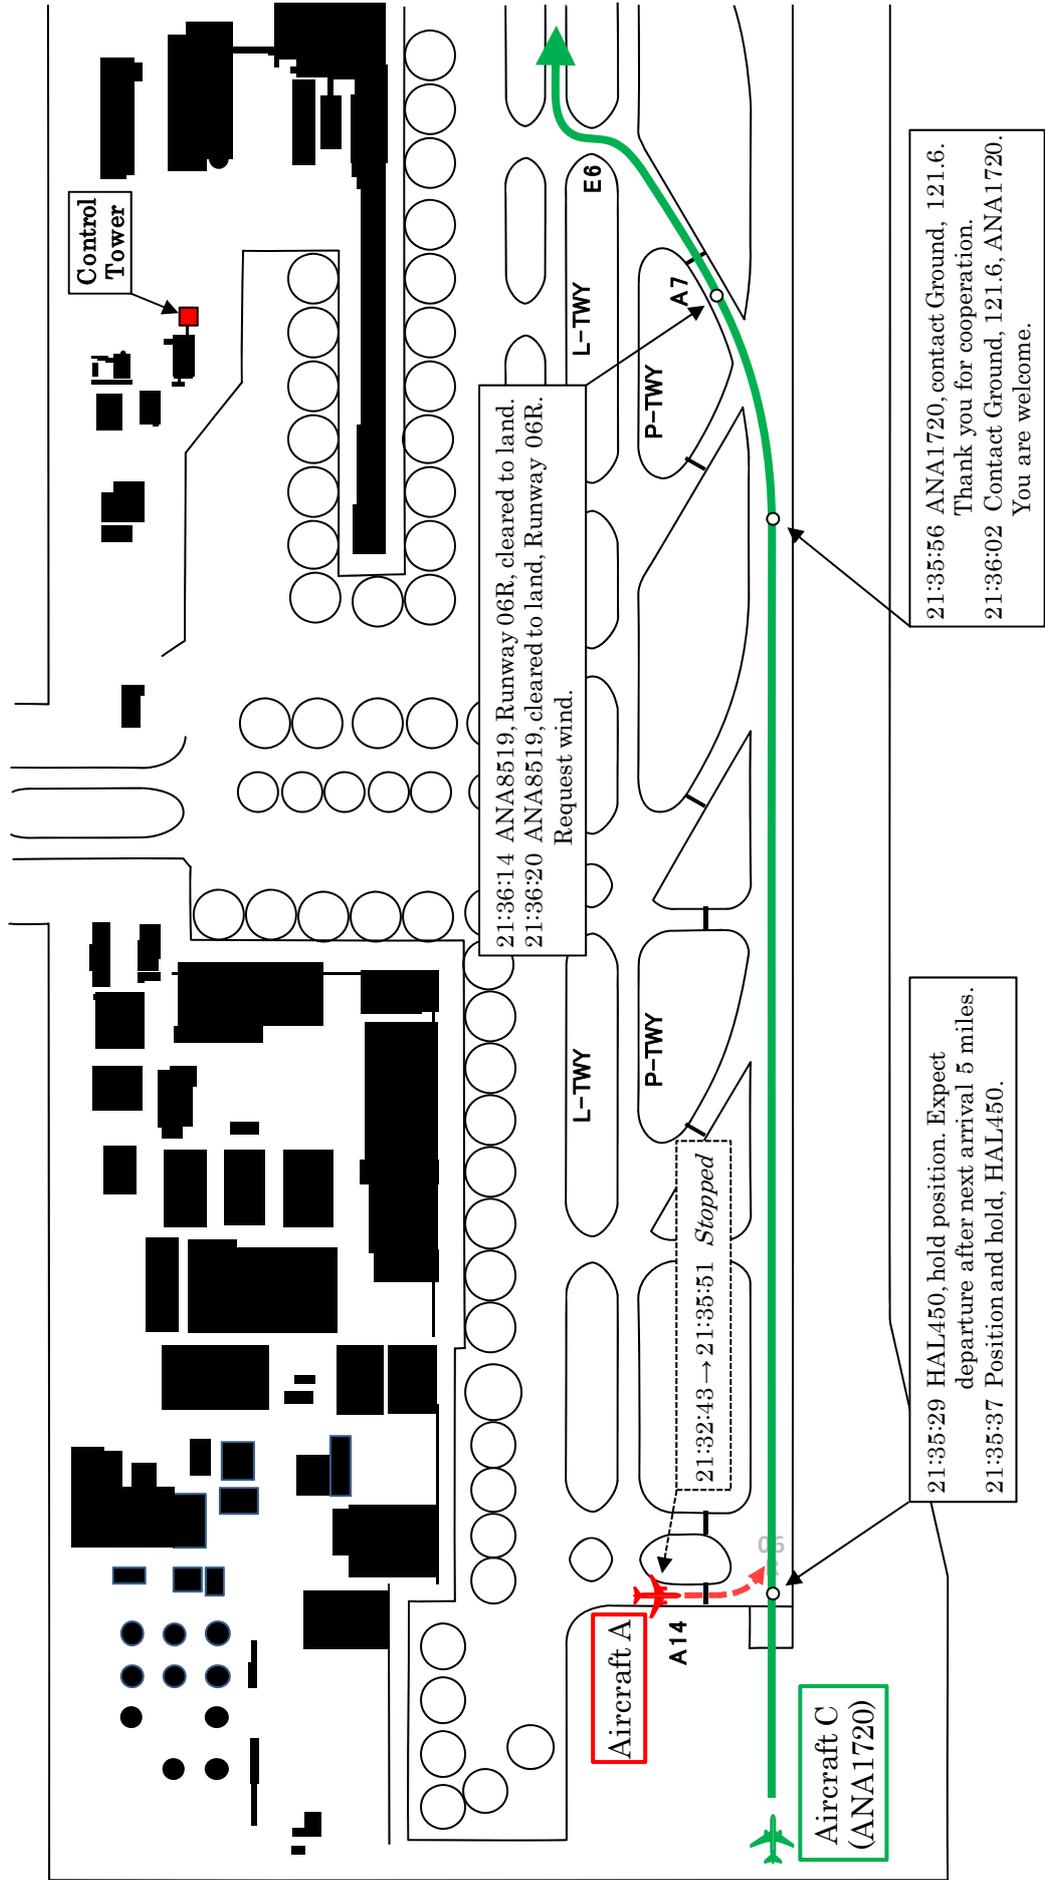
Figure 2: Estimated Landing and Taxiing route of Aircraft C

21:35:29	The Aircraft C passed over the runway threshold. The Tower instructed the Aircraft A, “Hold position” and also advised, “Expect departure after next arrival 5 miles.”

21:35:56	The Tower instructed The Aircraft C, which had landed and was leaving the runway through Taxiway A7, to contact the Ground.
21:36:14	The Tower cleared the Aircraft B to land on Runway 06R. The Aircraft B read it back and requested wind information.
