AA2004-2

AIRCRAFT ACCIDENT INVESTIGATION REPORT

ASB FLYING CLUB
SUKHOI SU-26, RA2821K
A CRASH TO THE GROUND
AERIAL CIRCUIT IN MOTEGI TOWN, HAGA COUNTY,
TOCHIGI PREFECTURE, JAPAN
OCTOBER 31, 2003

July 30, 2004

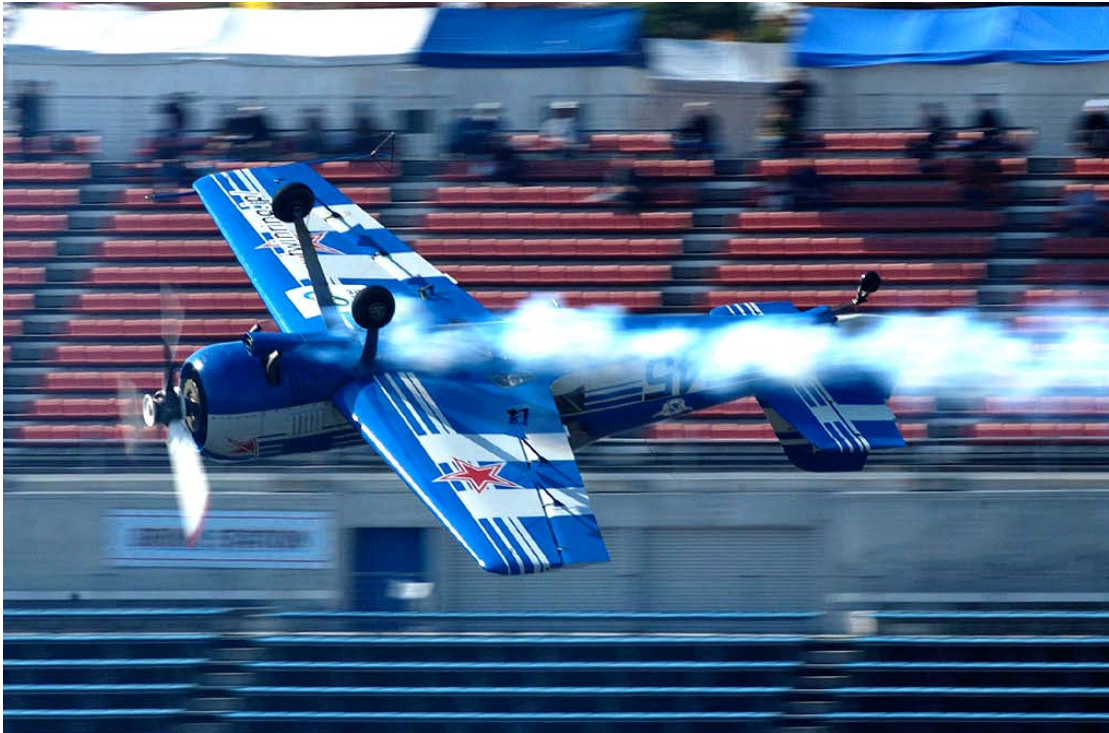
Photograph 1 Immediately before the Collision

After entering the course, when the aircraft had rolled inverted in level flight and was wings level, after the aircraft's right wing lowered (viewed from behind) and it moved to the right side of the course, then its left wing lowered and its flight direction changed from rightwards to leftwards (viewed along the course centerline). The aircraft began to climb as its left wing lowered and then just before the gate it began to descend.

Because the aircraft flew diagonally across the course to the left with its left wing lowered and it continued to descend after passing through the gate, the aircraft collided with a flood light stay and other obstructions located around 60m from the left pole of the gate in the direction of travel while inverted and crashed.

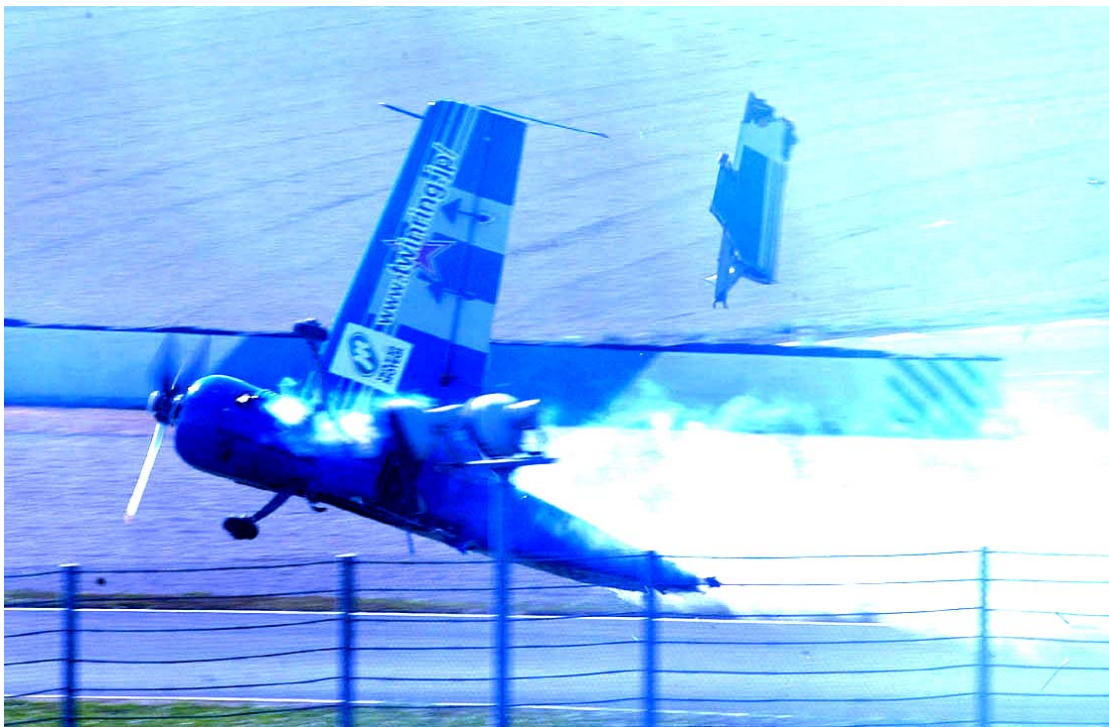
Photograph 2 Immediately after the Collision

It is estimated that because the aircraft had deviated to the left of the course as a result of flying across the course in a banked attitude, and because it was in a steep descent attitude just before the tape, the Captain raised the aircraft's nose in front of the lighting pole, but it was too late and the aircraft collided with the flood light stay, which was 5.4m lower than the poles from which the tape was stretched, and other obstructions near the left of the course, in inverted flight and crashed.

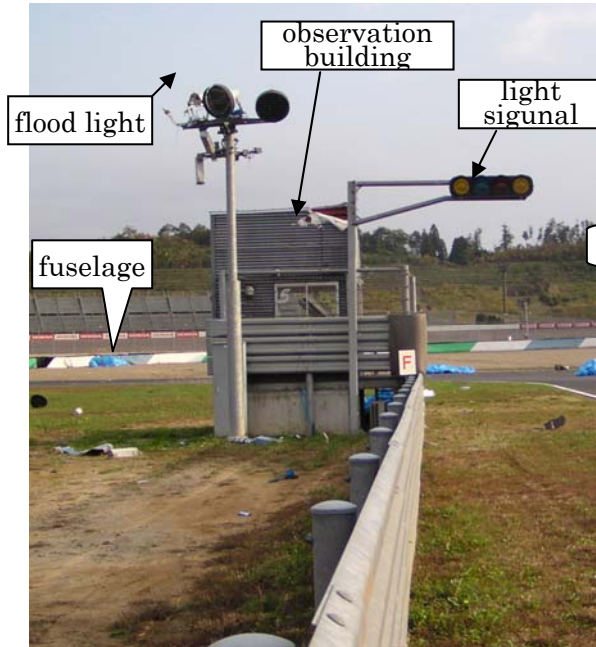
Photograph 3

A flood light stay, a light signal stay and the roof of a small observation building were damaged.

The accident site was located in the Twin Ring Motegi Auto Racing Circuit. Two of the four lights on the flood light stay which the aircraft collided with were damaged, and the arm to which the lights were attached was rotated 180 degrees horizontally. A signal pole located around 2m from the lighting pole's course side was slightly inclined in the aircraft's direction of travel, part of the roof of a neighboring observation building was damaged and a horizontal stabilizer had fallen near the observation building. There were several score marks on the asphalt surface of the racetrack caused by propeller strikes around 50m from the observation building in the aircraft's direction of travel. Traces attributed to collision with aircraft's nose and canopy were found on the shock-absorbing crash barrier made of piled tires that surrounds the racetrack around 100m from the observation building in the aircraft's direction of travel.

Flood light stay
Light signal stay
Observation building

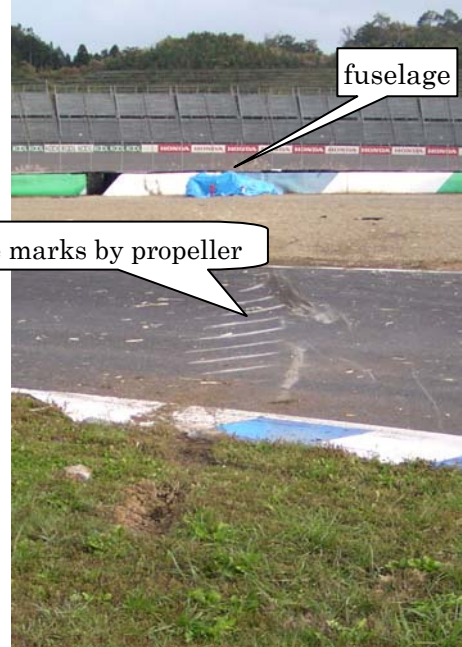
Photograph 4

The aircraft's fuselage came to rest around 5m in front of the crash barrier, and the left wing separated at the root and came to rest around 10m from the fuselage in the aircraft's direction of travel. The wooden propeller was broken into small fragments, and aircraft debris was scattered over an area around 35m wide and around 75m long in the direction of travel from near the flood light stay.

Score marks
by propeller

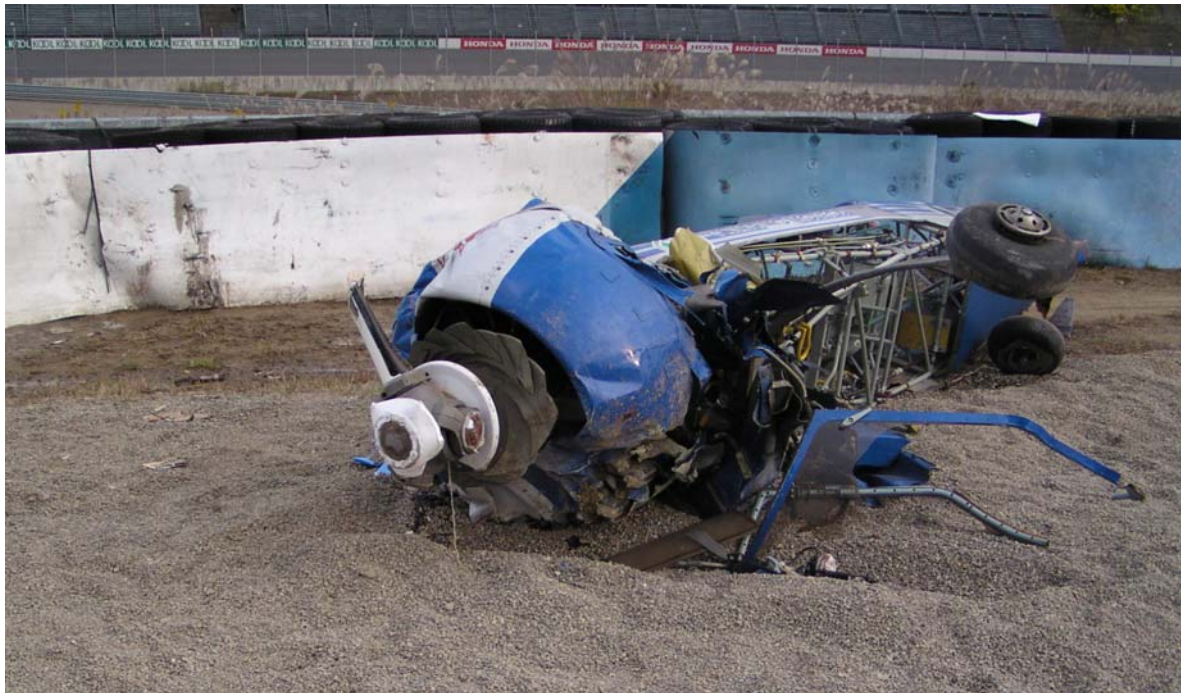
Photograph 5 Accident aircraft(Fuselage)

The aircraft was severely damaged.

Fuselage:	Damaged
Wings:	Right wing: broken at the mid span and at the root Left wing: severed at the root.
Vertical stabilizer:	Broken off at the root and at upper portion.
Propeller:	All three wooden propeller blades were destroyed, breaking into small fragments.
Landing gear:	The right main gear was severely damaged by bending. The tail wheel was damaged.

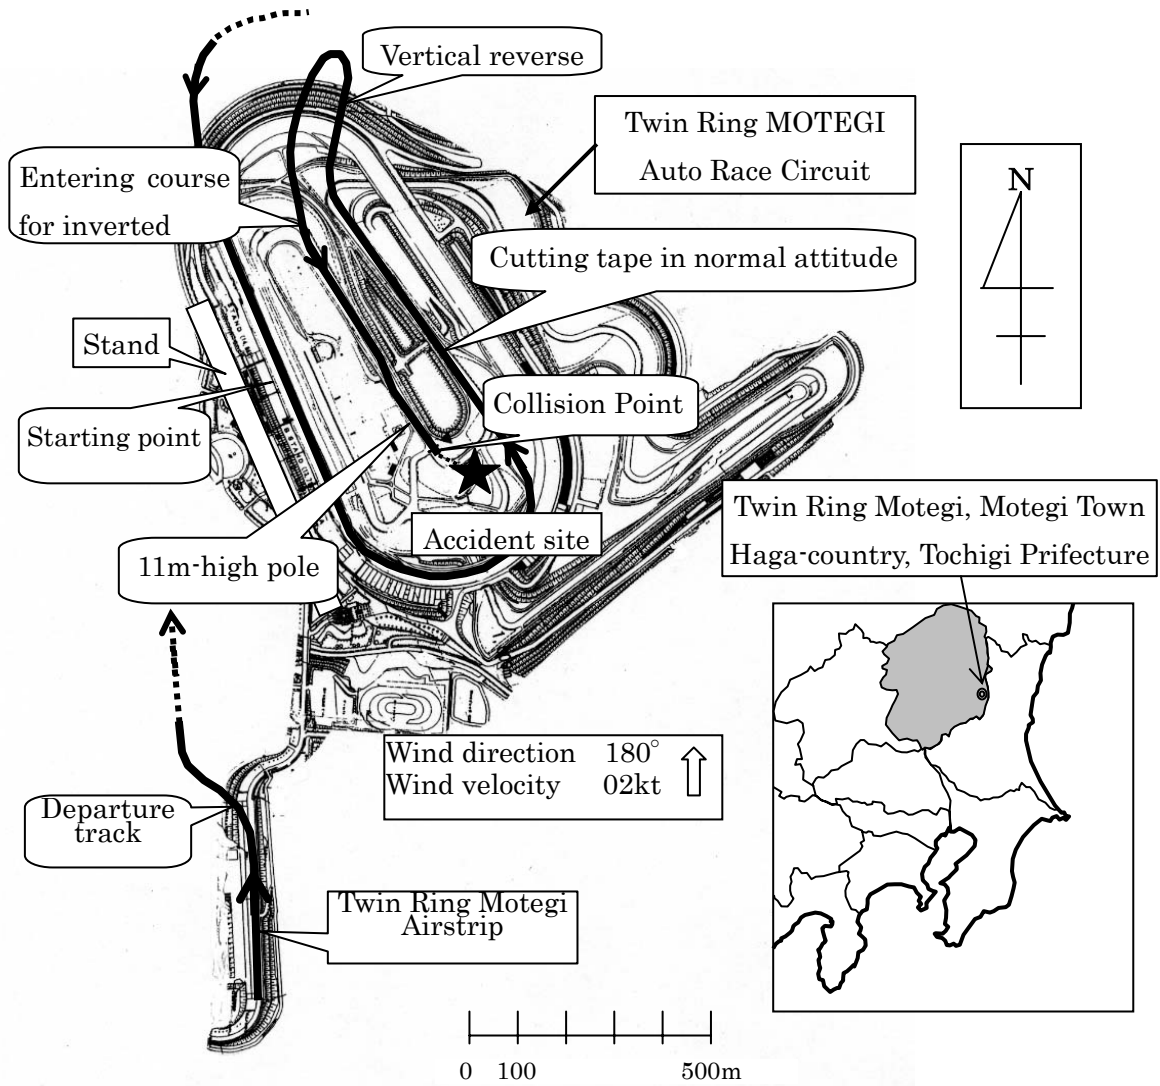
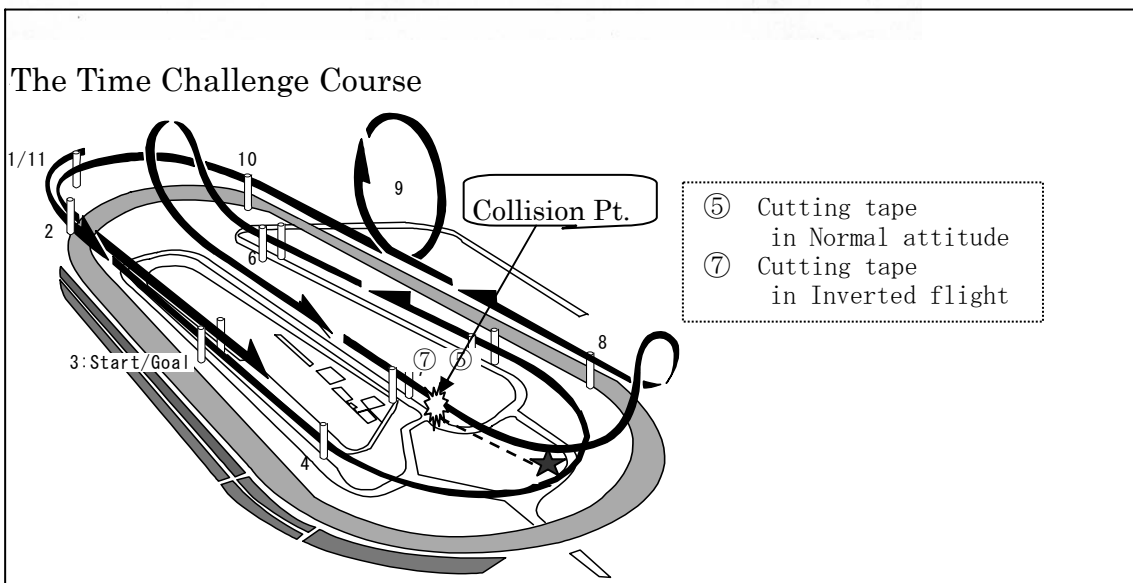
Figure1 Estimated Flight Path

After succeeding in cutting the first tape by passing through the gate in a normal flight attitude, the aircraft performed vertical reverse and then made a steep descent to enter the course for the next gate to cut the tape in inverted flight (Refer Figure 1 (7).)

3.1.4 As described in section 2.11, the aircraft performed vertical reverse and entered the course in level flight just above the course centerline, and then become inverted by rolling to the right. It is estimated that the aircraft deviated to right from of the course centerline at that time because the right side wing was lowered (viewed from rear). After that, it is estimated that the aircraft recovered to wing levels and then in order to align with the course, the left side wing was lowered (viewed from rear), and at the same time the aircraft started to climb.

The aircraft climbed to a height of around 20m while flying inverted from the right to the left of the course. After that, it is estimated that the Captain sighted the target tape in front of him and aiming for it, he descended while flying diagonally across the course.

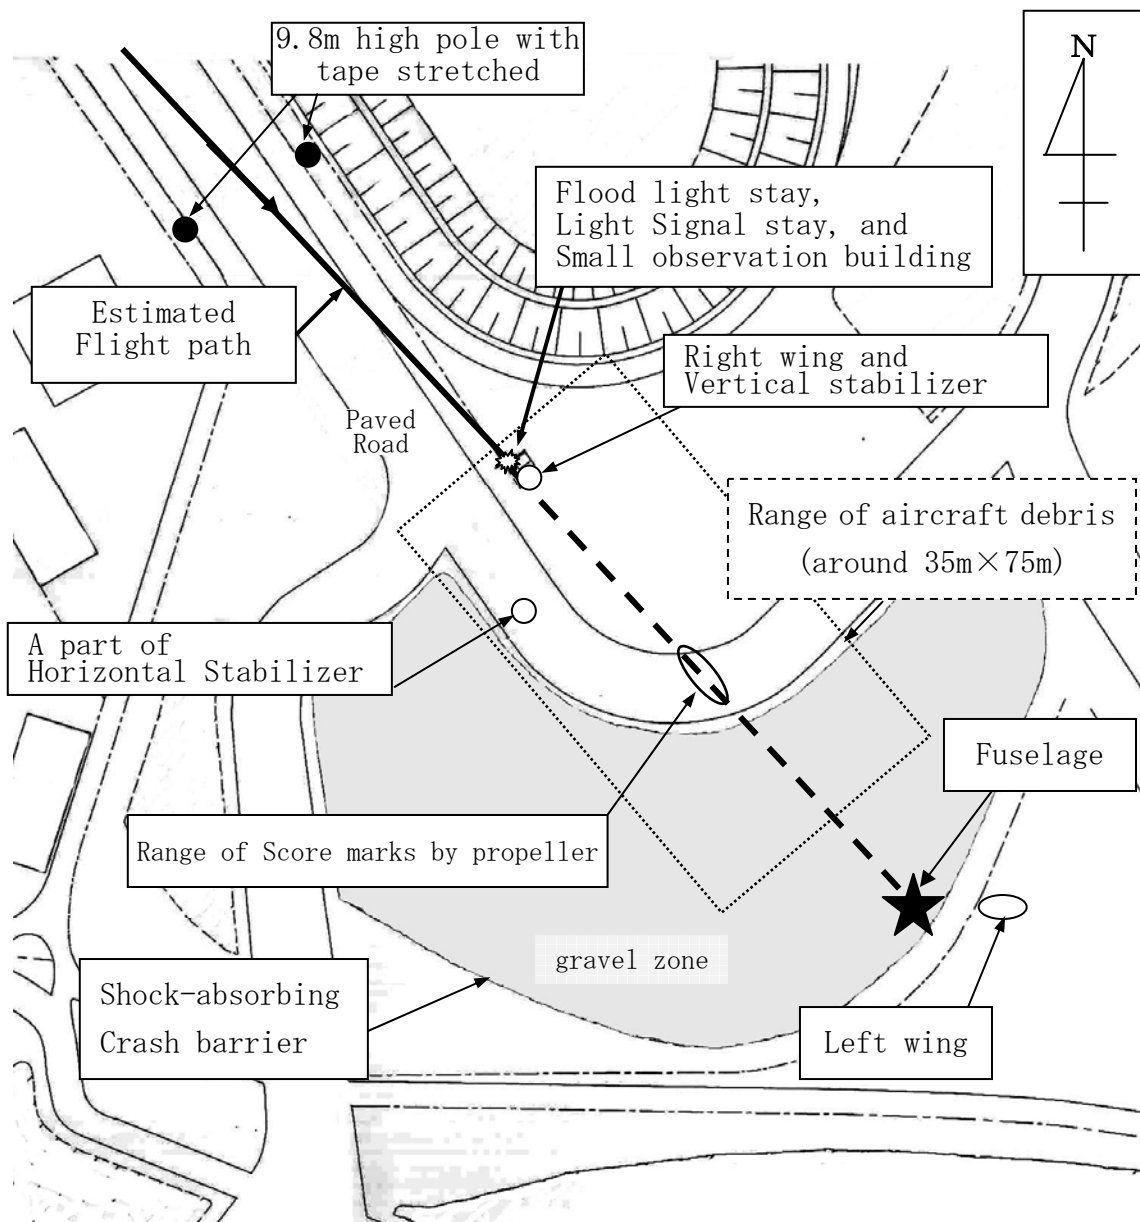
Figure 2 Topography of the Accident Site

The inverted flight portion of the air race course was set to be 200m away from the stand of the circuit.

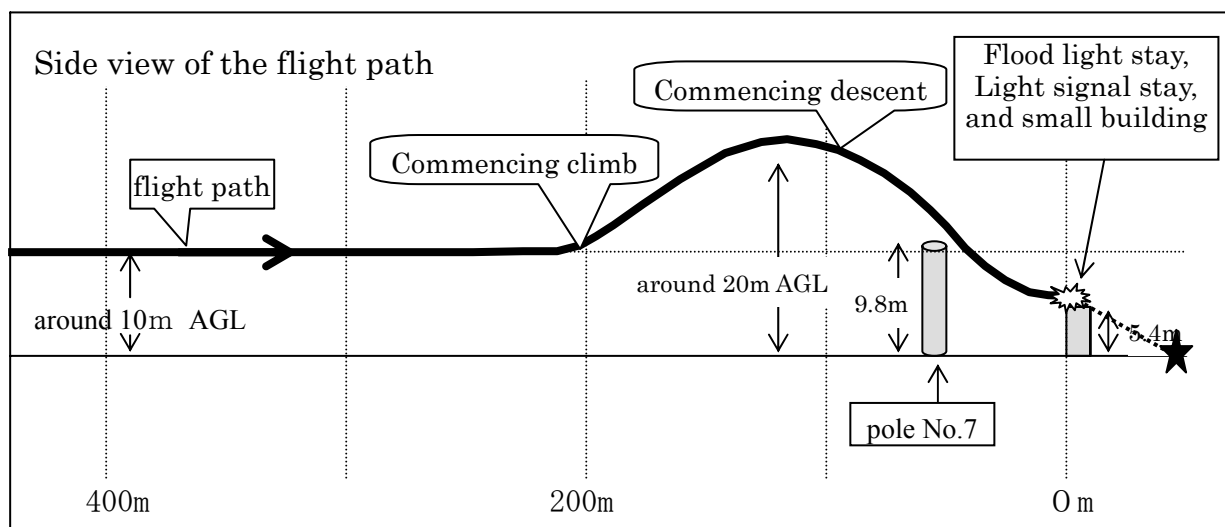
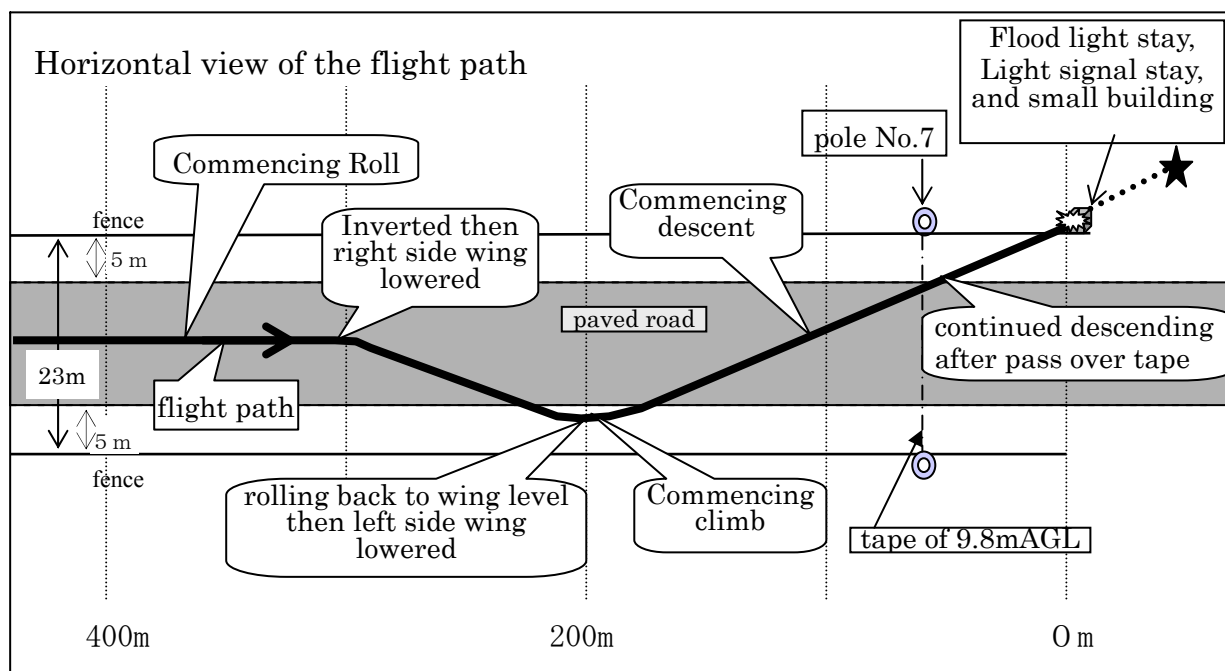
Figure3 Analysis of Estimated Flight Path

The aircraft entered the course just above the centerline of paved road at a height of around 9.8m above the ground. The aircraft rolled to the right at 1030:40, and became inverted at 1030:40.5, at which time it was around 10m above the ground. Viewed from behind, once the aircraft had become inverted the right side wing lowered and it started to deviate right of the course centerline. At 1030:42.0, viewing along the direction of travel, the aircraft entered the non-paved zone at the right side of the road, and after rolling back to wings level, the left side wing lowered viewed from behind the aircraft, and at a time the aircraft started to climb. At 1030:43.4 the aircraft reached an altitude of around 20m above ground.

Thereafter, the aircraft started to descend with the left side wing lowered viewed from behind from around 60m before the gate, and at 1030:44.3, it passed over the tape stretched 9.8m above ground at the gate slightly to the left of the course centerline. The aircraft continued descending after passing the gate with the left side wing lowered (viewed from the rear), flew diagonally across the course and deviated from the course to the left. Although the aircraft’s nose lifted just before the lighting pole, at 1030:44.9 its right wing struck the flood light stay at a height of 5.6m above the ground a distance of 60.5m from left side pole exit gate pole in the direction of the travel. The root of the tail wing then collided with a 5m-high light signal stay, and the aircraft crashed.

The aircraft’s average airspeed during the time from level flight before starting to roll until striking the flood light stay was 270km/h (approx. 75m/s), the time between starting to climb until the first collision was around 2.8 seconds, and the flight distance was around 200m.
