MA2013-9

**MARINE ACCIDENT
INVESTIGATION REPORT**

Accident Type	Fatal accident involving a superintendent
Date and Time	Unidentified : between 03:15 and 07:25, October 6, 2012 (local time, UTC + 9 hours)
Location	Kudamatsu Coal Transshipment Terminal, Tokuyama-Kudamatsu Port, Yamaguchi Prefecture (approximately 33°58.7' N, 131°53.2' E)
Summary of the Accident	While the cargo ship SAGE SAGITTARIUS was unloading coals from the cargo holds by operating unloaders of the automatic unloading device at Kudamatsu Coal Transshipment Terminal in Tokuyama-Kudamatsu Port on October 6, 2012, Superintendent under boarding the vessel for undertaking the maintenance of the device and instructing the method of operation was found trapped in feeder conveyor roller of the unloader at about 07:25 and was confirmed dead.
Process and Progress of the Investigation	<p>(1) Set up of the Investigation The Japan Transport Safety Board appointed an investigator-in-charge (from the Hiroshima Regional Office) and a regional investigator to investigate this accident on December 13, 2012. Later, the Board appointed another investigator-in-charge and a marine accident investigator.</p> <p>(2) Comments from Parti

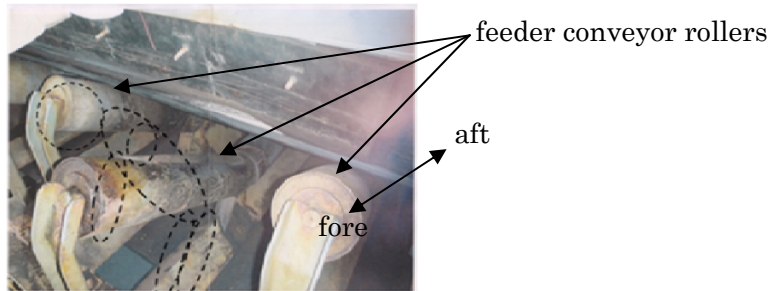
Photo3: The Site Where the Accident Occurred

Injuries to Persons	One fatality (SI)
Damage to Vessel (or Other Facilities)	None
Events Leading to the Accident	<p>(1) Movement of the Vessel</p> <p>(a) The Vessel was loaded with coals and departed from Newcastle Port, Commonwealth of Australia for Japan on September 17 with Master, 24 crew members (all with Philippine nationality), SI and another person on board.</p> <p>(b) The Vessel berthed alongside at Kudamatsu Coal Transshipment Terminal in Tokuyaka-Kudamatsu Port at about 07:30 on October 3, 2012.</p> <p>(2) Cargo handling situation</p> <p>(a) According to the plan laid by Sankyu Inc. (hereinafter referred to as “Company B”), the unloading of coals from the cargo holds of the Vessel was to be started at about 17:00 on October 3, and to be completed during October 6.</p> <p>(b) The gang of stevedores of Company B in charge of the coal unloading work by operating No.1 unloader (hereinafter referred to as “No.1”) consisted of a foreman, an operator and a deckman.</p> <p>(3) Course of the events</p> <p>While the Vessel was unloading coals from the cargo holds by operating No.1 at Kudamatsu Coal Transshipment Terminal, SI was informed by a stevedore that the feeder conveyor of No.1 was making an abnormal noise. Therefore, SI identified the feeder conveyor roller which was generated abnormal noise (hereinafter referred to as “the Roller”). Accordingly, SI stopped the abnormal noise by lubricating the Roller without stopping the operation of No.1. As the Roller made an abnormal noise again while the coal unloading work was going on, SI told a stevedore that he would lubricate the Roller about every three hours.</p> <p>Informed by a stevedore that the Roller was making an abnormal noise at about 02:00 on October 6, SI replied that he would go to check the situation later on.</p> <p>At about 03:15, an able seaman of the Vessel saw SI walking toward No.1 with a torch lamp.</p> <p>At about 07:25, finding a human leg protruding above the feeder conveyor passage of No.1, the operator in the operation room of No.1 put No.1 to an emergency stop and radioed to the deckman for confirming the situation. The deckman found SI trapped in the Roller.</p> <p>The ambulance crew of the Kudamatsu City Fire Station in response to the notification boarded on the Vessel at about 07:42, and then confirmed the death of SI.</p>

The crew of the Vessel started removing the Roller and other related works at about 07:50. The ambulance crew carried SI out of the Vessel at about 08:54. On the other hand, a broken lubricating oil can was found near the feeder conveyor of No.1.

The autopsy diagnosed the cause of SI's death as suffocation by chest compression.

<p>Analysis</p> <p>Involvement of Crew</p> <p>Involvement of Hull, Engine, etc.</p> <p>Involvement of Weather and Sea Conditions</p> <p>Analysis of the Findings</p>	<p>Applicable</p> <p>Applicable</p> <p>Not applicable</p> <p>(1) The cause of SI's death was suffocation by chest compression.</p> <p>(2) It is probable that SI told a stevedore that he would lubricate the Roller about every three hours, because the Roller generated an abnormal noise again even after SI stopped the abnormal noise by lubricating the Roller without stopping the operation of No.1 while the Vessel was unloading coals from the cargo holds by operating No.1 at Kudamatsu Coal Transshipment Terminal in Tokuyama-Kudamatsu Port.</p> <p>(3) It is probable that SI replied that he would go to check the situation later on when informed by a stevedore that the Roller were making an abnormal noise at about 02:00 on October 6.</p> <p>(4) It is probable that according to the findings that an able seaman of the Vessel saw SI walking toward No.1 with a torch lamp at about 03:15 and that a stevedore found SI trapped in the Roller at about 07:25 while the Vessel was engaged in unloading work by operating the automatic unloading device, SI was caused to be dead by having been trapped in the Roller between these times.</p> <p>(5) It is probable that according to the findings that a broken lubricating oil can was found near the feeder conveyor of No.1, SI was trapped in the Roller when he was lubricating the Roller by himself in the feeder conveyor passages without stopping the operation of No.1. However, it was not possible to determine the situation in which he was trapped in the Roller because there were no witnesses of the accident.</p> <p>(6) It is somewhat likely that because of the following reasons, SI tried to manage the situation only by lubricating the Roller without replacing them.</p> <p>(a) The new crew after changing entirely at Newcastle Port were unaccustomed to replacing feeder conveyor rollers.</p> <p>(b) Replacing the Roller required the unloading work to be suspended for about one hour.</p> <p>(7) It is probable that SI was lubricating the Roller in the feeder conveyor passage without stopping the operation of No.1, and it was also probable that he was required to pay attention to the movement of the grab, according to the findings that the feeder</p>

<p>conveyor and its passages moved fore and aft as the grab moved, which might possibly break down SI's posture while working in the feeder conveyor passage, and that the warning system was not to be activated when the feeder conveyor passages and others moved. However, it is somewhat likely that only a single floodlight set up in the feeder conveyor passages was not bright enough for making it possible to confirm the movement of the grab while working at night.</p>
Probable Causes	<p>It is probable that the accident occurred because SI was trapped in the Roller while lubricating the Roller in the feeder conveyor passage after being informed that the Roller were making an abnormal noise again, as the Roller were to be lubricated every three hours after SI managed to stop the previous abnormal noise in the feeder conveyor by lubricating the Roller without stopping the operation of No.1 while the Vessel was unloading coals from the cargo holds by operating No.1 at Kudamatsu Coal Transshipment Terminal in Tokuyama-Kudamatsu Port.</p>

Safety Actions	<p>After the accident, Company A implemented the following measures.</p> <ol style="list-style-type: none"> (1) Gratings for preventing from getting trapped in feeder conveyor rollers were installed along a feeder conveyor and a longitudinal conveyor. (2) A switch and an activating wire for putting a conveyor to an emergency stop were installed in a feeder conveyor. (3) Additional floodlights were set up along feeder conveyor passages. (4) A safety manual was made prescribing such measures as suspending the unloading work before replacing conveyor rollers when they were making an abnormal noise.
