MA2010-5

**MARINE ACCIDENT
INVESTIGATION REPORT**

MARINE ACCIDENT INVESTIGATION REPORT

Vessel type and Name: Fishing vessel DAIEI-MARU No.11

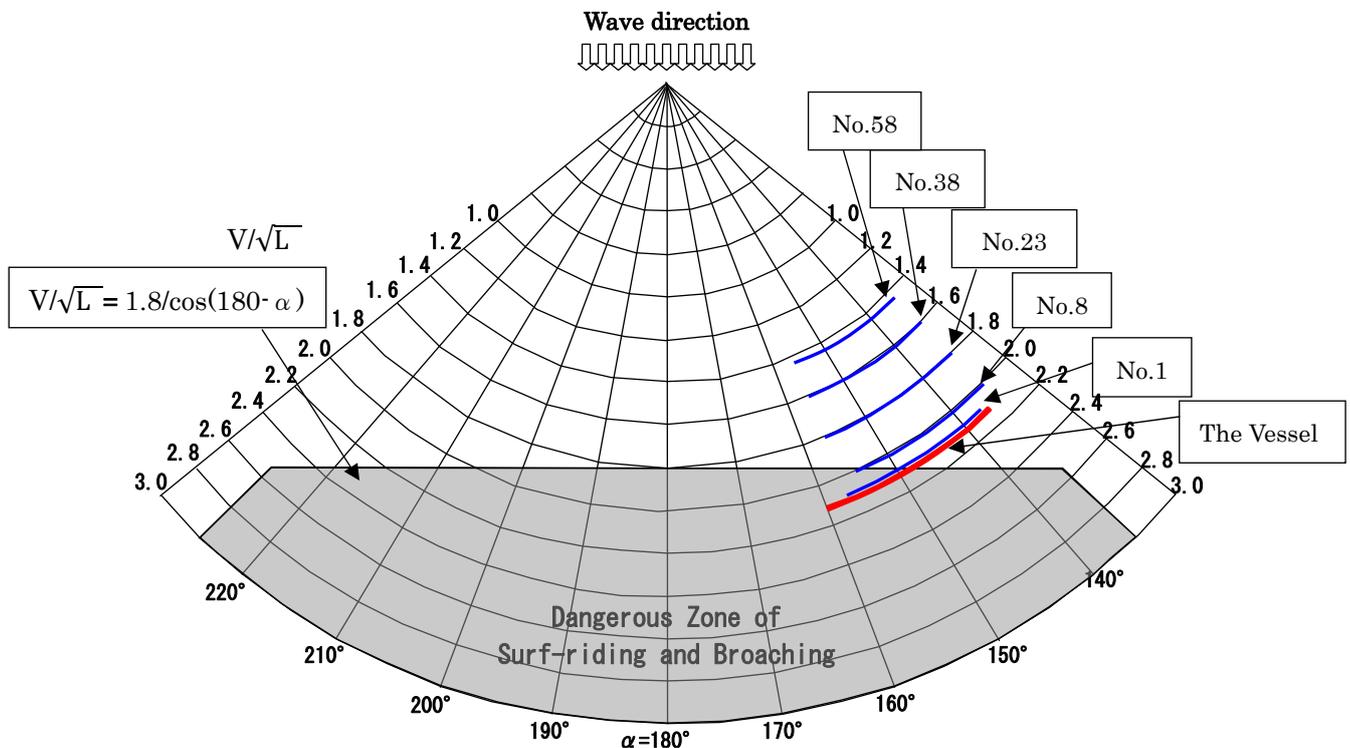
According to 2.8 (1) and (1) above, it is probable that when the accident occurred, the angle of encounter of the Vessel was within the range of conditions inducing the occurrence of surf-riding and broaching phenomena, and the Vessel was put in a dangerous situation which might lead to surf-riding and broaching because such conditions were satisfied when the angle of encounter became about 154° to 161°.

However, according to the findings that the Vessel turned to port after steering to port before capsizing, and turned to starboard after steering to starboard after being hit by the Second Wave and, it is probable that the Vessel was steerable at that time and neither surf-riding nor broaching occurred.

With respect to the consort vessels, it is probable that while No.1 was situated in the dangerous zone when the angle of encounter became about 155° to 158° as shown in the figure above, the other consort vessels were situated outside the dangerous zone.
