MA2014-1

**MARINE ACCIDENT
INVESTIGATION REPORT**

Vessel type and name: Container ship FLEVODIJK
IMO number: 9412488
Gross tonnage: 9,994 tons
Accident type: Collision (Sea Wall)
Date and time: Around 0439 hrs (local time, UTC+9 hours), August 19, 2011
Location: The Sea Wall on the northern side of the Akashi Kaikyo Bridge, Kobe City, Hyogo Prefecture, Japan
Around 053°, 4,470 m from the Esaki Lighthouse located in Awaji City, Hyogo Prefecture
(Approximately 34° 37.9' N, 135° 02.0' E)

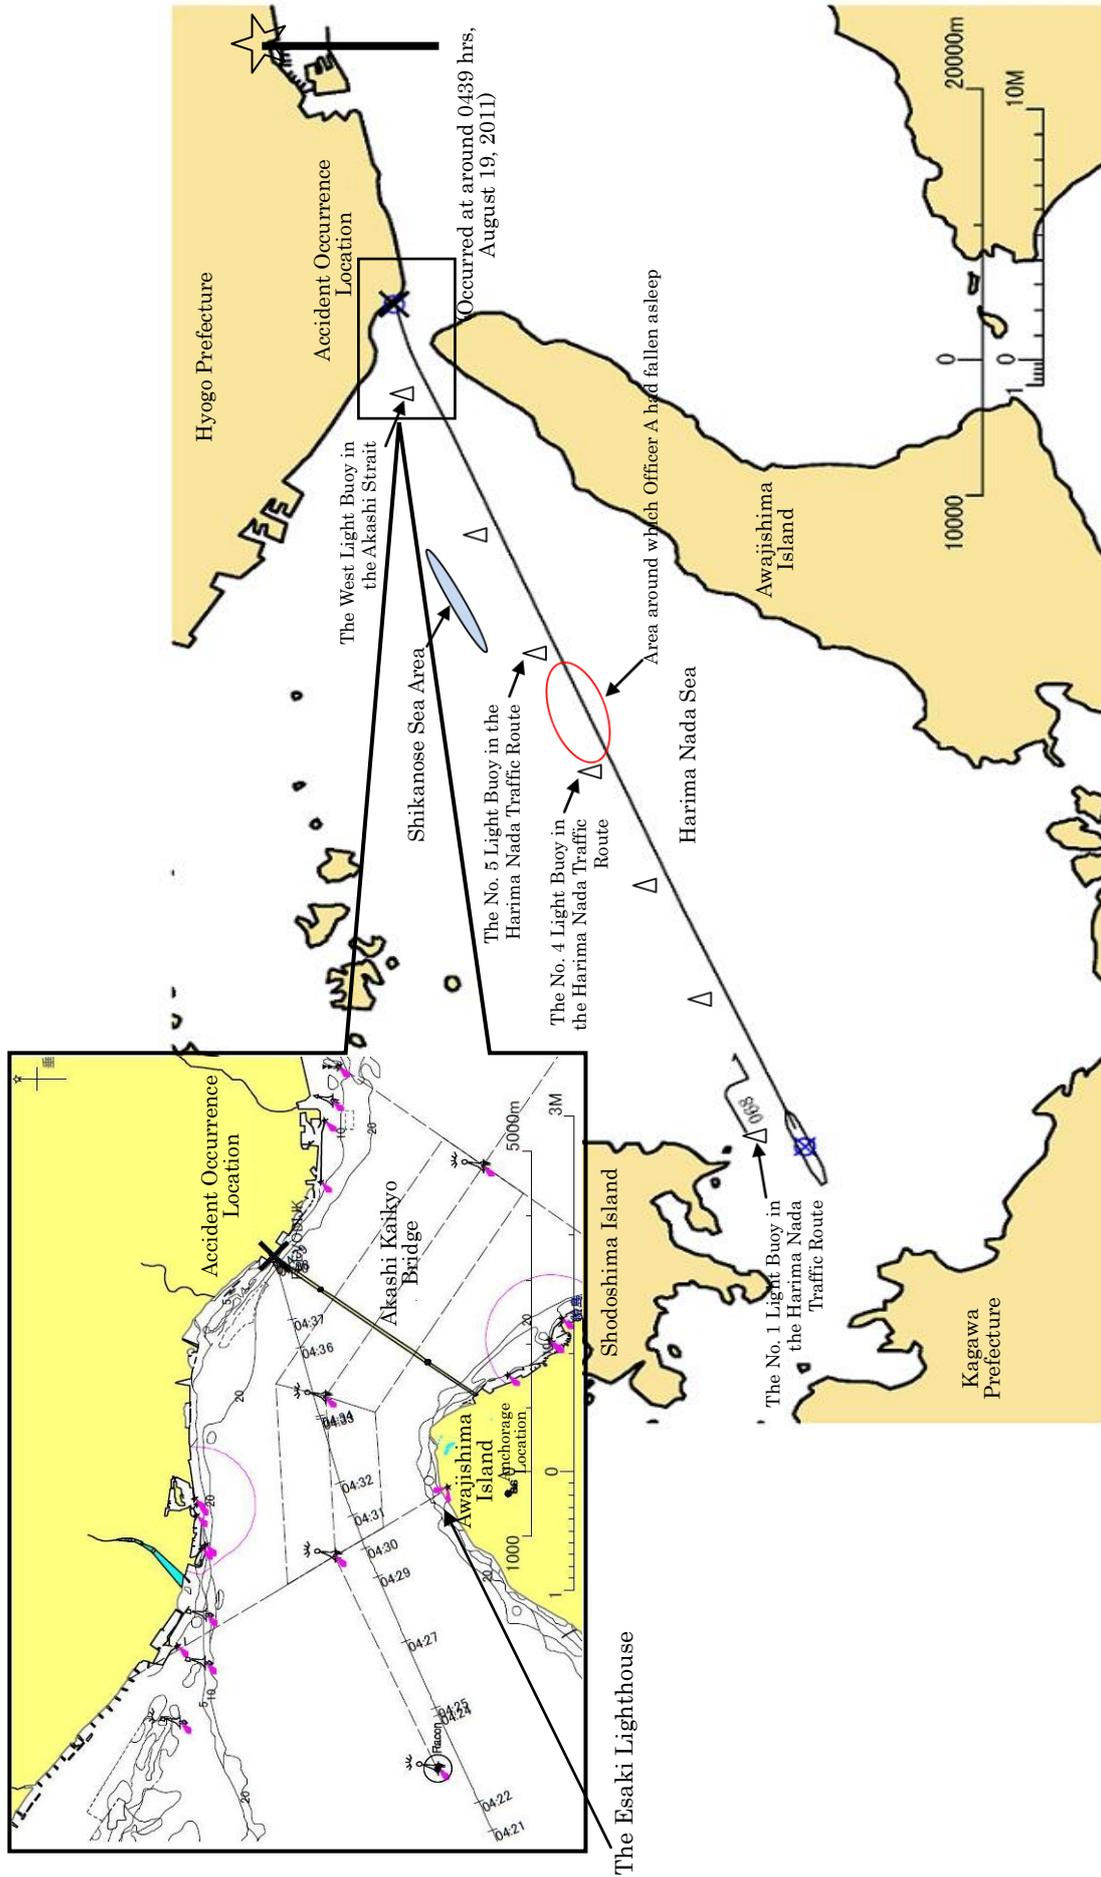
Attached diagram 1: Estimated Ship Positions

The time and the location of this accident were at around 0439 hrs, August 19, 2011 and at around 053°, 4,470 meters from the Esaki Lighthouse.

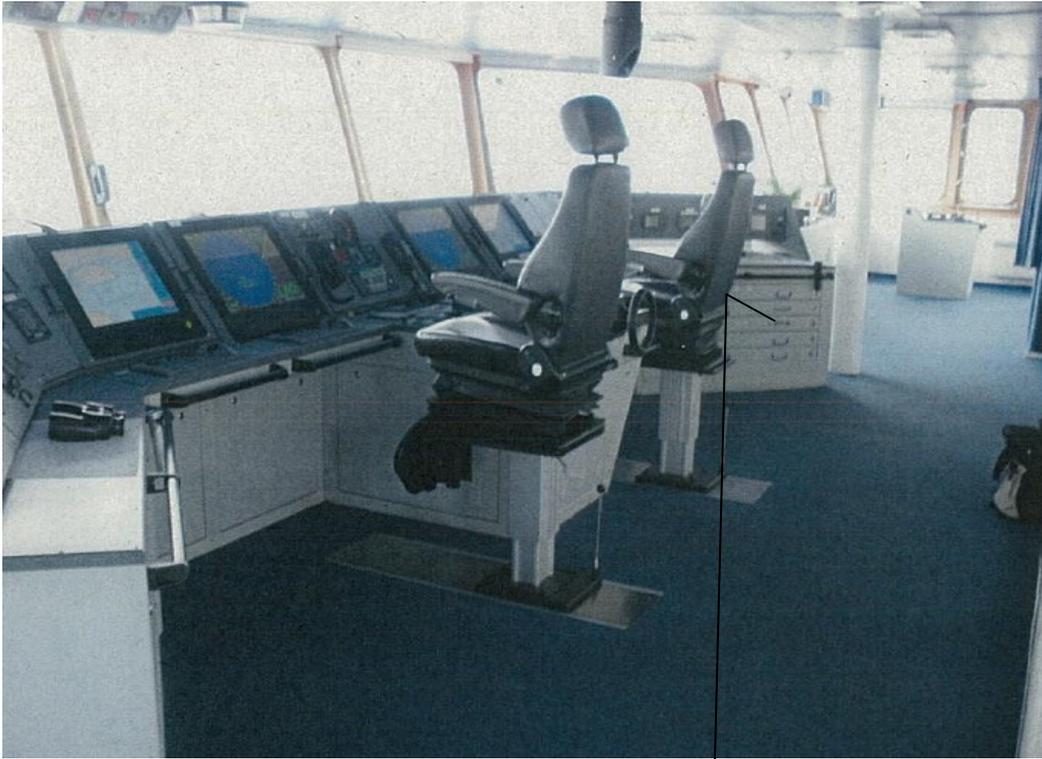
Photo 1: Appearance of the Wheelhouse (around the Chair)

Officer A began to feel drowsy and walked around in the bridge to relieve his drowsiness. Even though he failed to relieve his drowsiness, he thought he would not fall asleep because he had not slept during his watchkeeping duties in the past and continued on the watchkeeping duty by sitting on the Chair without his drowsiness being relieved. After approximately 20 minutes, he went into a twilight state, but kept sitting in the Chair without his drowsiness relieved. Finally, he had fallen asleep.

The Chair

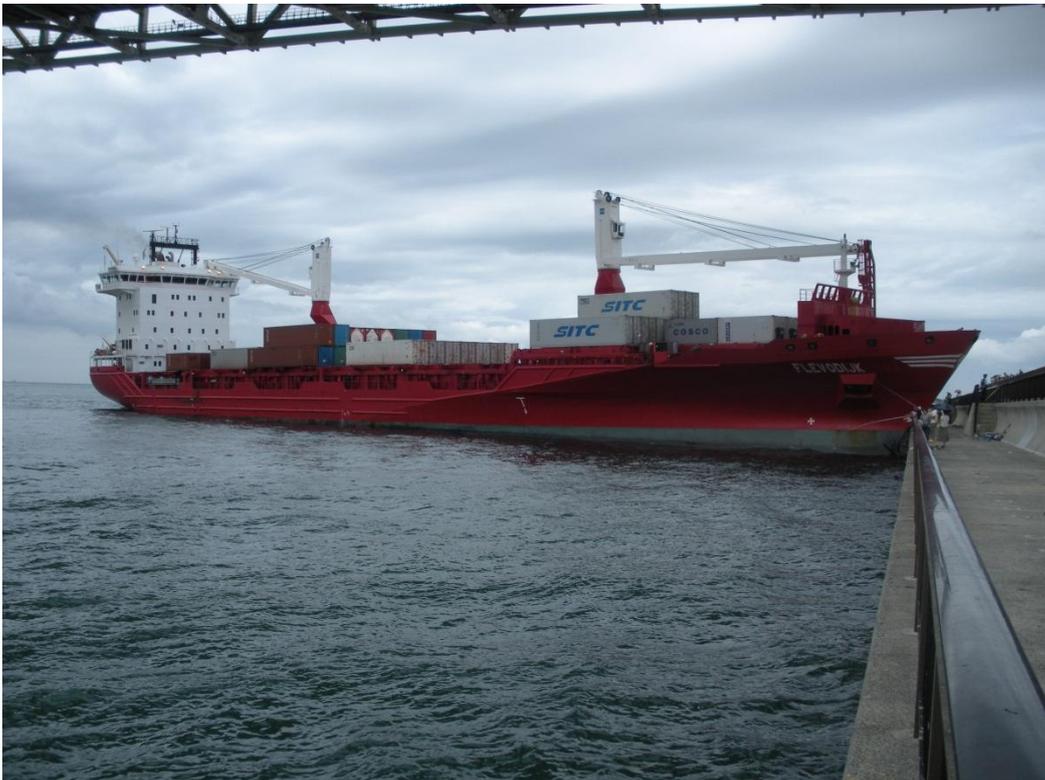
Photo 2: Collision Status with the Sea Wall

After coming up to the bridge, the Master confirmed that the time of the collision was around 0440 hrs with the clock in the Ship, which was verified as 0439 with the AIS records after further investigation. The location where the accident was occurred was at around 053°, 4,470 m from the Esaki Lighthouse, according to the measurement by Officer A.

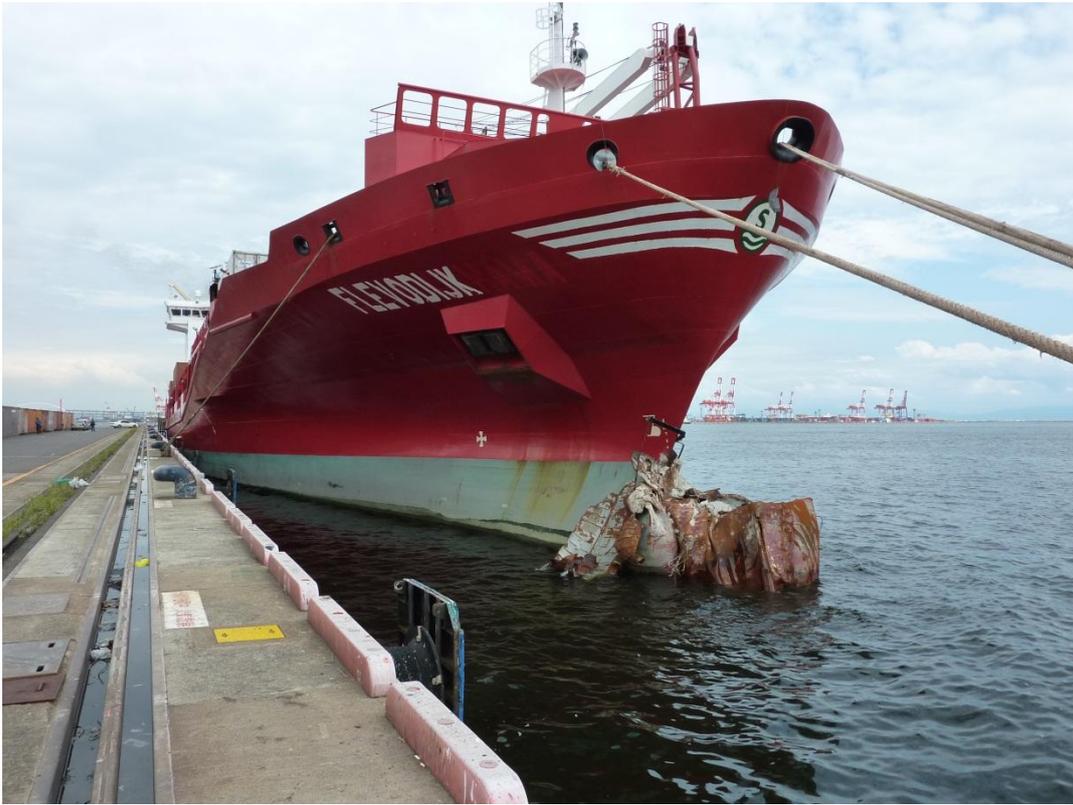
Photo 3: Damage to the Bulbous Bow

The Ship was damaged around the bulbous bow along with cracks, recesses and scratches including broken holes, in addition to water flooding of the forepeak tank^{*2}.

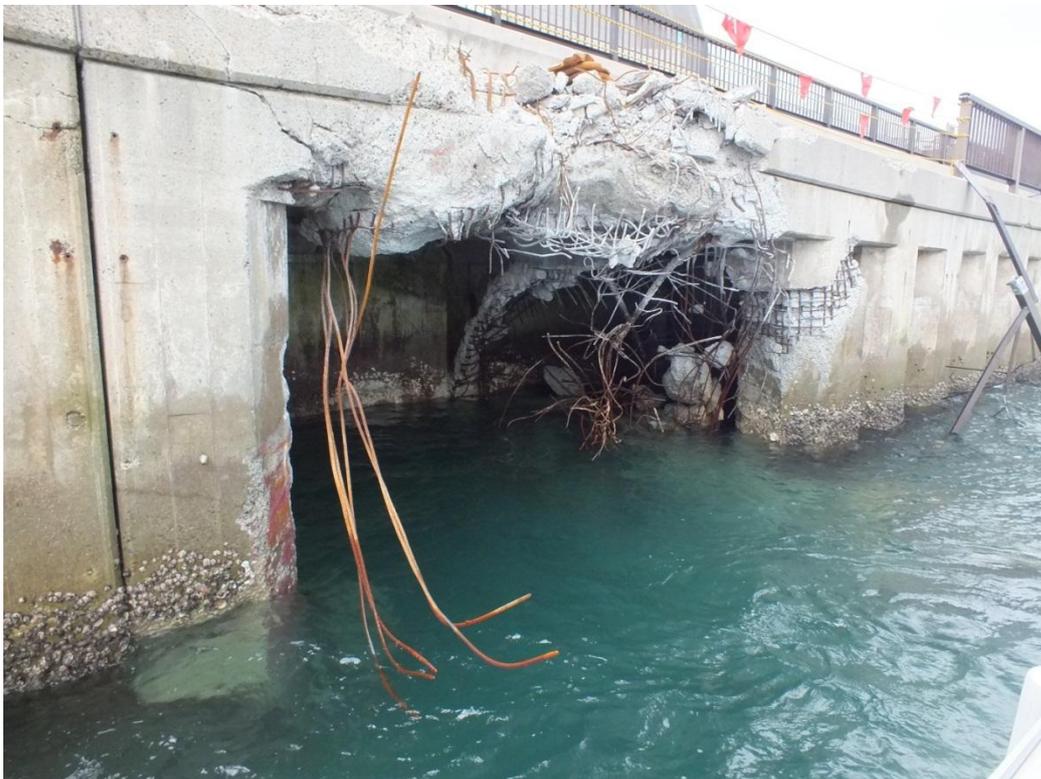
Photo 4: Damaged Part of the Sea Wall

For the Sea Wall, three pillars were lost and partial damage occurred on two pillars.
