MA2014-11

**MARINE ACCIDENT
INVESTIGATION REPORT**

Marine Accident Investigation Report

Accident type	Foundering
Date and time	Around 12:38 (local time, UTC+9 hours) on April 30, 2013
Location	Shiomi Quay 4, Sakai Senboku-Ku, Hanshin Port Around 196° in true bearing, approximately 0.85 nautical miles (M) from Senboku Otsu East Breakwater Lighthouse, Izumiotsu City, Osaka Prefecture (approximately 34°30.67'N 135°22.95'E)
Summary of the accident	Cargo ship Favor Sailing, with a master and eight other crew members on board, which listed over and foundered at around 12:38 on April 30, 2013 while moored at Shiomi Quay 4, Sakai Senboku-Ku, Hanshin Port. There were no injuries to the crew.
Process and progress of the investigation	The Japan Transport Safety Board appointed an investigator-in-charge (from the Kobe Office) and an investigator to investigate this accident on April 28, 2013. The Board later appointed an additional investigator-in-charge and an additional investigator. April 28, 30 and October 16, 2013: On-site investigation April 30, May 1, June 21, and October 17: Interviews

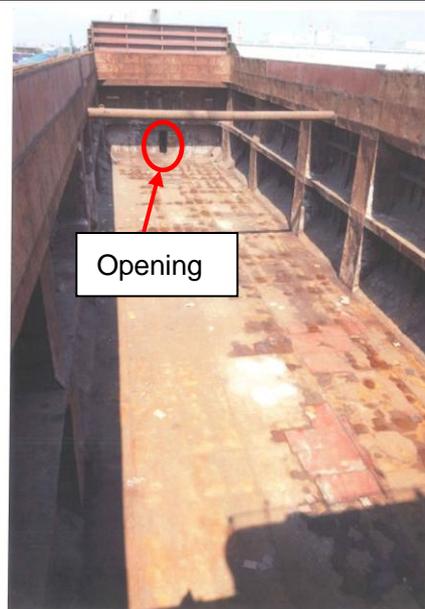
Photo 1. Cargo hold before loading

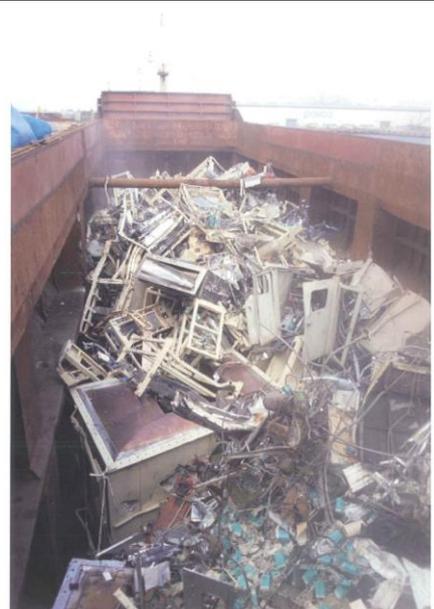
Photo 2. After lighter scrap was loaded

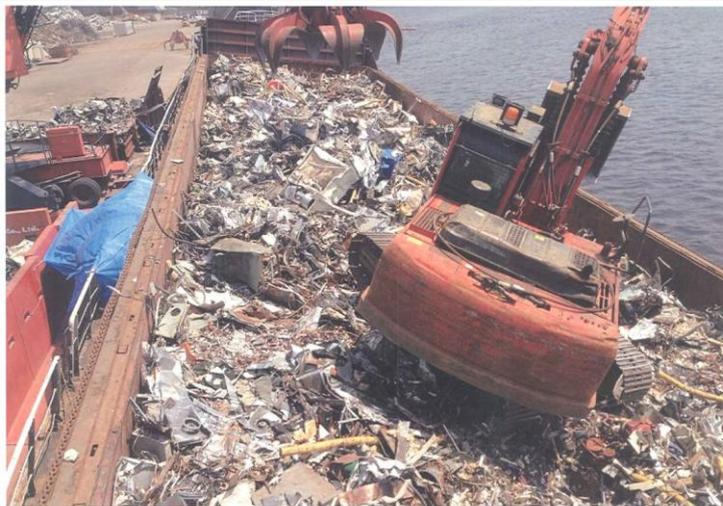
The stevedores resumed loading at around 8:00 on the 27th, and at around 10:00, they put a hydraulic power shovel with a weight of approximately 23 tons in the cargo hold and continued loading compressing cargo volume by running the power shovel on the scrap. (See Photo 3)

Photo 3. Scrap being compressed by a power shovel

- (4) It is probable that, during the loading on the 27th, the scrap was loaded and compressed by the hydraulic power shovel in the cargo hold, and that there was no lateral movement of cargo.

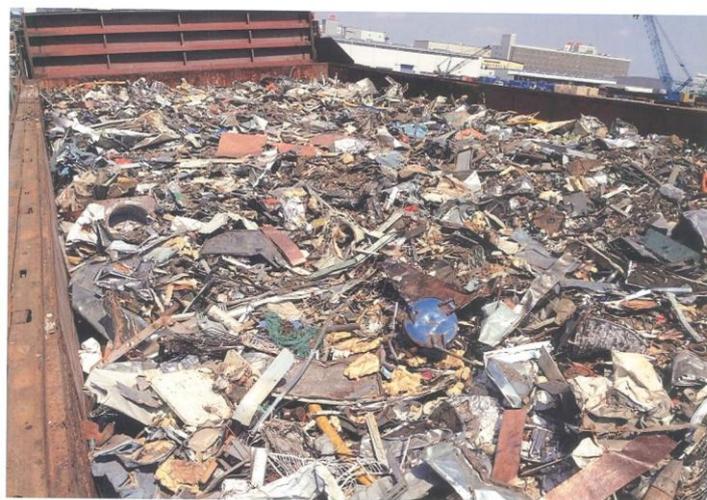
The Vessel listed approximately 3° to 4° to port at that time and the chief officer continued ballast operation until the Vessel returned to upright position at around 13:50. (See Photo 4)

Photo 4. Cargo hold when loading was completed

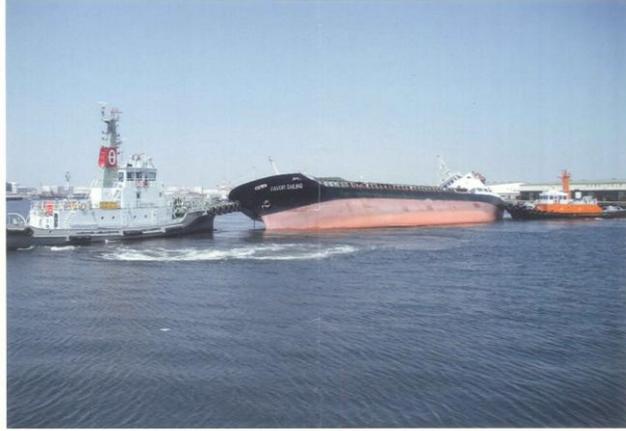
Photo 5. The Vessel under towing

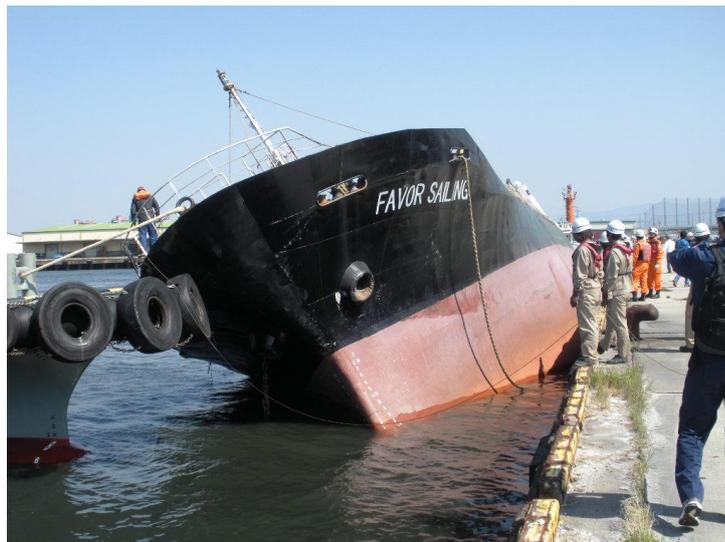
towline from another tug boat was attached to the stern of the Vessel at around 08:30, and after the crew who returned to the Vessel cut off the anchor chain at around 10:40, the tug boats started to tow the Vessel towards No.4 Quay, Shiomi Wharf, Sakai Senboku-Ku, (hereinafter referred to as "Shiomi Quay") at around 12:30 and, when moored the Vessel's portside alongside the Shiomi Quay at around 14:00, the Vessel listed approximately 28° to starboard. (See Photo 5 and Photo 6)

Photo 6. The Vessel arriving at Shiomi Quay

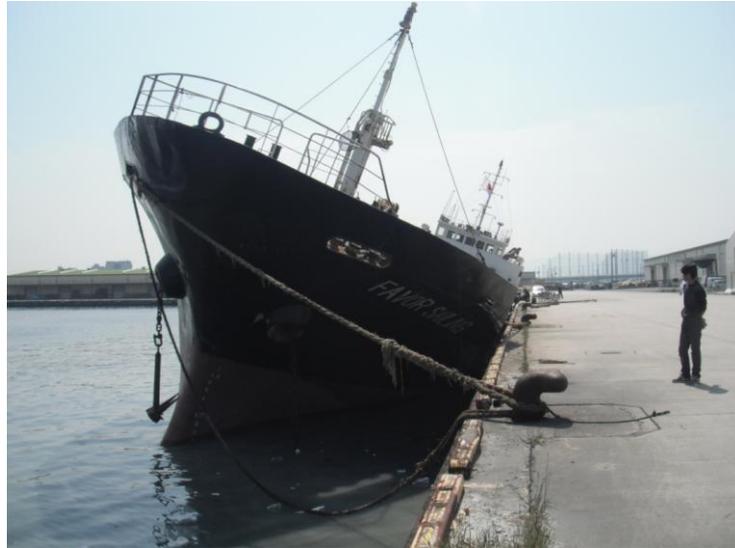
The list of the Vessel was reduced to approximately 8° to starboard at around 03:00 on the 29th, then the Vessel suddenly listed approximately 22° to port. (See Photo 7)

Photo 7. The Vessel listed to port on the 29th

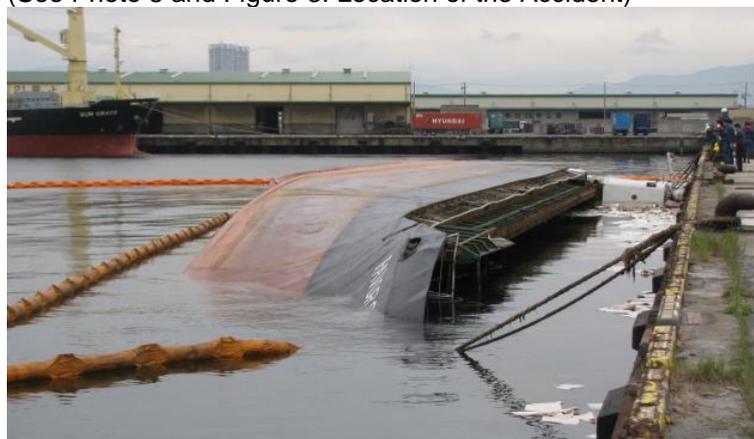
The Vessel rolled over to port and foundered at around 12:38 on the 30th.
(See Photo 8 and Figure 3. Location of the Accident)

Photo 8. The Vessel rolled over and foundered

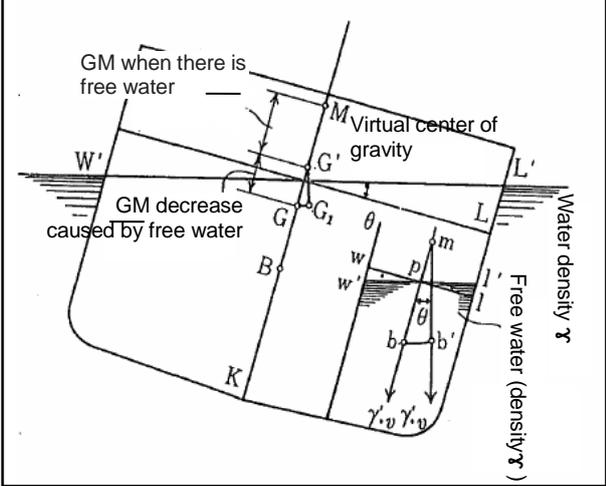
<p>Figure 2. Reduction of GM by free water</p> <p>Where i is secondary moment of the tilt axis p of the free surface wl of the free water, bm is equivalent to the radius of the meta center. $bm=i/v$</p> <p>While the center of gravity G of the entire ship will increase to GG' if the center of gravity of the free water increases to bm, that quantity, in other words the quantity of GM decrease, can be expressed in the following formula. $GG' = bm \cdot \gamma' v / \gamma V = \gamma' i / \gamma V$</p> <p>When the density of liquids inside and outside is equal, $GG' = i/V$ V indicates the volume of displacement of the hull.</p> <p>It should be noted that GG' does not relate to the volume v of the free water, but rather only relates to the form of the free surface.</p>

<p>Accordingly, even though there is only a small volume of free water, if there is a broad free surface, the stability is significantly reduced.</p> <p>GG' subtracted from GM is referred to as virtual metacentric height (G'M).</p>
Other matters	<ol style="list-style-type: none"> (1) The chief officer had shipped scraps, loaded in Japan to the Haimen Port or the Ningbo Port of the People's Republic of China, four times since he joined the Vessel and knew that holes were made on the bottom of the cargo hold hit by a grab of a crane during discharging. (2) The Vessel entered a dock in March 2013, repaired the bottom of cargo hold, and had a valid Cargo Ship Safety Construction Certificate issued by a classification society. (3) The Vessel, when the ship was anchored at Hanshin Port, Sakai Senboku-Ku, at around 18:05 on April 25, was loaded with approximately 25.6t of fuel oil and approximately 2,200l of lubricating oil onboard. (4) At around 08:00 on the 26th, the depths of the bilge water in the aft part of both sides of the cargo hold were approximately 20cm at the port side and 50cm at the starboard side; the quantities were not as much as they would overflow from bilge wells with the depth of approximately 50cm, and there was no free water in the cargo hold. (5) The Vessel, When carried out initial survey before loading after mooring at Sukematsu Warf in Hanshin Port, Sakai Senboku-Ku, on the 26th, there was no free water in the cargo hold, and the forward draft was approximately 1.70m, and the after draft was approximately 2.88m. (6) When the final survey after loading was carried out on the 27th, the weight of the loaded scrap was approximately 920t, and the forward draft was approximately 3.57m and the after draft was approximately 4.63m. (7) Port state control officers of the Ministry of Land, Infrastructure, Transport and Tourism carried out PSC (port state control) on the Vessel on 29th and observed that, seawater leaked into the cargo hold from a hole with a length of approximately 9cm and a width of approximately 3cm on the tank top of the No. 1 port ballast tank (bottom plate of the store room), the Vessel listed approximately 25° to port, the depth of the bilge was approximately 1.92m when measured at the port side in the aft part of the cargo hold; seawater retained in the cargo hold, and, there was a hole in the center guarder separating the ballast tank into port and starboard sections. The PSC officers instructed the master to find cause of sea water spilt in the cargo hold and the cause of approximately 25° of the listing of the Vessel to port and issued an Order to Conform to Technical Standards concerning repair of the hole. (See Photo 9)

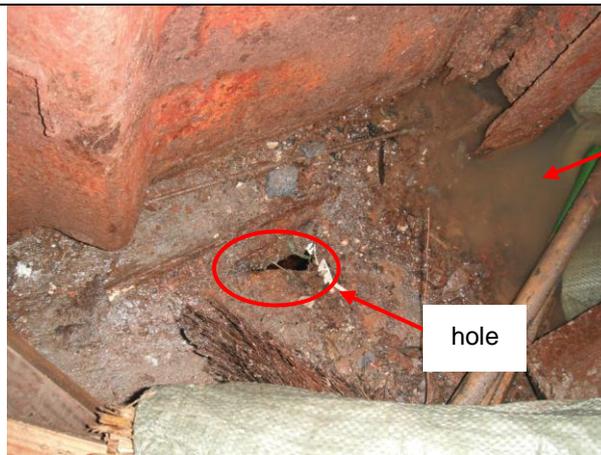
Photo 9. Hole on the bottom of store room

- (1) As the Vessel was 29 years old, and from the conditions of the holes that occurred on the bottom of store room (tank top of No.1 ballast tank), bottom of the cargo hold (tank tops of No.1 and No.3 ballast tank) and the center guarder of No.1 ballast tank, it is probable that the hull had been worn out with age.
- (2) According to the results of the calculation, it is probable that conditions of the Vessel including the stability were as displayed in Table 1.
