MA2016-2

**MARINE ACCIDENT  
INVESTIGATION REPORT**

<b>Accident type</b>	Fatality of a worker
<b>Date and time</b>	Around 15:18 on September 1st, 2014
<b>Location</b>	Kashima Port, Timber Quay, Ibaraki Prefecture (Approximately 35 ° 55.4'N, 140 ° 39.7'E)
<b>Summary of the Accident</b>	While the Cargo ship CAMPANULA was handling operation of unloading raw wood in Kashima Port at around 15 hours 18 minutes on September 1, 2014, a raw wood which had been suspended hit a cargo worker, and the worker died.
<b>Process and Progress of the Investigation</b>	<p>(1) Set up of the Investigation The Japan Transport Safety Board appointed an investigator-in-charge and other investigators to investigate this accident on September 3, 2014.</p> <p>(2) Collection of Evidence On September 3, and October 19 and 20 in 2014, on-site investigation and interviews were held; on September 4, and November 13 and 14 in 2014, interviews were held; on May 28 and June 1, 2015, answer document received.</p> <p>(3) Comments from Parties Relevant to the Cause Comments on the draft report were invited from parties relevant to the cause of accident.</p> <p>(4) Comments from the Flag State Comments on the draft rep

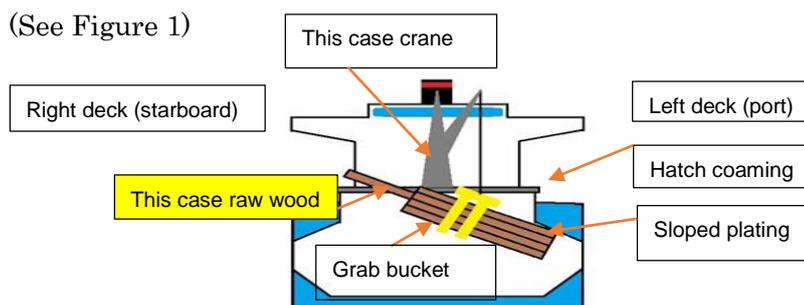
This case crane man, after starting the lift-up, recognizing that there was "a raw wood extending by 4-5 meters outside of the bunch" (hereinafter referred to as "this case raw wood") included in this case bunch of raw wood, with this he knew that the whole length of this case bunch of raw wood exceeds the width of the opening of the cargo hold, he started to lift-up by pushing one edge part of this case bunch of raw wood against the sloped plating of top side tank (hereinafter referred to as the "Sloped plating") on the left side deck, therefore this case bunch of raw wood was kept slant.

Figure 1 The lift-up situation of this case bunch of raw wood using the sloped plating

<p><b>Safety Actions</b></p>	<p>After this accident, Company A considered a recurrence preventive measure and took the measures as follows.</p> <p>(1) As a revision of the Standard Operation Manual the following items were added and education and guidance for the working staffs were performed.</p> <p>(i) When it is felt dangerous, stop the deck crane, and resume the work after being sheltered in a safe place once.</p> <p>(ii) When grasping had been made in the state where some raw wood extended out of the bunch widely, try to grasp it again properly.</p> <p>(iii) It is prohibited to lift-up when the full length of the bunch of raw wood exceeds the width of the opening or the edge part of the bunch of raw wood had been caught at the opening.</p> <p>(2) It was decided to carry the following thoroughly.</p> <p>(i) Do the KY activity securely in a meeting before starting of loading/unloading work.</p>

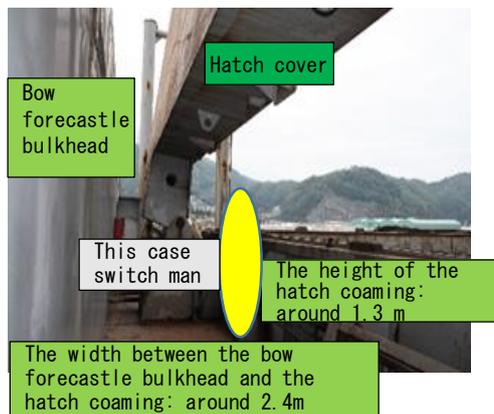
This case crane man witnessed at around 15:18 hours, while lifting-up this case bunch of raw wood in the slant state, that the bunch started to circle counter-clockwise, moved through the gap (around 1.0 meter) between the upper edge of the hatch coaming on the bow side of No.1 cargo hold and the lower edge of the hatch cover, and bounced by the forecastle bulkhead after colliding to this case switch man.

Photo 3 Bow side of No. 1 cargo hold

- (1) This case raw wood was about 12.0 m of length, about 0.7 m of diameter and about 1 t of weight.
- (2) In the hatch coaming area of No. 1 cargo hold bow side, the width between the bow forecastle bulkhead and the hatch coaming was about 2.4m, while the height of the hatch coaming was about 1.3m.

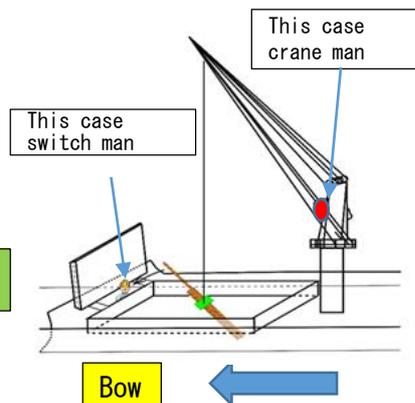
Figure 2 Circle state of this case bunch of raw wood
